Vehicle Safety Compliance Testing
for Occupant Crash Protection,
Windshield Mounting, Windshield Zone Intrusion,
and Fuel System Integrity

Kentron, Inc.
1994 Kentron SS Sport Top Van
NHTSA Number: CR1301
TRC Test Number: 940322

Transportation Research Center Inc.
10820 State Route 347
East Liberty, Ohio 43319

Final Report

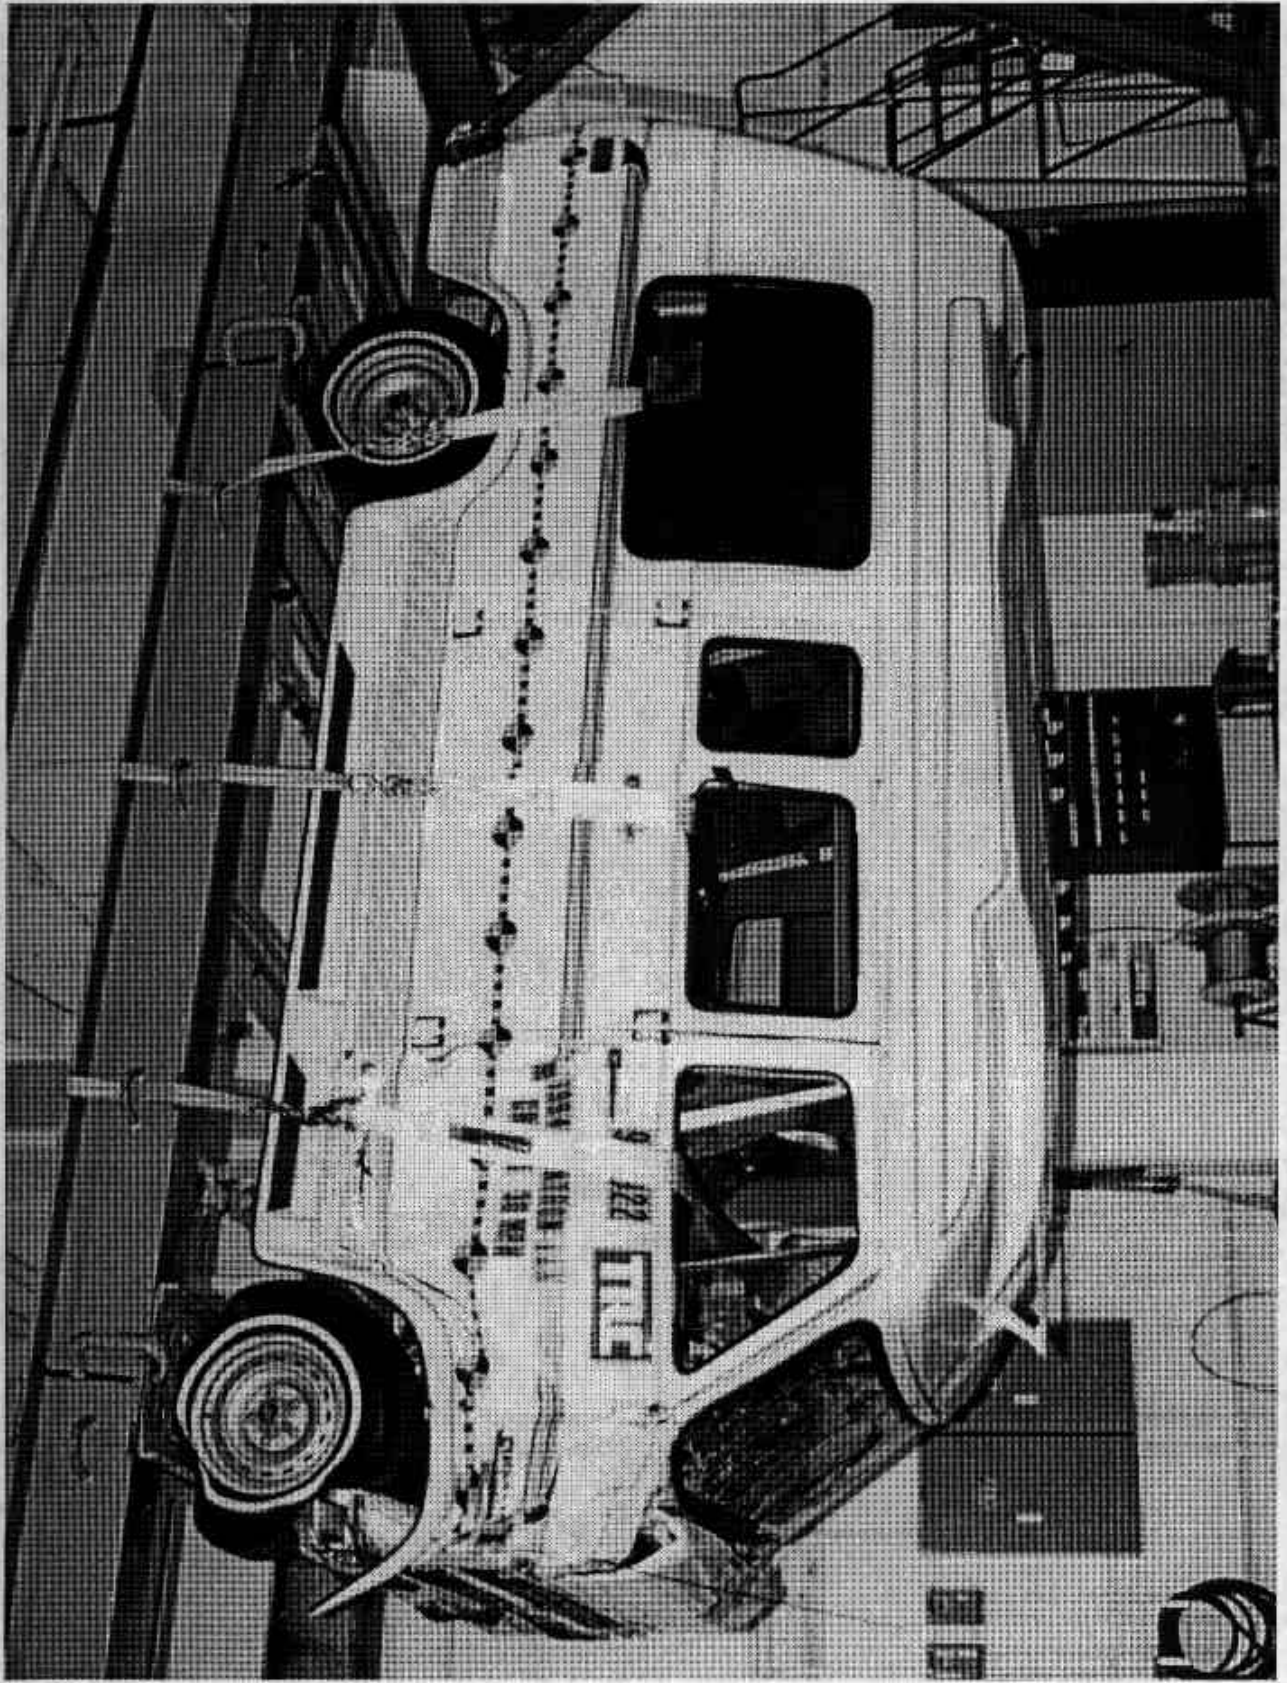
Figure A-61. Post-test Vehicle on Static Rollover Machine View

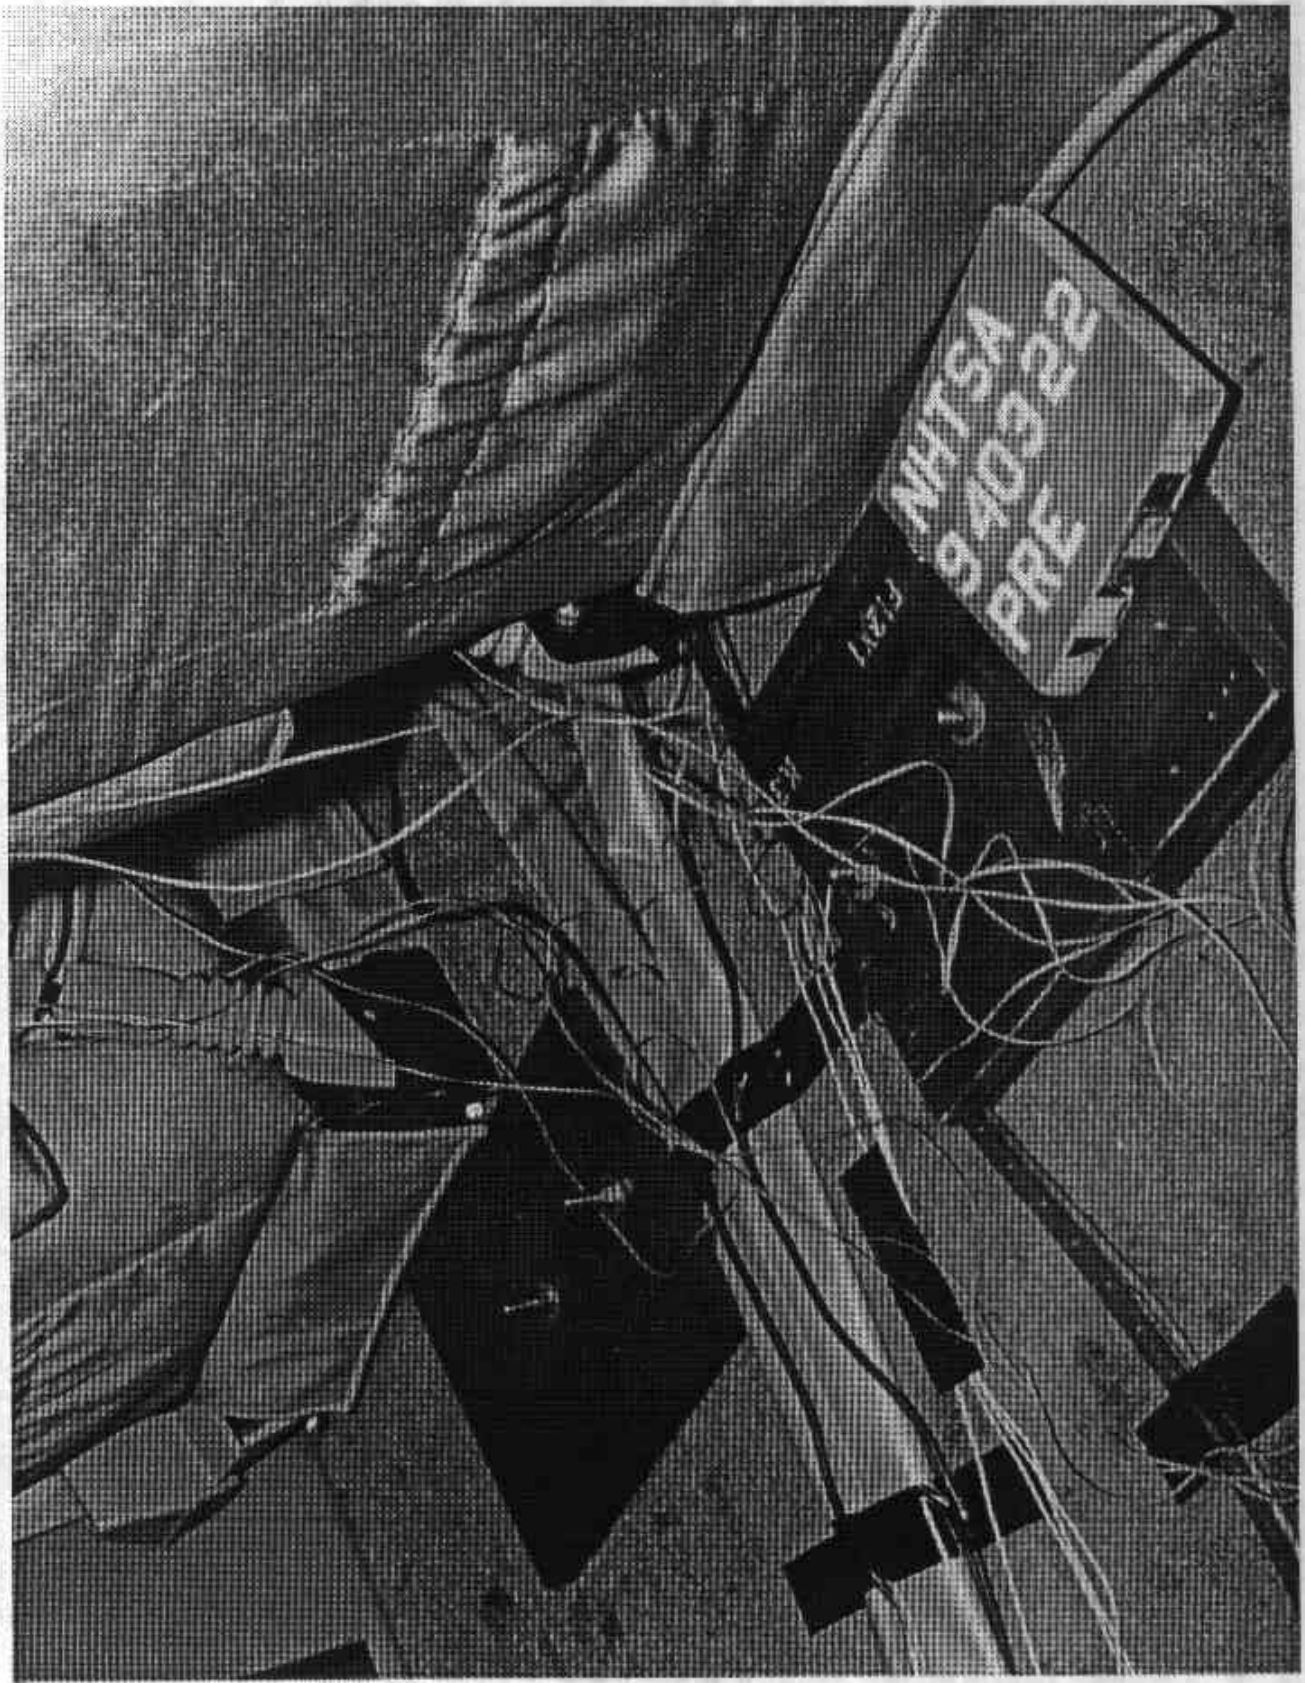
Figure A-62. Pre-test Ballast Location View
A-63

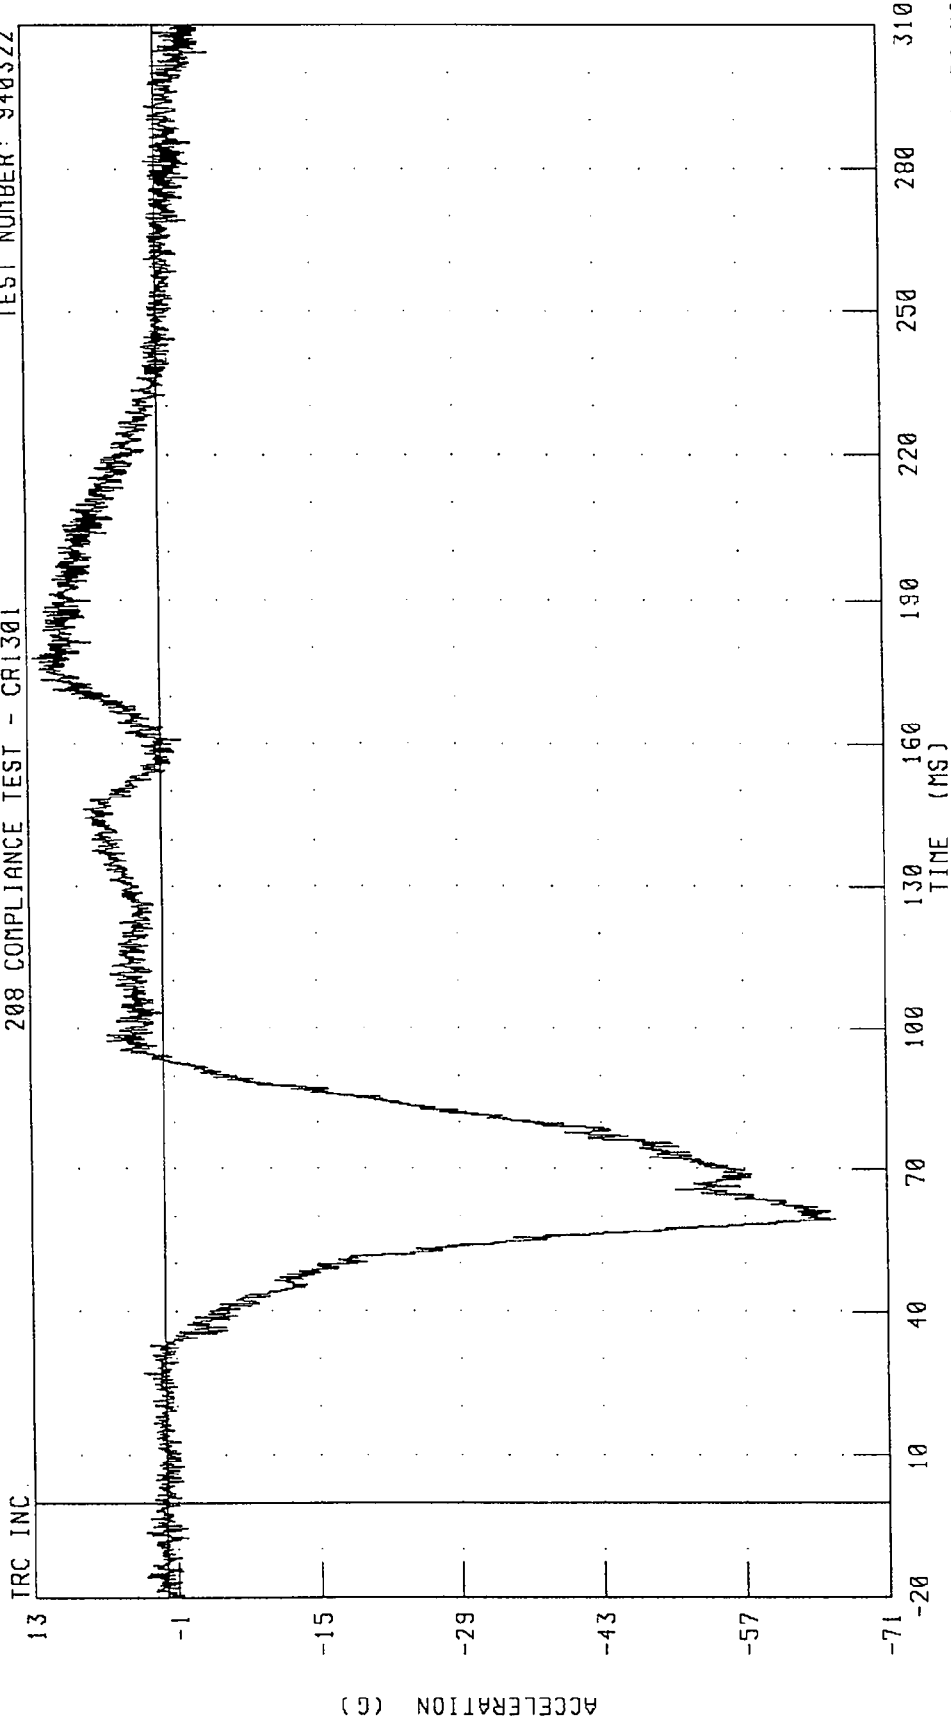
1994 KENTRON SS SPORT TOP VAN INTO FLAT FRONTAL BARRIER
DRIVER HEAD X-AXIS ACCELERATION
208 COMPLIANCE TEST - CR1301

CHANNEL: HEDXG1 FILTER: CH. CLASS 1000

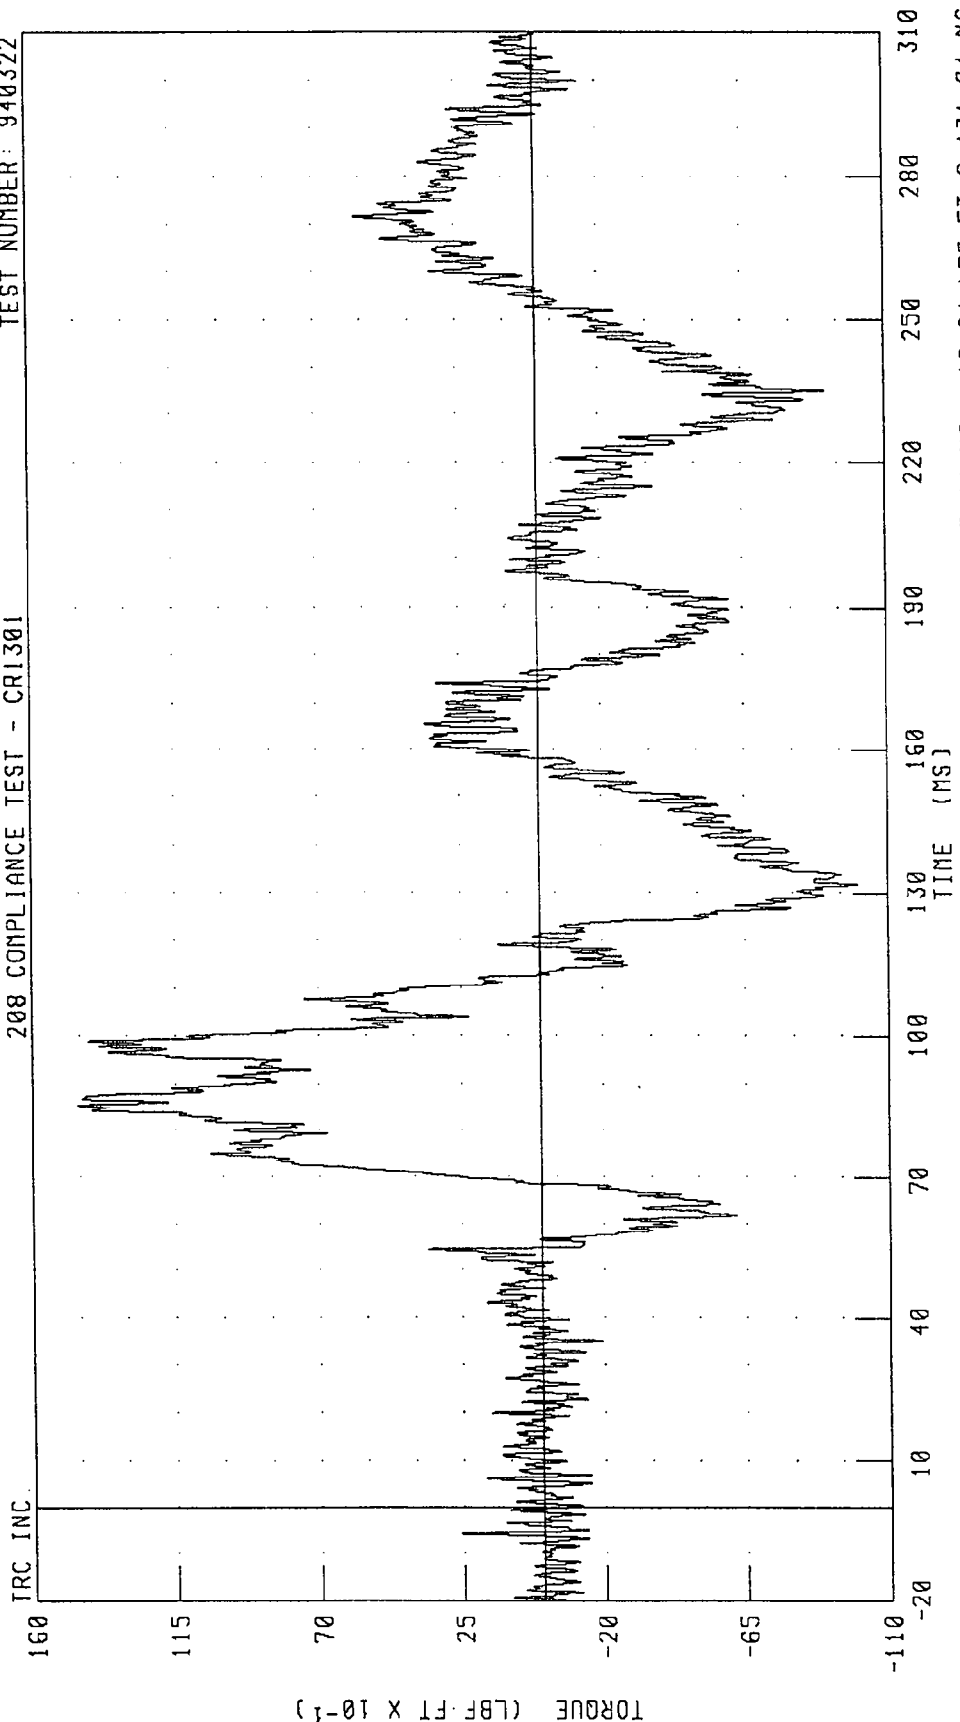
1994 KENTRON SS SPORT TOP VAN INTO FLAT FRONTAL BARRIER
RIGHT FRONT PASSENGER NECK MOMENT ABOUT Y AXIS
208 COMPLIANCE TEST - CR1301

CHANNEL: NEKYM2 FILTER: CH. CLASS 600 PEAK DATA: 122.77 LBF-FT @ 103.44 MS; -47.91 LBF-FT @ 233.04 MS

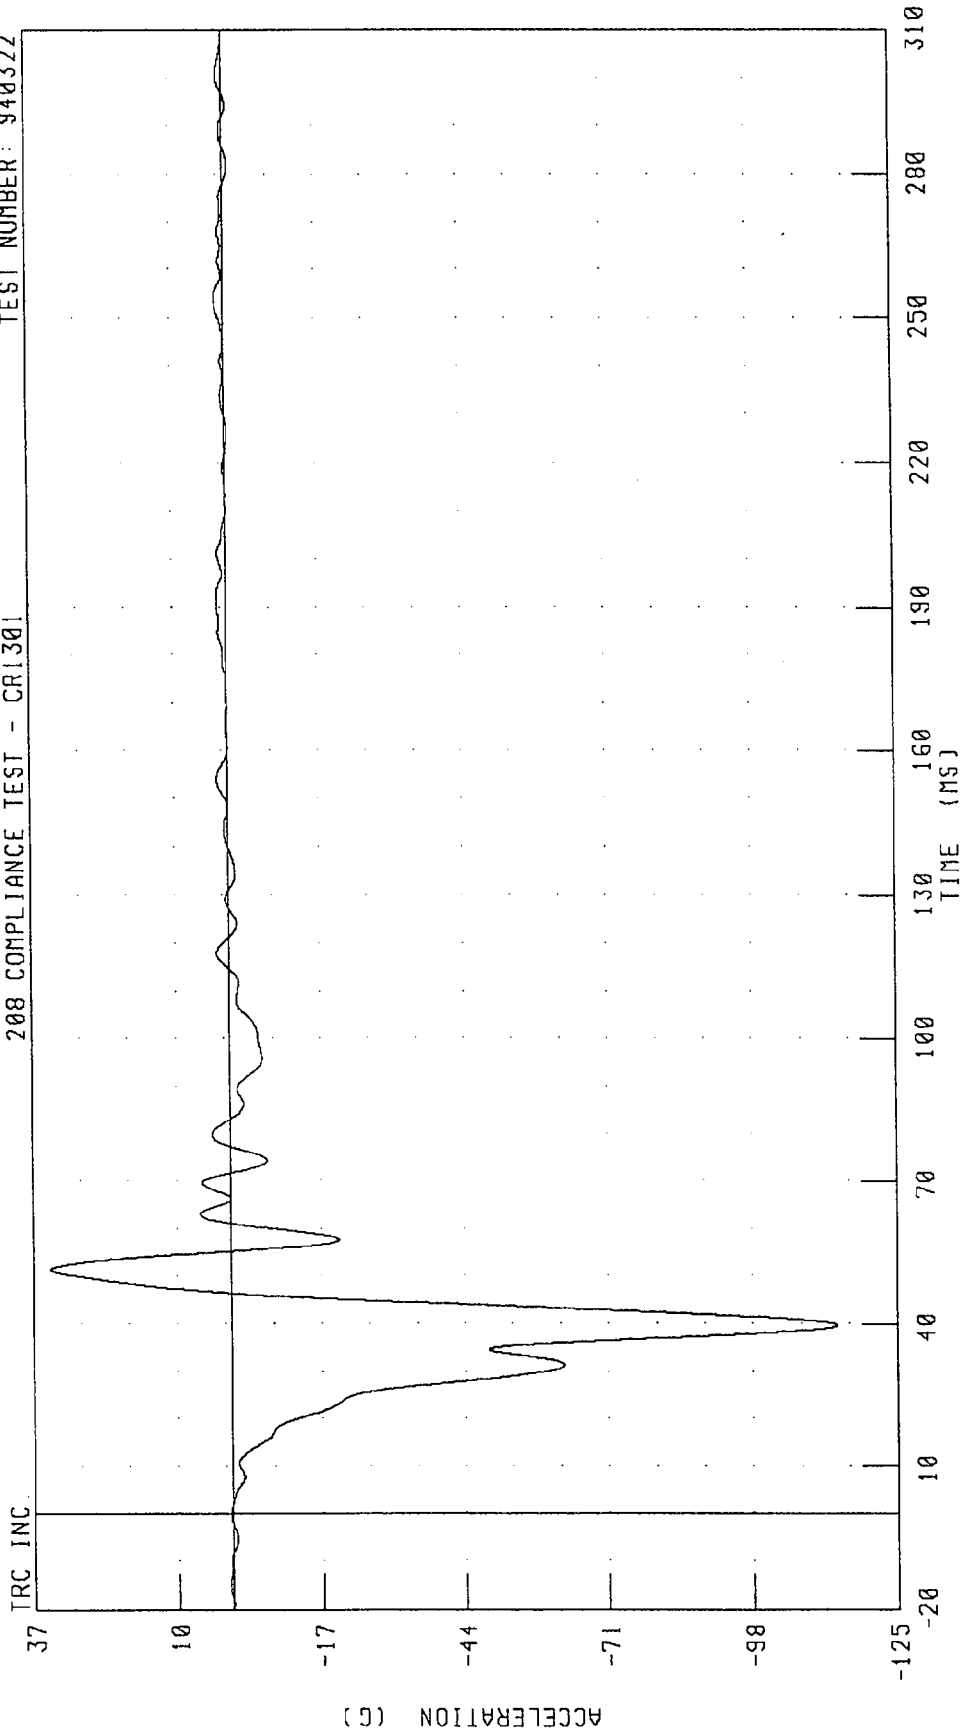
1994 KENTRON SS SPORT TOP VAN INTO FLAT FRONTAL BARRIER
ENGINE BOTTOM BLOCK X-AXIS ACCELERATION
208 COMPLIANCE TEST - CRI301

CHANNEL: ENGXC2 FILTER: CH. CLASS 60

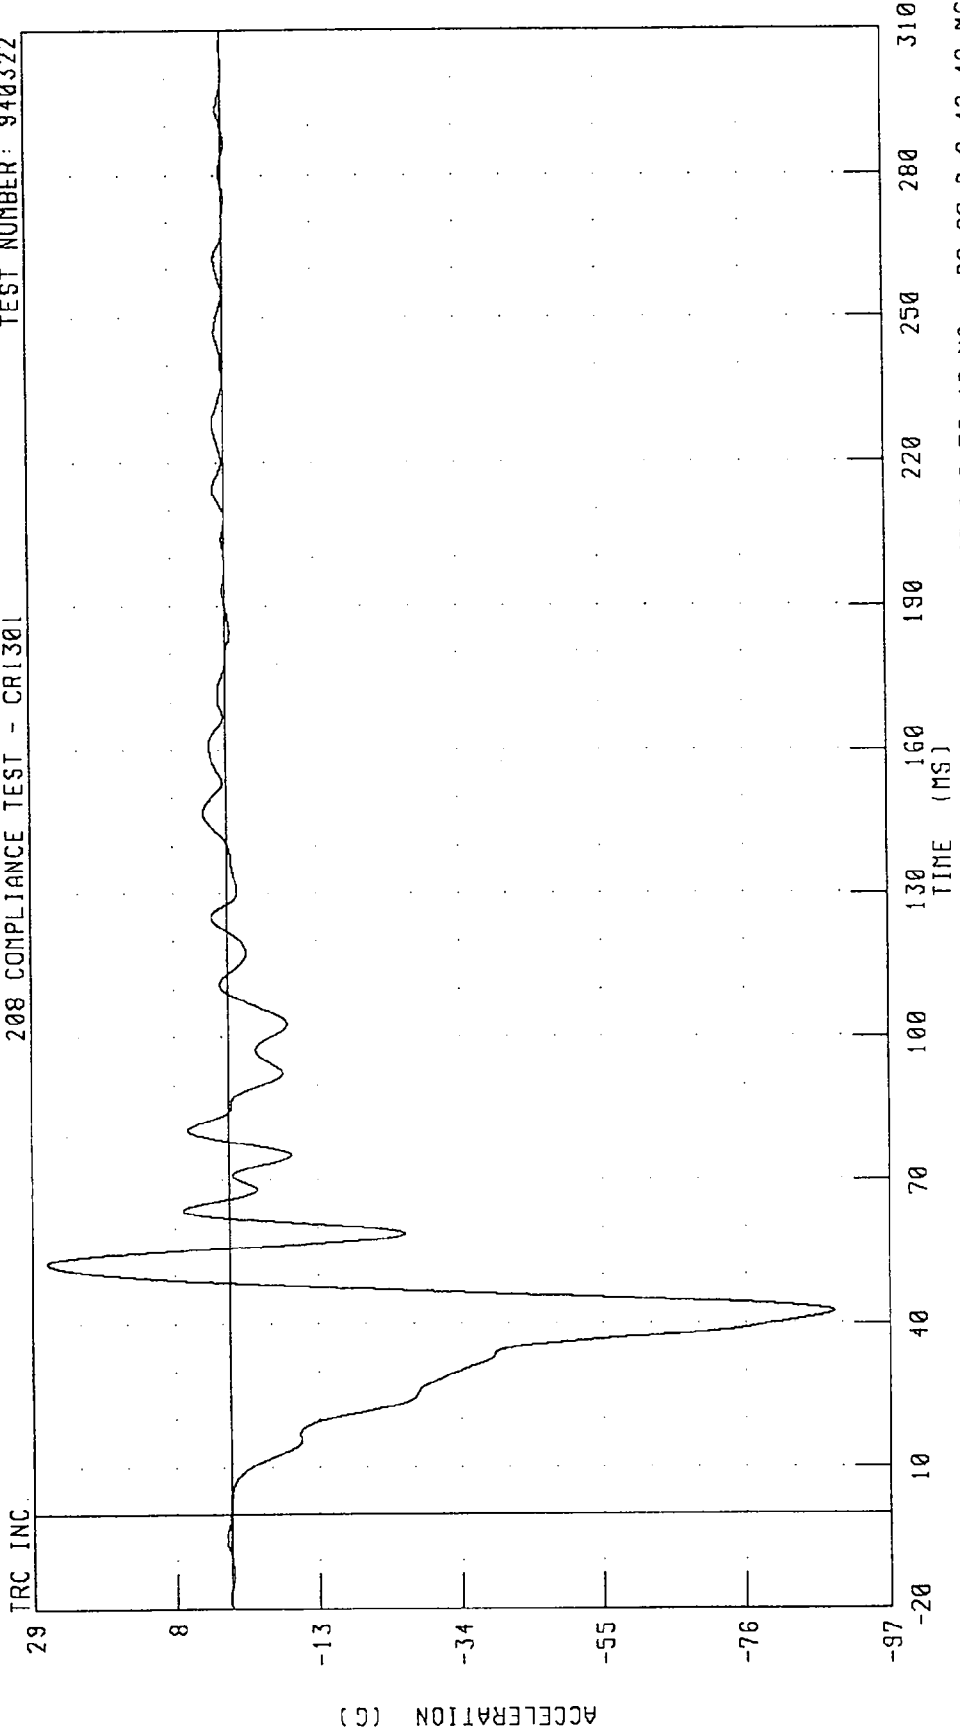
1994 KENTRON SS SPORT TOP VAN INTO FLAT FRONTAL BARRIER
RIGHT BRAKE CALIPER X-AXIS ACCELERATION
208 COMPLIANCE TEST - CRI301

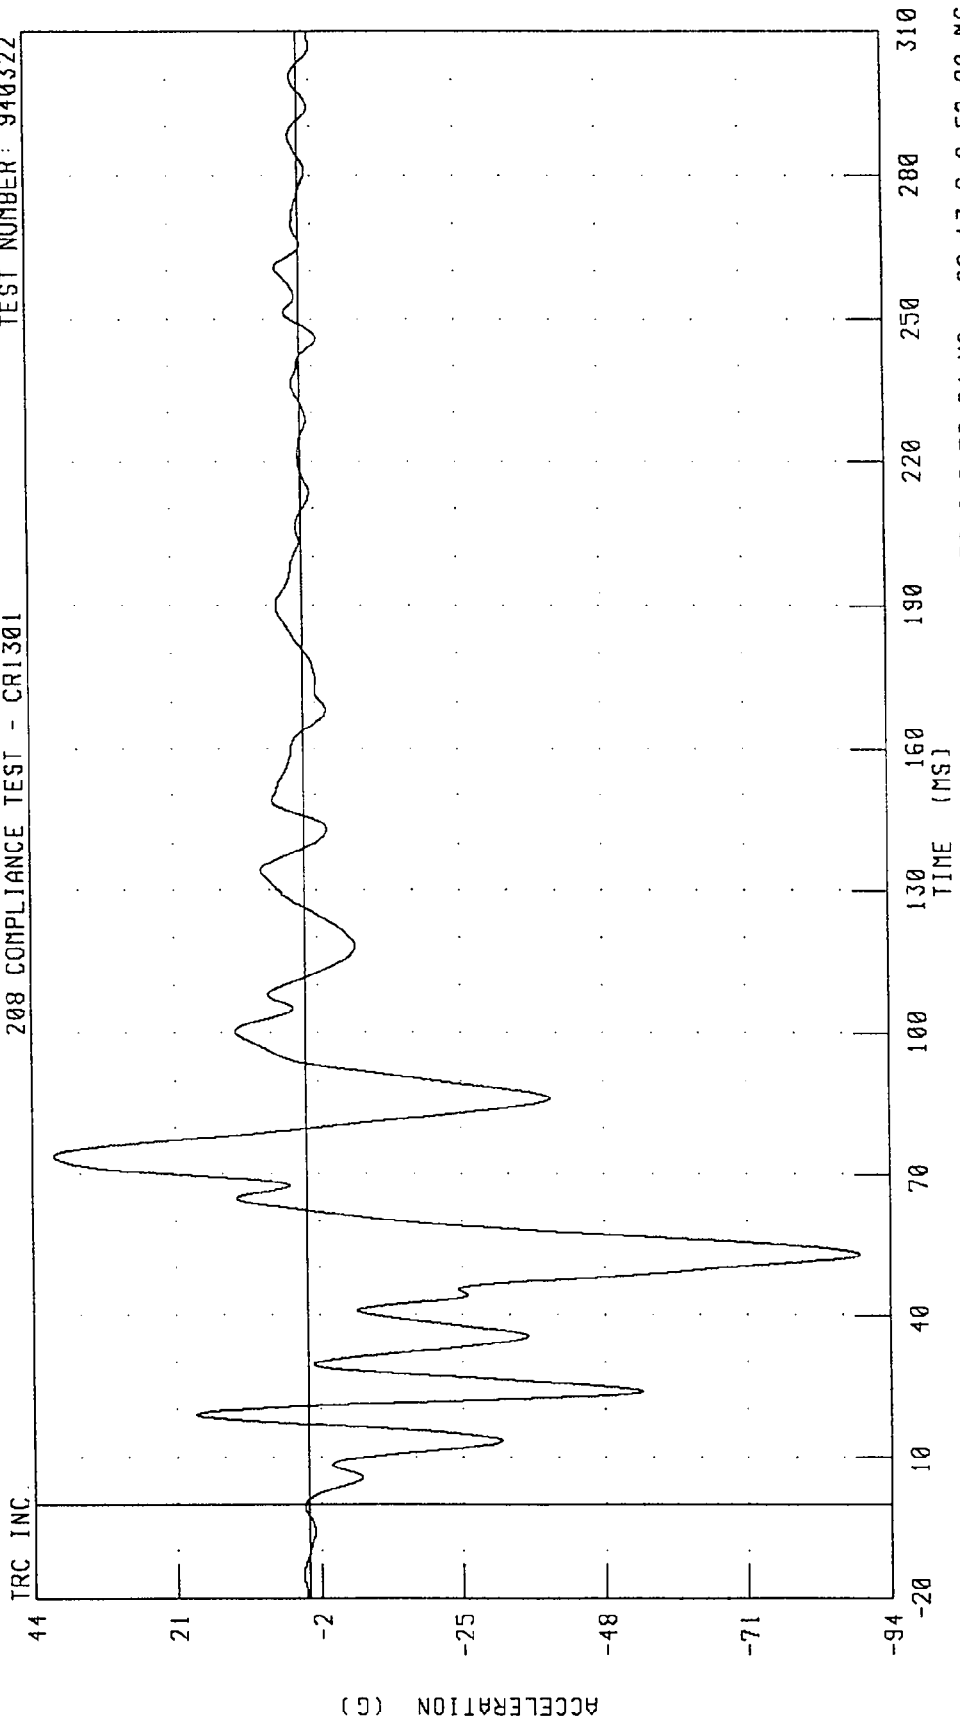
1994 KENTRON SS SPORT TOP VAN INTO FLAT FRONTAL BARRIER
LEFT BRAKE CALIPER X-AXIS ACCELERATION
208 COMPLIANCE TEST - CRI301

CHANNEL: BCLXG1 FILTER: CH. CLASS 60

PEAK DATA: 60.02 G @ 59.84 MS; -83.15 G @ 41.84 MS

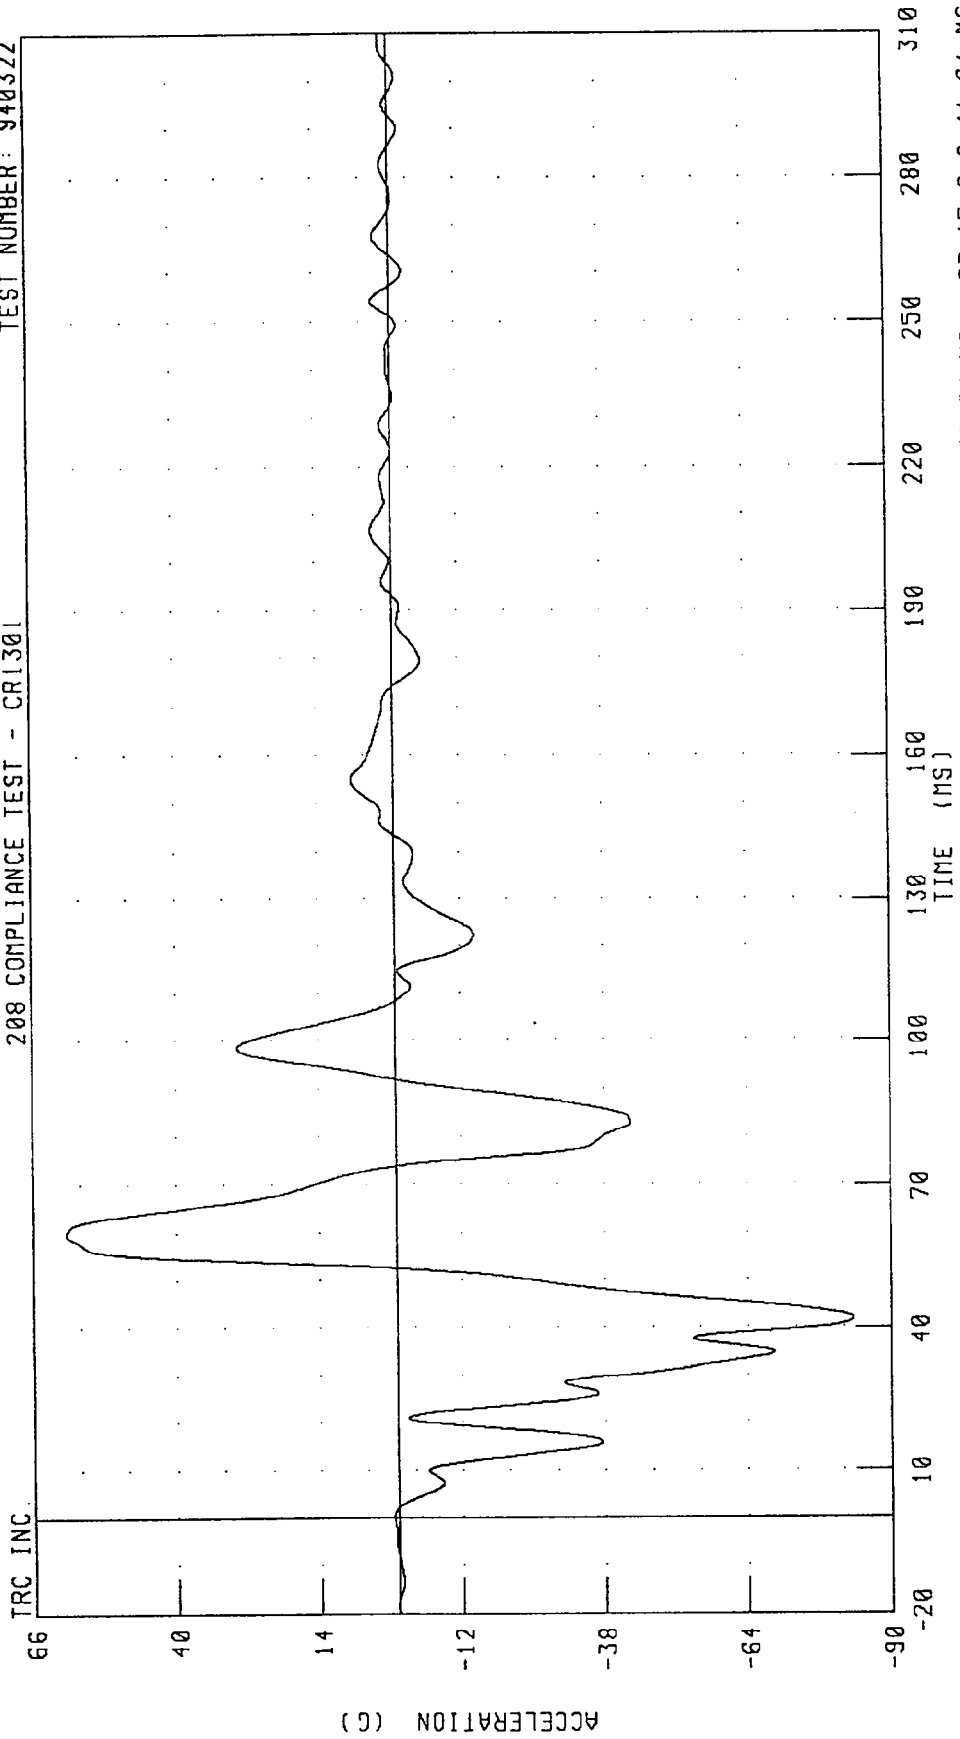
1994 KENTRON SS SPORT TOP VAN INTO FLAT FRONTAL BARRIER
DASH PANEL CENTER X-AXIS ACCELERATION
208 COMPLIANCE TEST - CRI301

CHANNEL: DPCXG1 FILTER: CH. CLASS 60

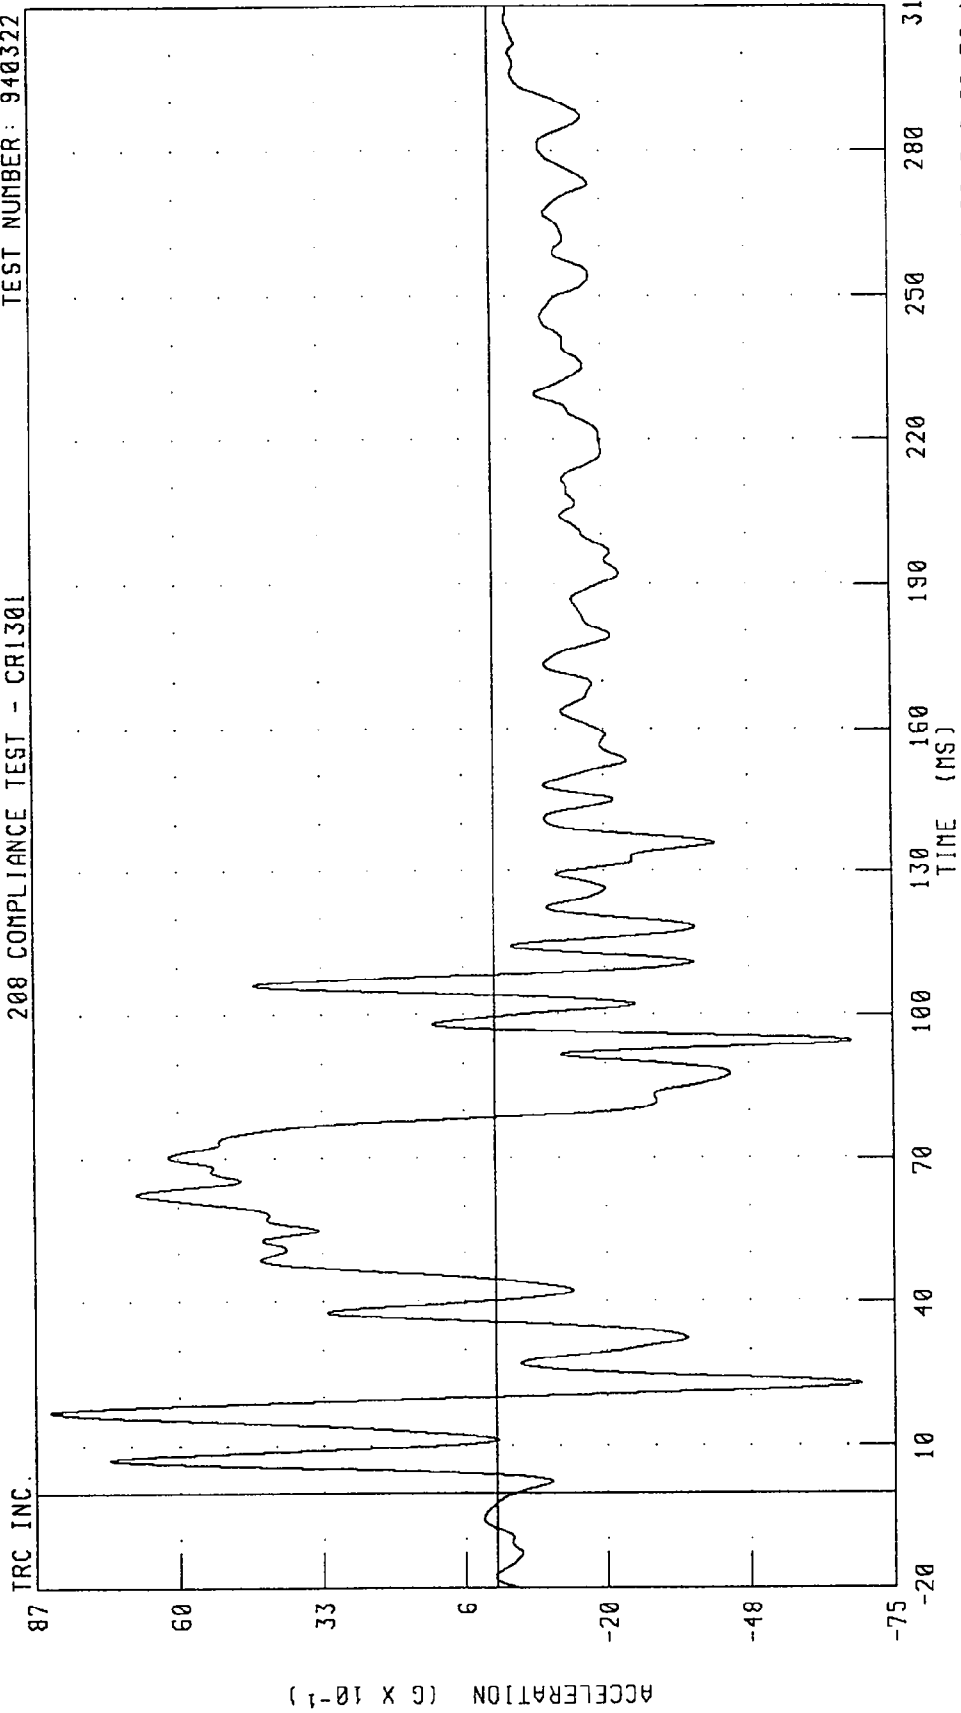
1994 KENTRON SS SPORT TOP VAN INTO FLAT FRONTAL BARRIER
VEHICLE REAR CENTER Z-AXIS ACCELERATION
208 COMPLIANCE TEST - CR1301

CHANNEL: RDKZG1 FILTER: CH. CLASS 60

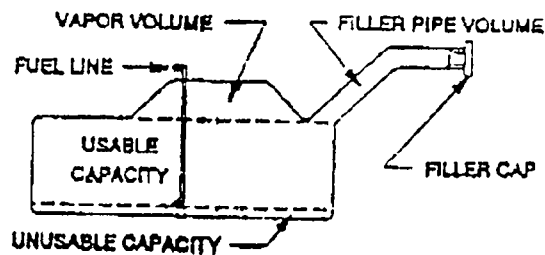
VEHICLE FUEL TANK ASSEMBLY

- 1 A. "Usable Capacity" of standard equipment fuel tank = 32.7 gallons.
- B. "Usable Capacity" of optional equipment fuel tank = N/A gallons.
- C. "Usable Capacity" of vehicle(s) used for certification testing to requirements of FMVSS 301 = 32.7 gallons.

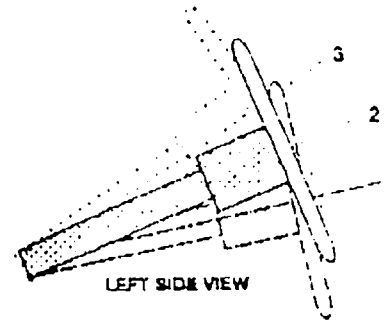
STEERING COLUMN ASSEMBLY

THE STEERING COLUMN HAS 5 POSITIONS
MID POINT IS 3RD POSITION UP FROM THE
BOTTOM

LEFT SIDE VIEW

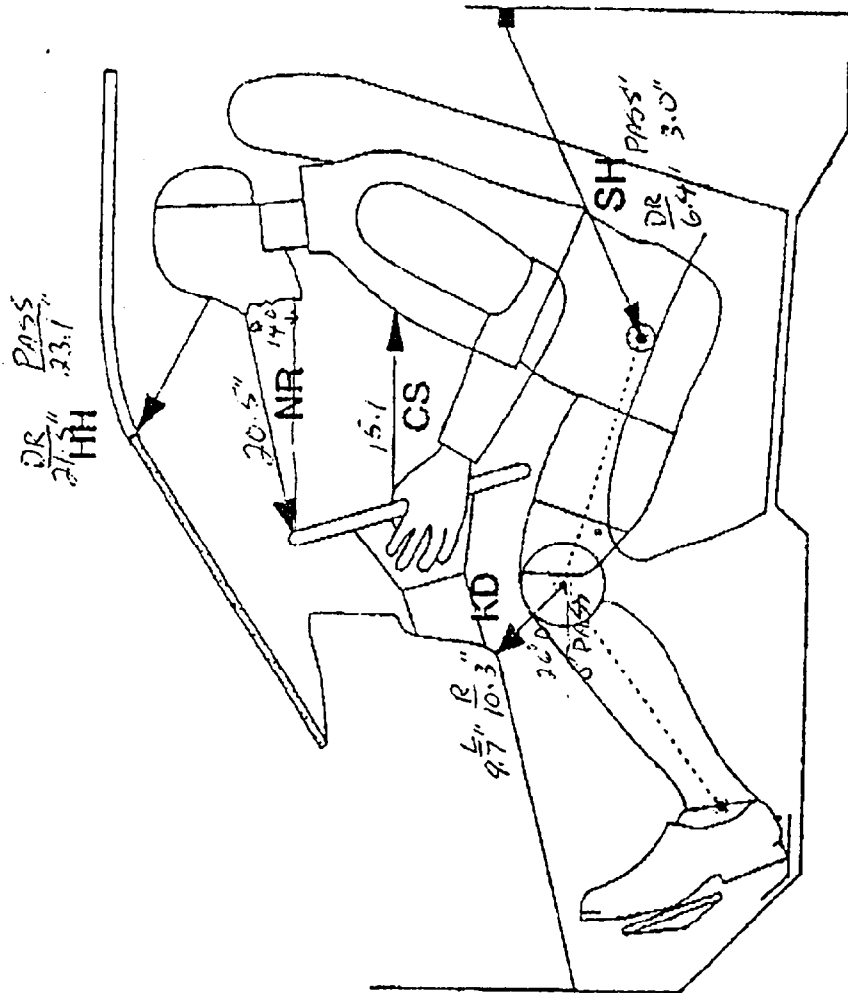
DUMMY MEASUREMENTS FOR FRONT SEAT PASSENGERS

- HH - Head to Header
- NR - Nose to Rim
- CS - Steering Wheel to Chest
- KDL/KDR - Knee to Dash
- SH - Striker to H-Point

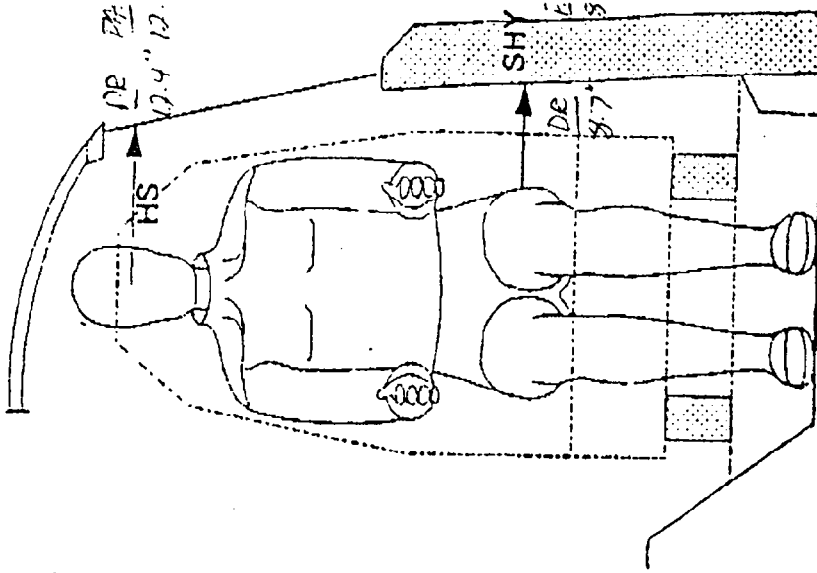
- SHY - Striker to H-Point (Y Dir.)
- HS - Head to Side Window
