**REPORT NUMBER: 301R/305-CAL-12-003**

**SAFETY COMPLIANCE TESTING FOR FMVSS 301 & 305  
Fuel System Integrity – Rear Impact  
Electric Powered Vehicles: Electrolyte Spillage and Electrical Shock Protection**

**General Motors LLC  
2012 Buick Lacrosse  
Four Door Sedan**

**NHTSA No: CC0104**

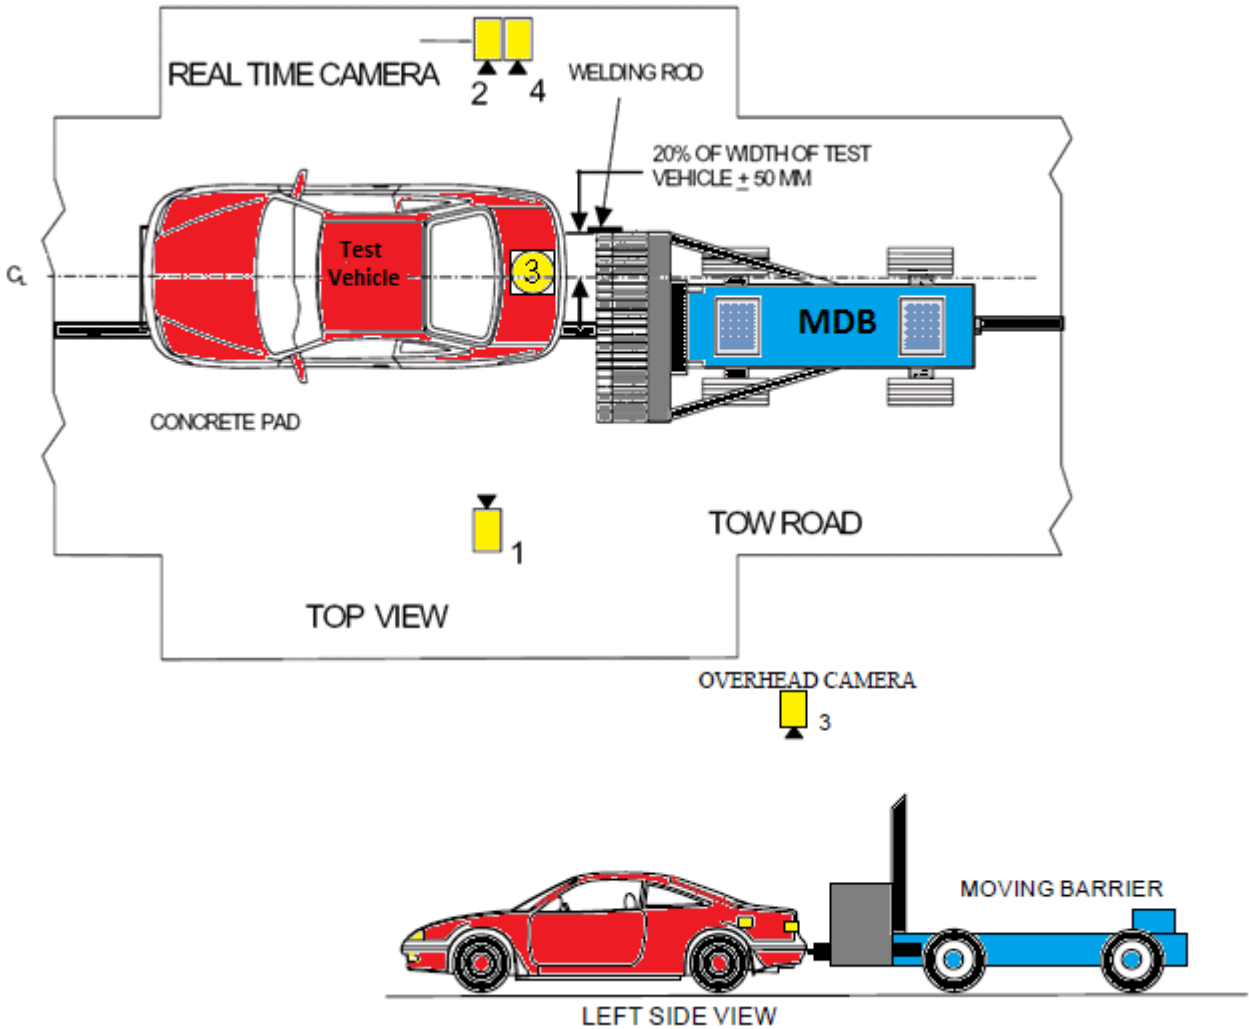
No.	Camera View	Coordinates (mm)			Angle (Deg)	Lens (mm)	Film Speed (fps)
		X*	Y*	Z*			
1	Left Side View	1600	8165	925	-0.8	24	1000
2	Real-Time Camera						30
3	Overhead View	517	0	5287	90.0	20	1000
4	Right Side View	1220	8565	954	-1.3	24	1000

\* Reference (from point of impact); all measurements accurate to within  $\pm 6$  mm.  
 X = (Impact Point) + Forward  
 Y = (Impact Point) + To Right  
 Z = (Ground Level) + Down

The crash event was recorded by three high-speed cameras and one real-time camera. High-speed camera locations and other pertinent camera information are found on page 3-9 of this report. Data sheets can be found starting on page 3-2. Pre-test and post-test photographs of the vehicle can be found in Appendix A.
