**REPORT NUMBER: NCAP305I-MGA-2019-005**

**NEW CAR ASSESSMENT PROGRAM (NCAP)  
FMVSS No. 305 Indicant Test**

**AUDI AG  
2019 Audi e-tron quattro 5-Door SUV  
NHTSA NUMBER: O20195805**

**MGA RESEARCH CORPORATION  
5000 Warren Road  
Burlington, WI 53105**

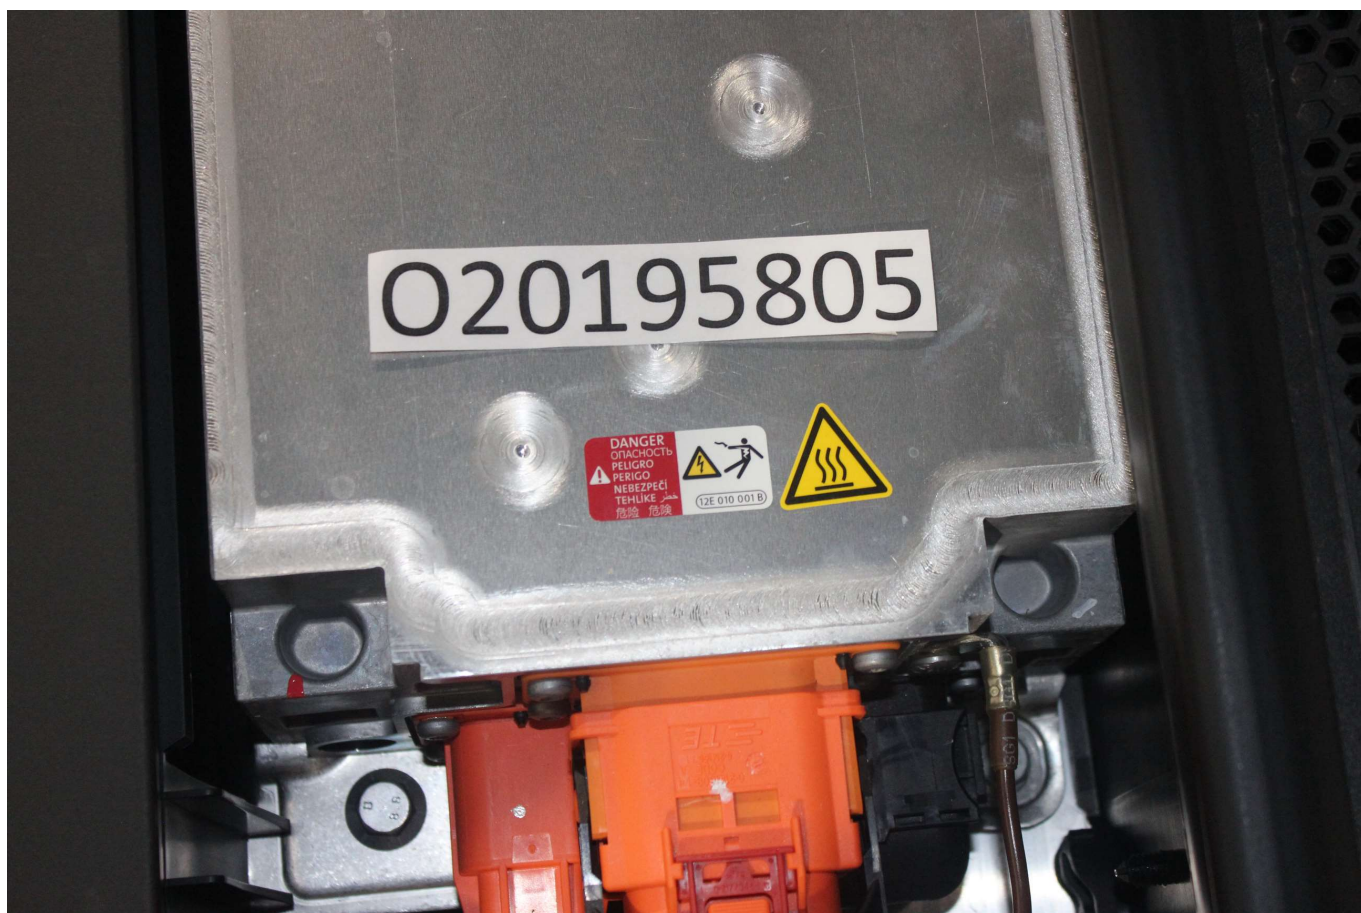
Photo No. 001 - Auxiliary Power Module Warning Label

| | | <u>Page No.</u> |
|---|---|---|
| Photo No. 001 | Auxiliary Power Module Warning Label | A-1 |

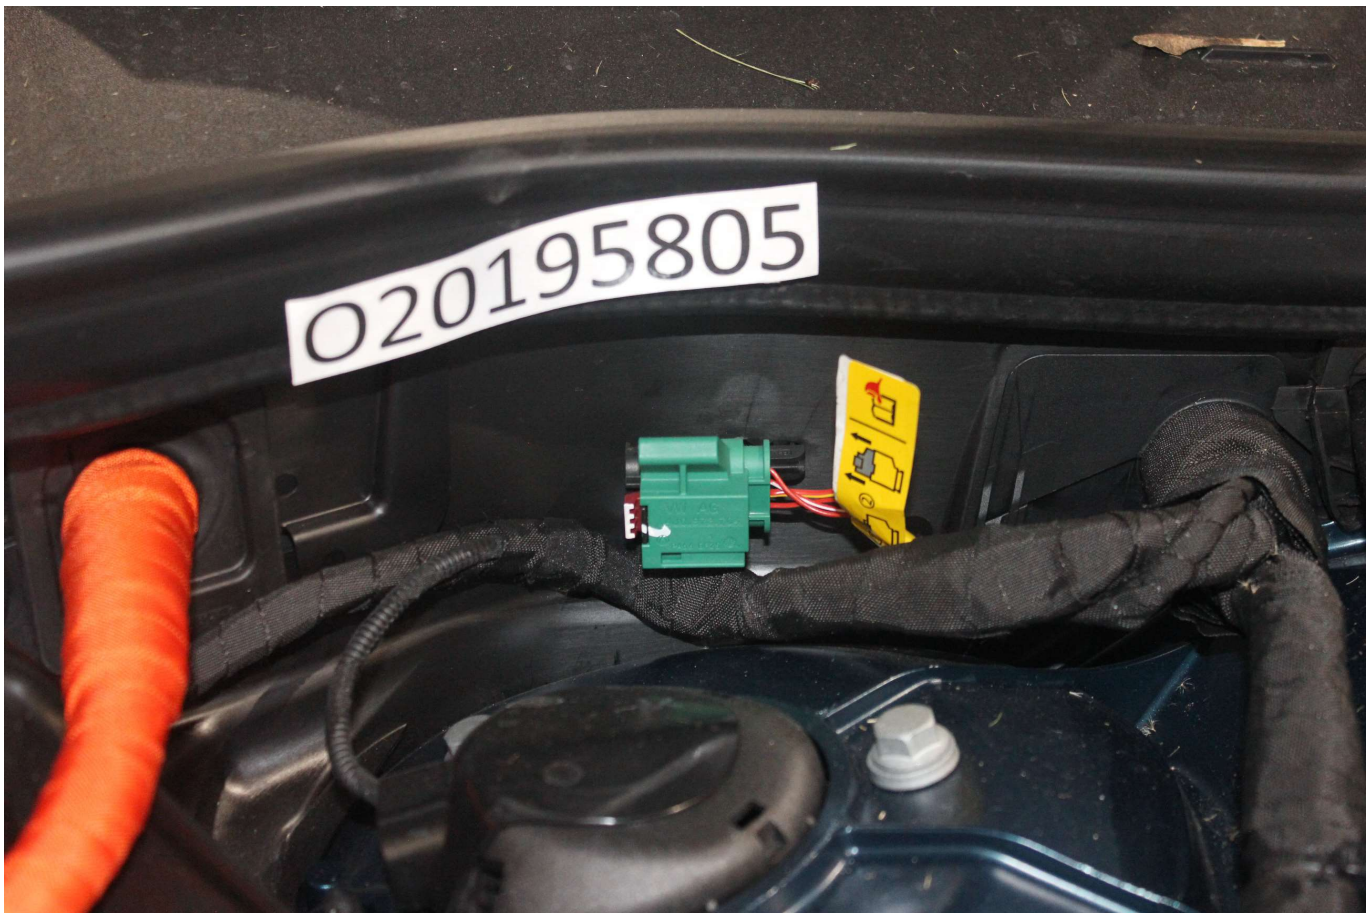
Photo No. 002 - Power Inverter Warning Label

| | | <u>Page No.</u> |
|---|---|---|
| Photo No. 002 | Power Inverter Warning Label | A-1 |

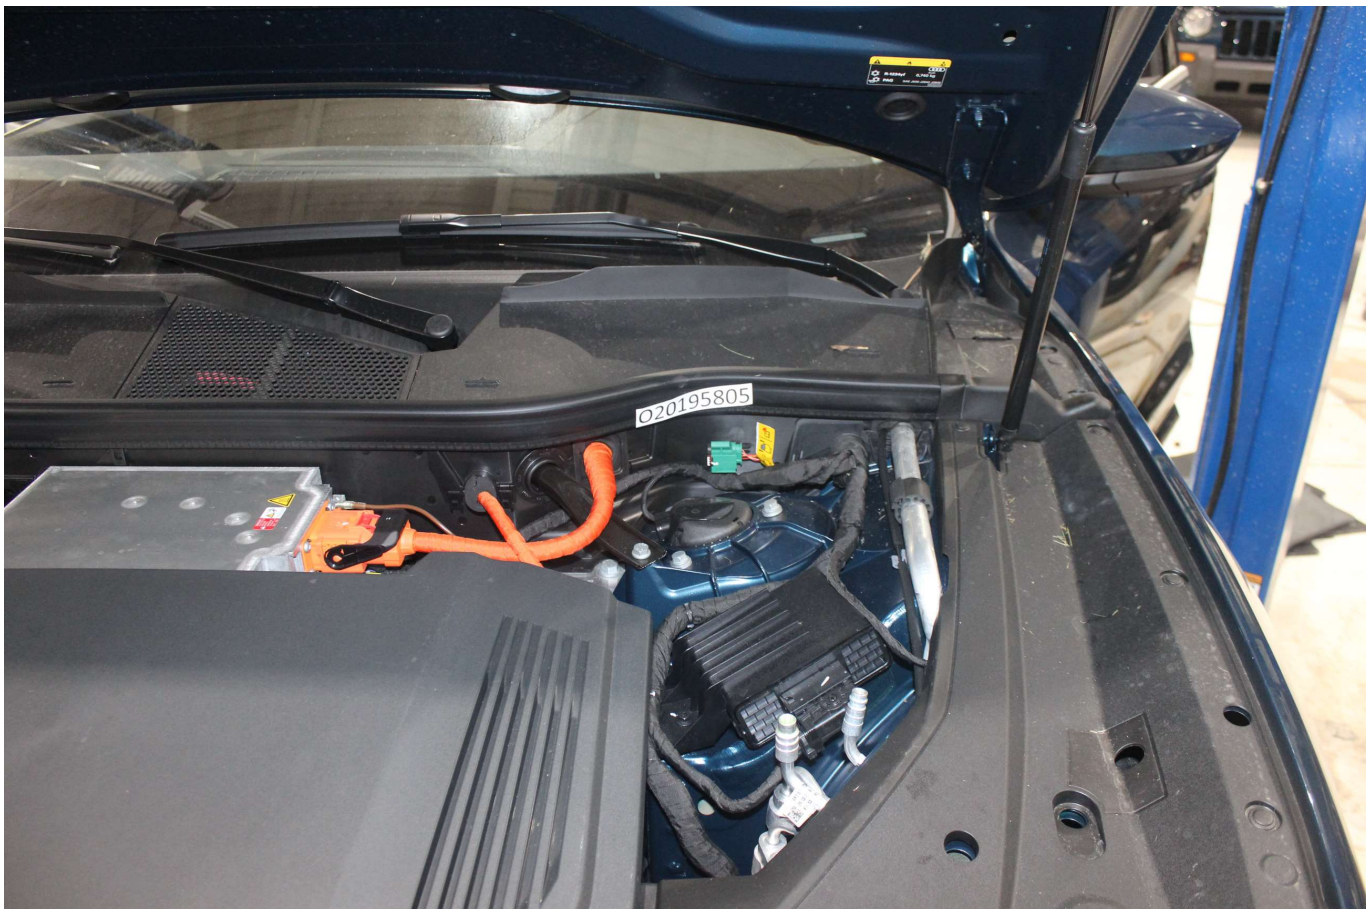
Photo No. 003 - First Responder Warning Label

| | | <u>Page No.</u> |
|---|---|---|
| Photo No. 003 | First Responder Warning Label | A-2 |

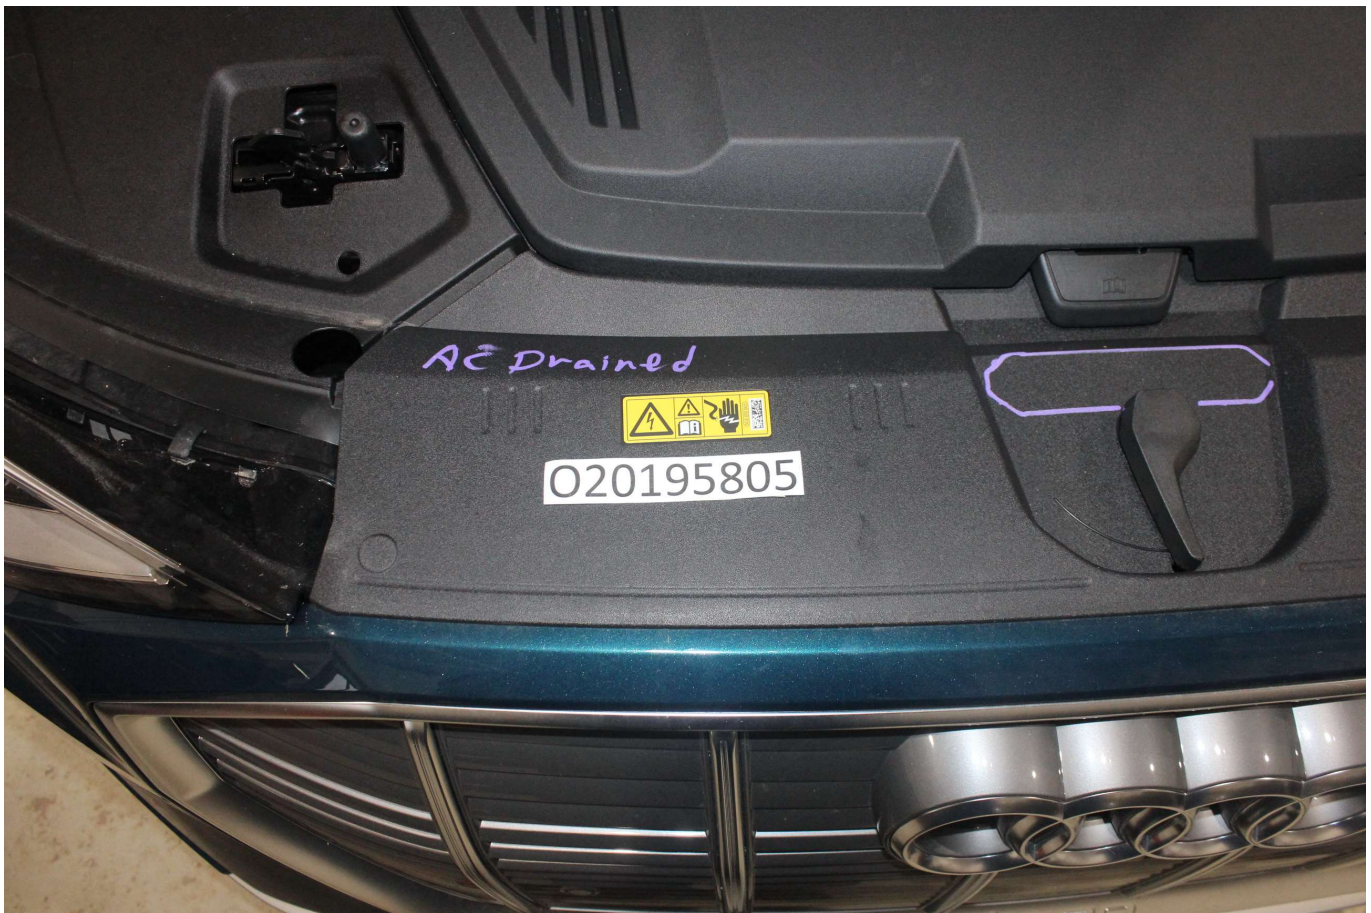
Photo No. 004 - First Responder Warning Location

| | | <u>Page No.</u> |
|---|---|---|
| Photo No. 004 | First Responder Warning Location | A-2 |

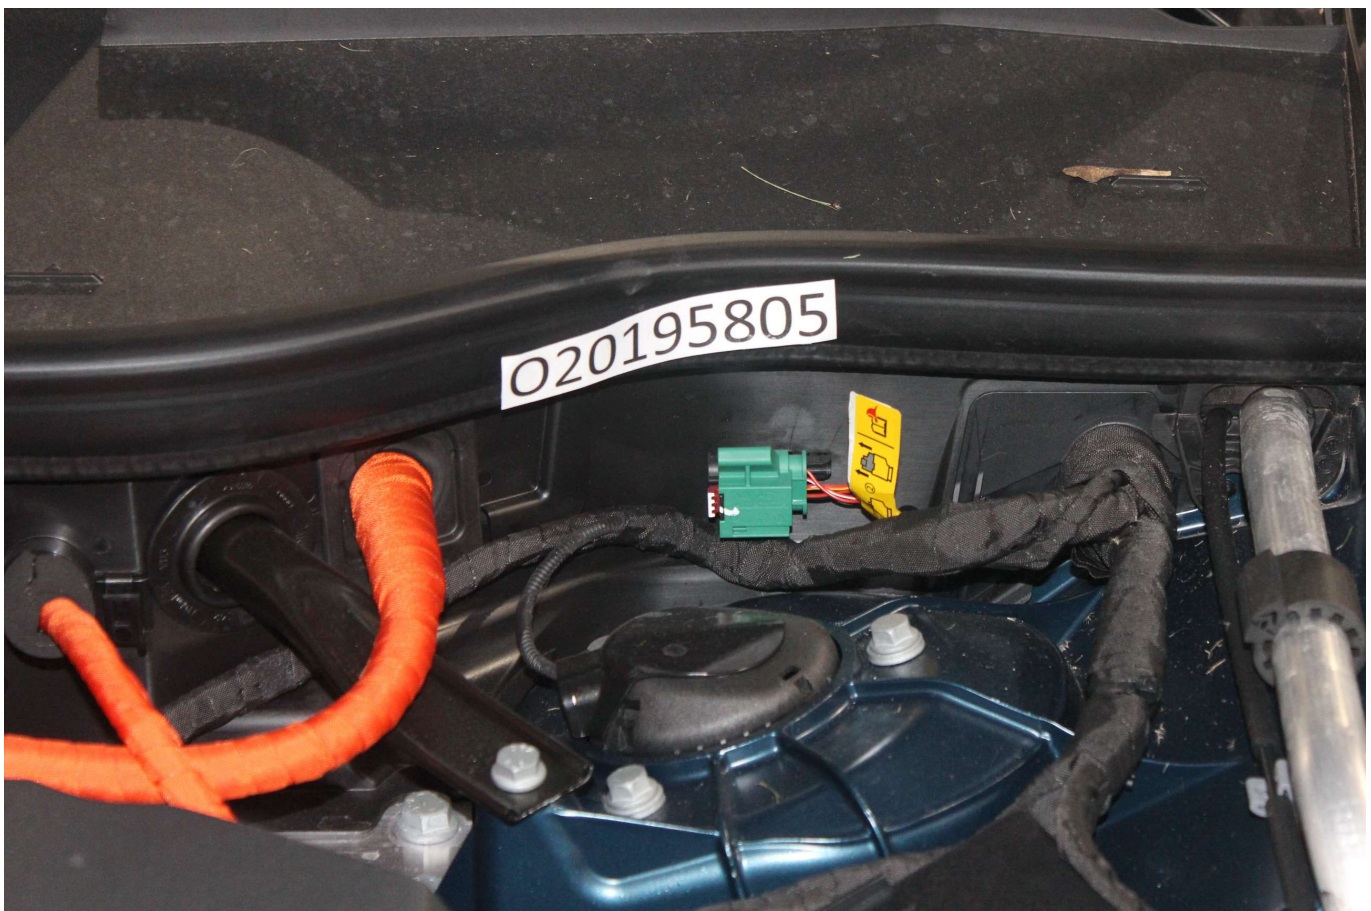
Photo No. 005 - Other Vehicle Label(s) Related to Electrical Propulsion System

| | | <u>Page No.</u> |
|---|---|---|
| Photo No. 005 | Other Vehicle Label(s) Related to Electrical Propulsion System | A-3 |

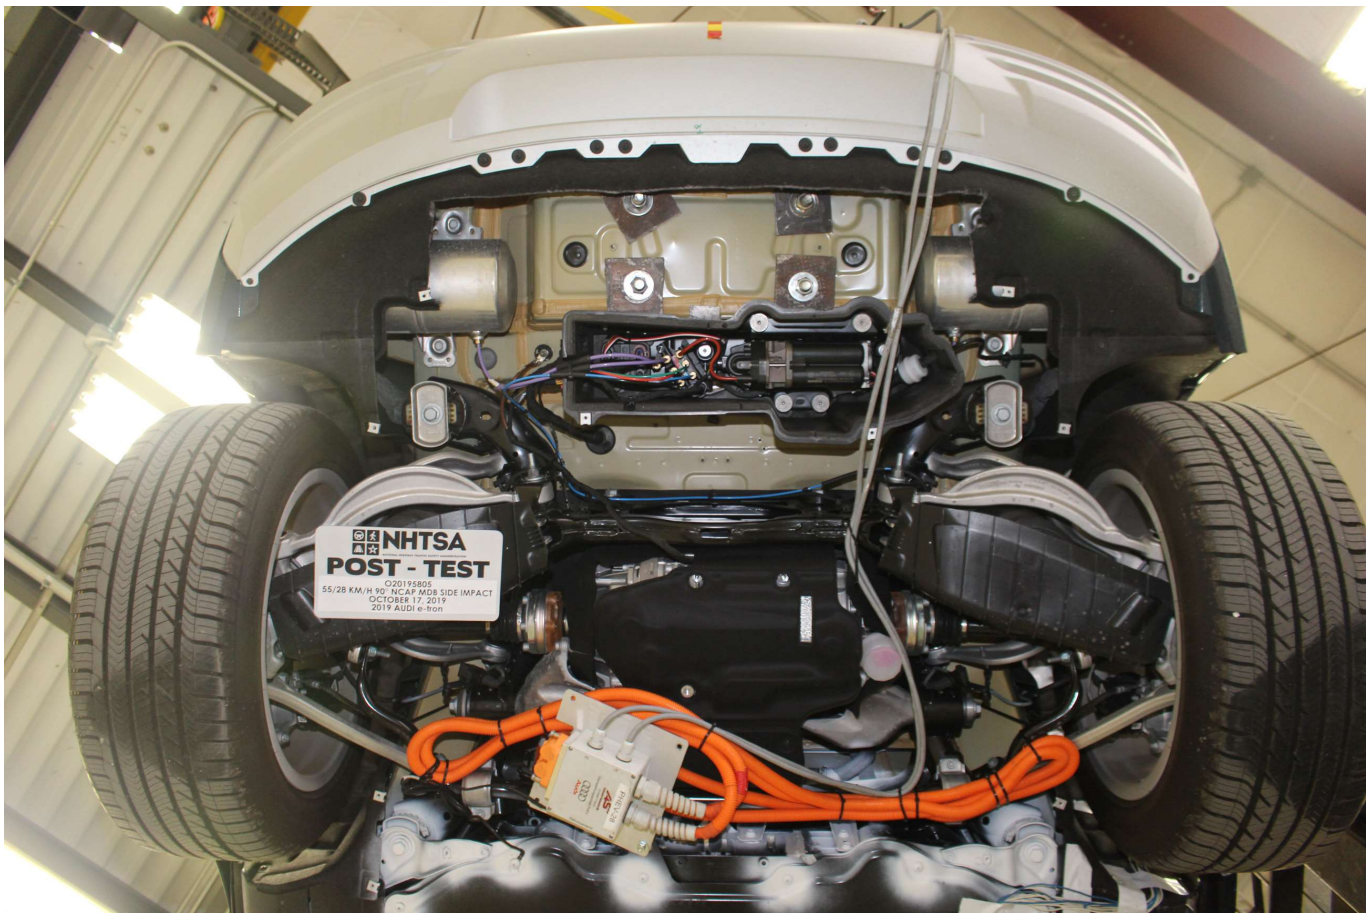
Photo No. 009 - Post-Impact Front View of Propulsion Battery

| | | <u>Page No.</u> |
|---|---|---|
| Photo No. 009 | Post-Impact Front View of Propulsion Battery | A-5 |

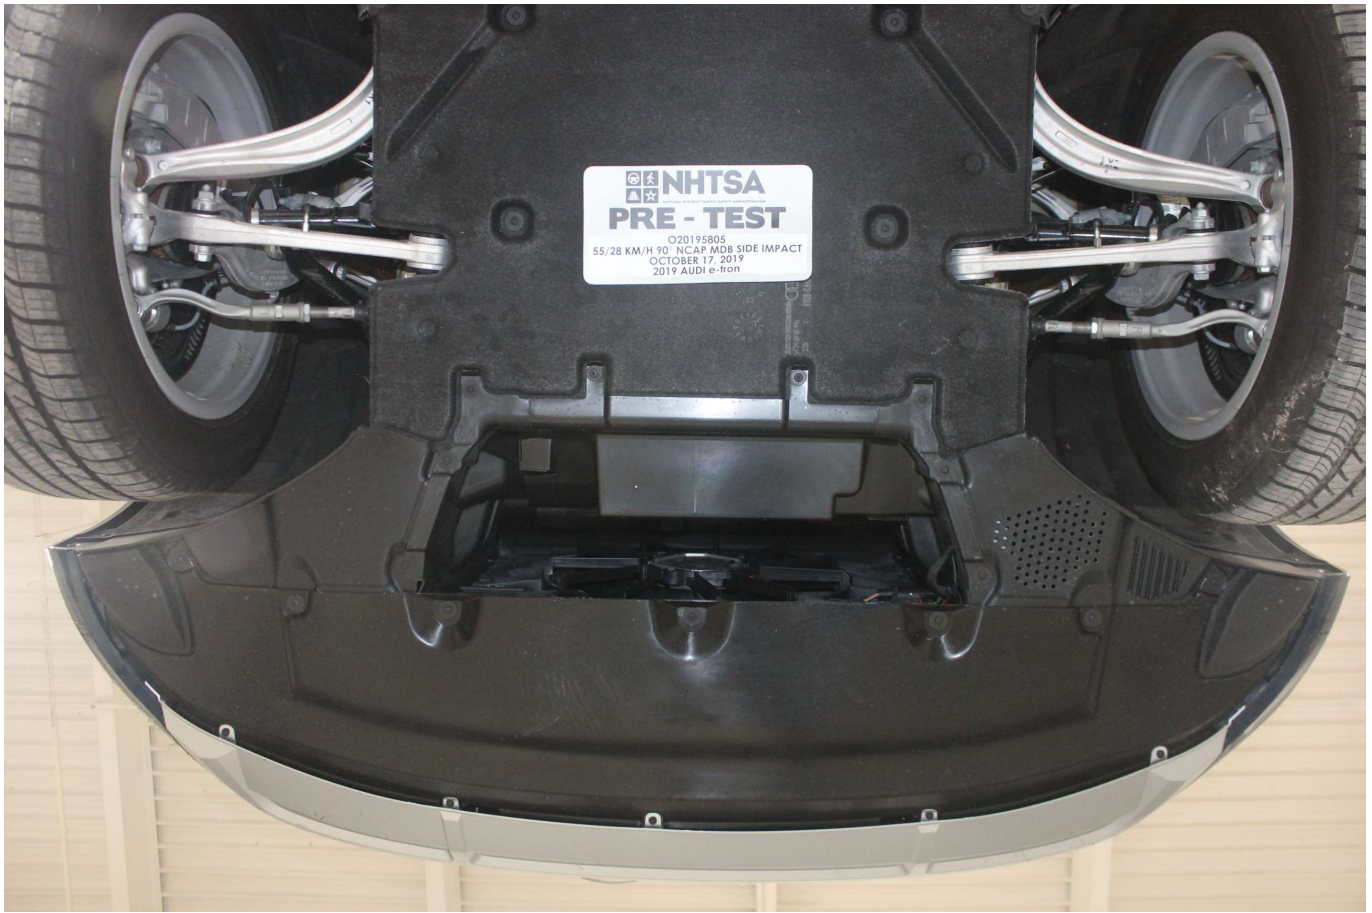
Photo No. 015 - Pre-Impact View of Electric Propulsion Drive

| | | <u>Page No.</u> |
|---|---|---|
| Photo No. 015 | Pre-Impact View of Electric Propulsion Drive | A-8 |

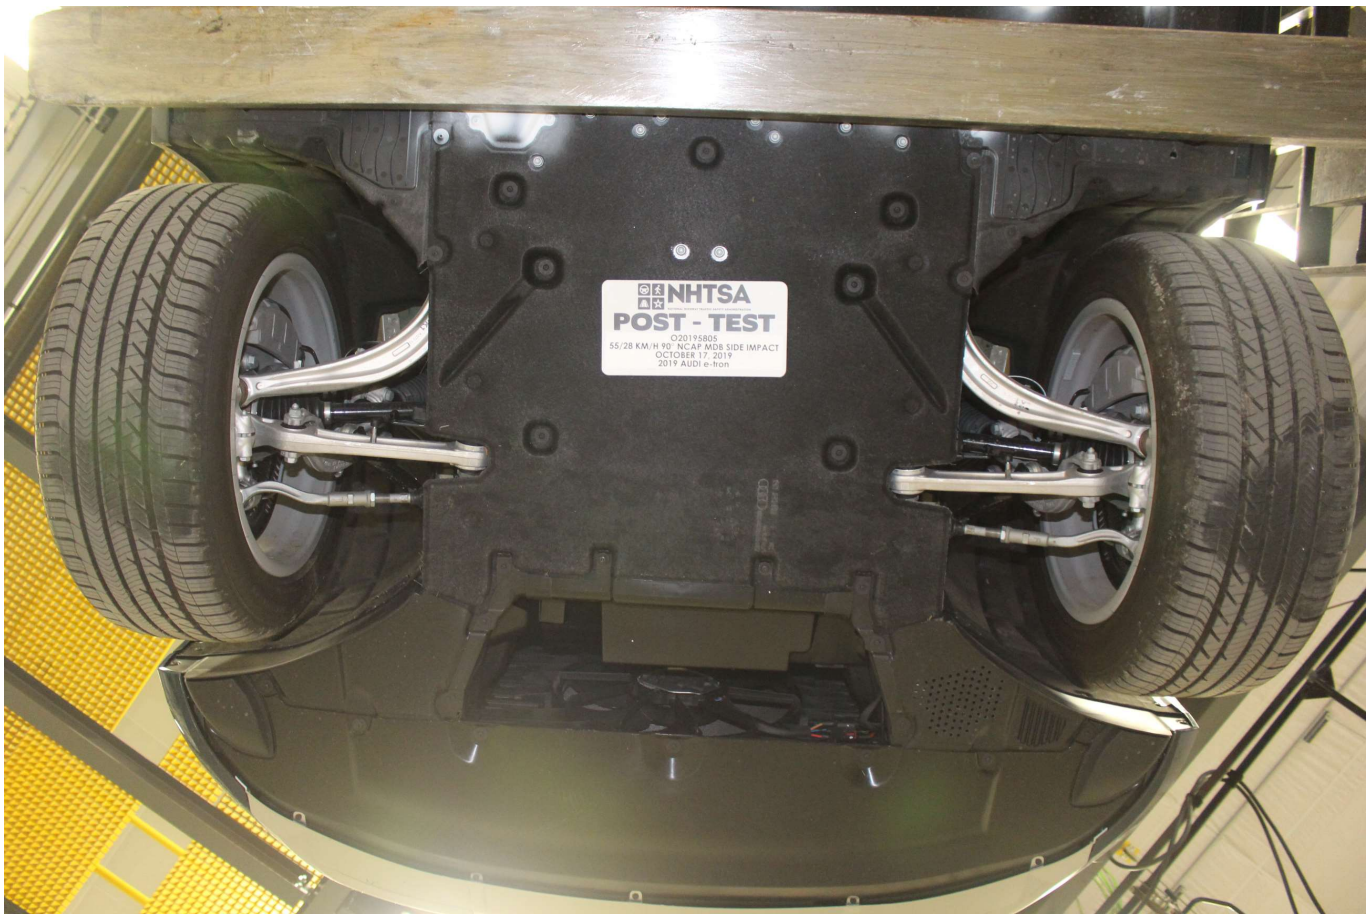
Photo No. 016 - Post-Impact View of Electric Propulsion Drive

| | | <u>Page No.</u> |
|---|---|---|
| Photo No. 016 | Post-Impact View of Electric Propulsion Drive | A-9 |

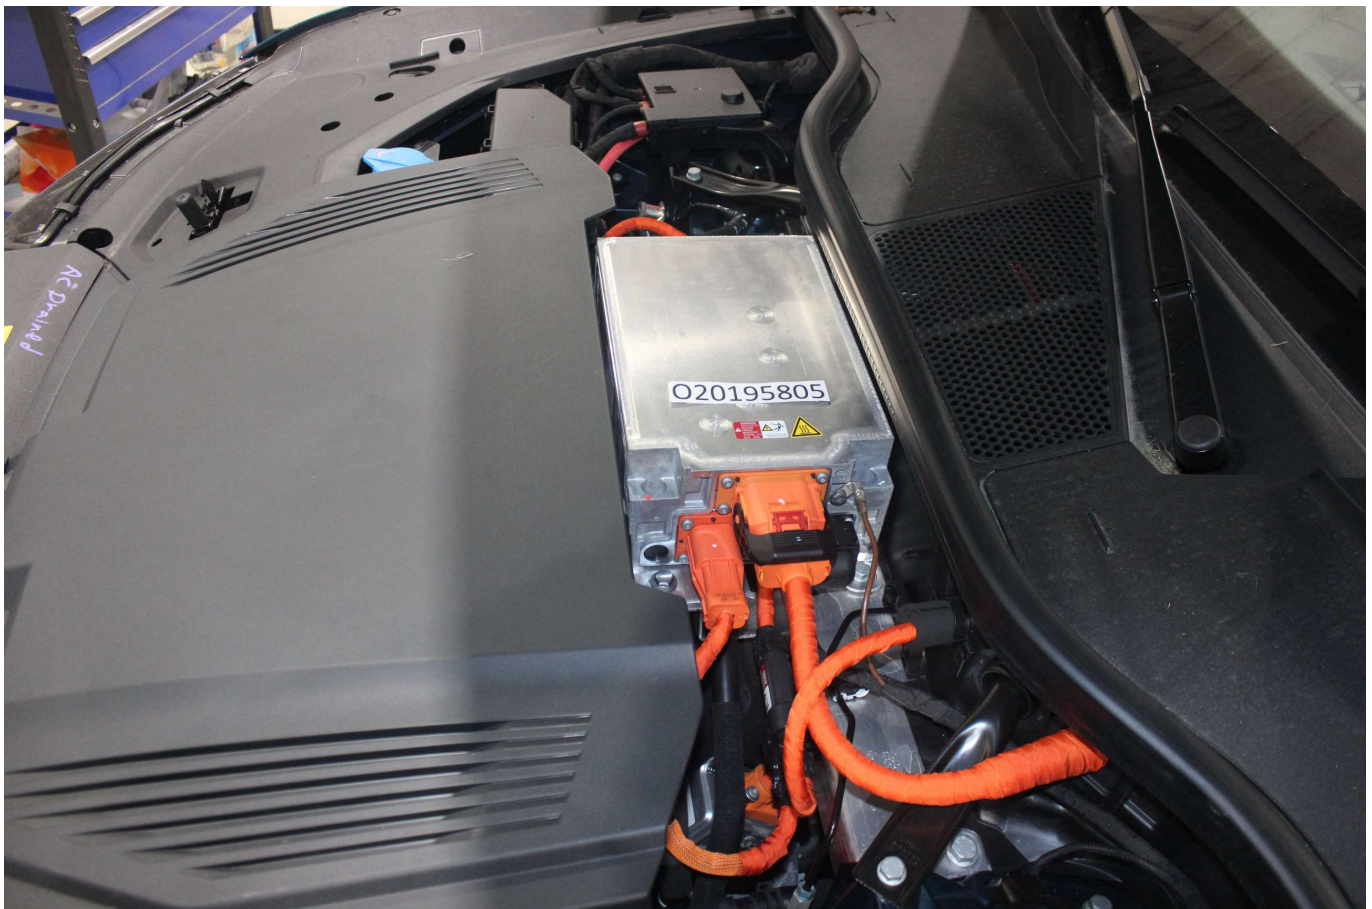
Photo No. 016a - Post-Impact View of Electric Propulsion Drive

| | | <u>Page No.</u> |
|---|---|---|
| Photo No. 016a | Post-Impact View of Electric Propulsion Drive | A-10 |

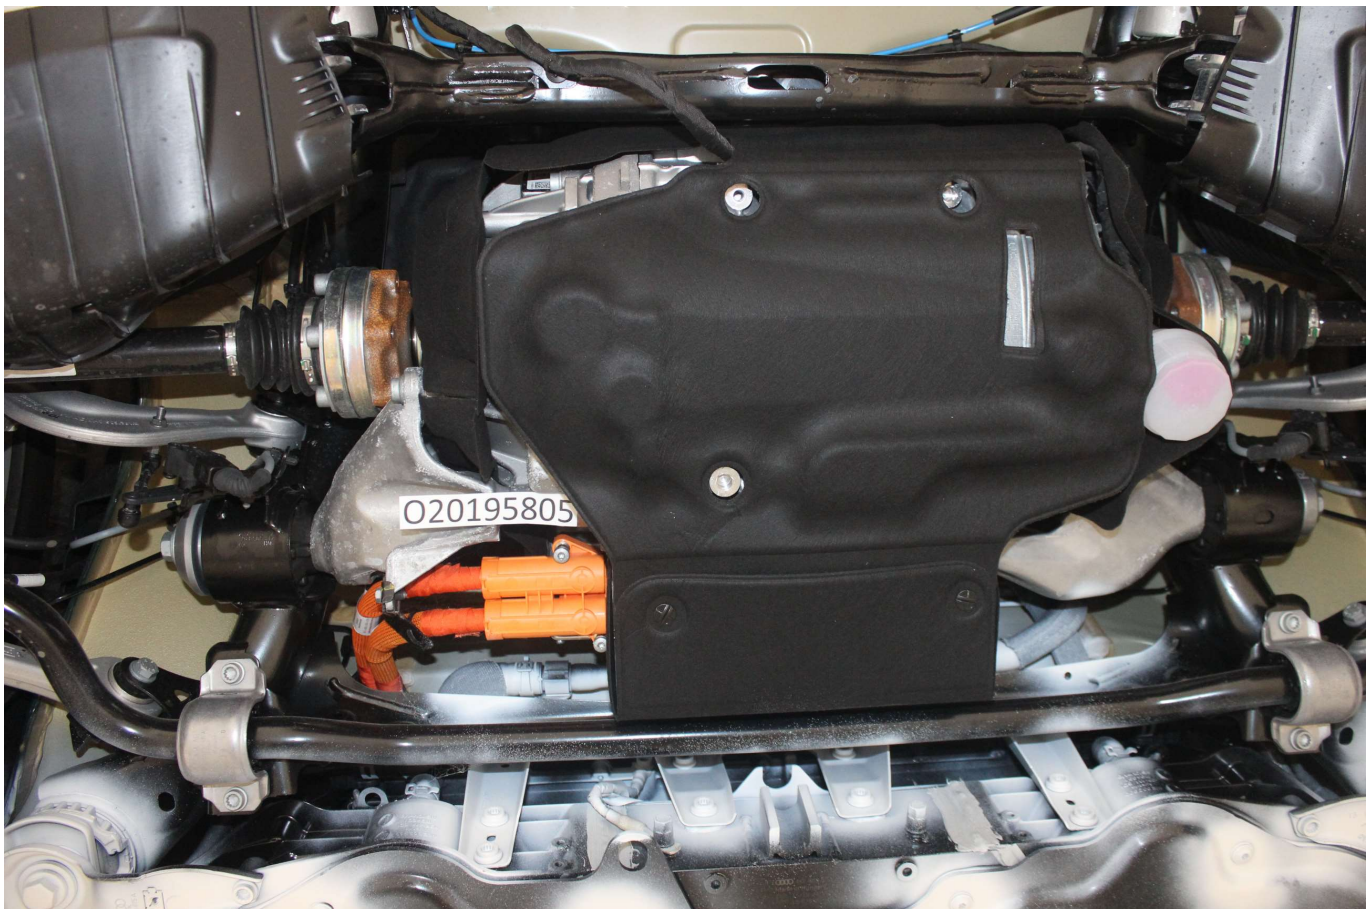
Photo No. 018 - Pre-Impact View Propulsion Battery Venting System(s)

| | | <u>Page No.</u> |
|---|---|---|
| Photo No. 018 | Pre-Impact View Propulsion Battery Venting System(s) | A-11 |

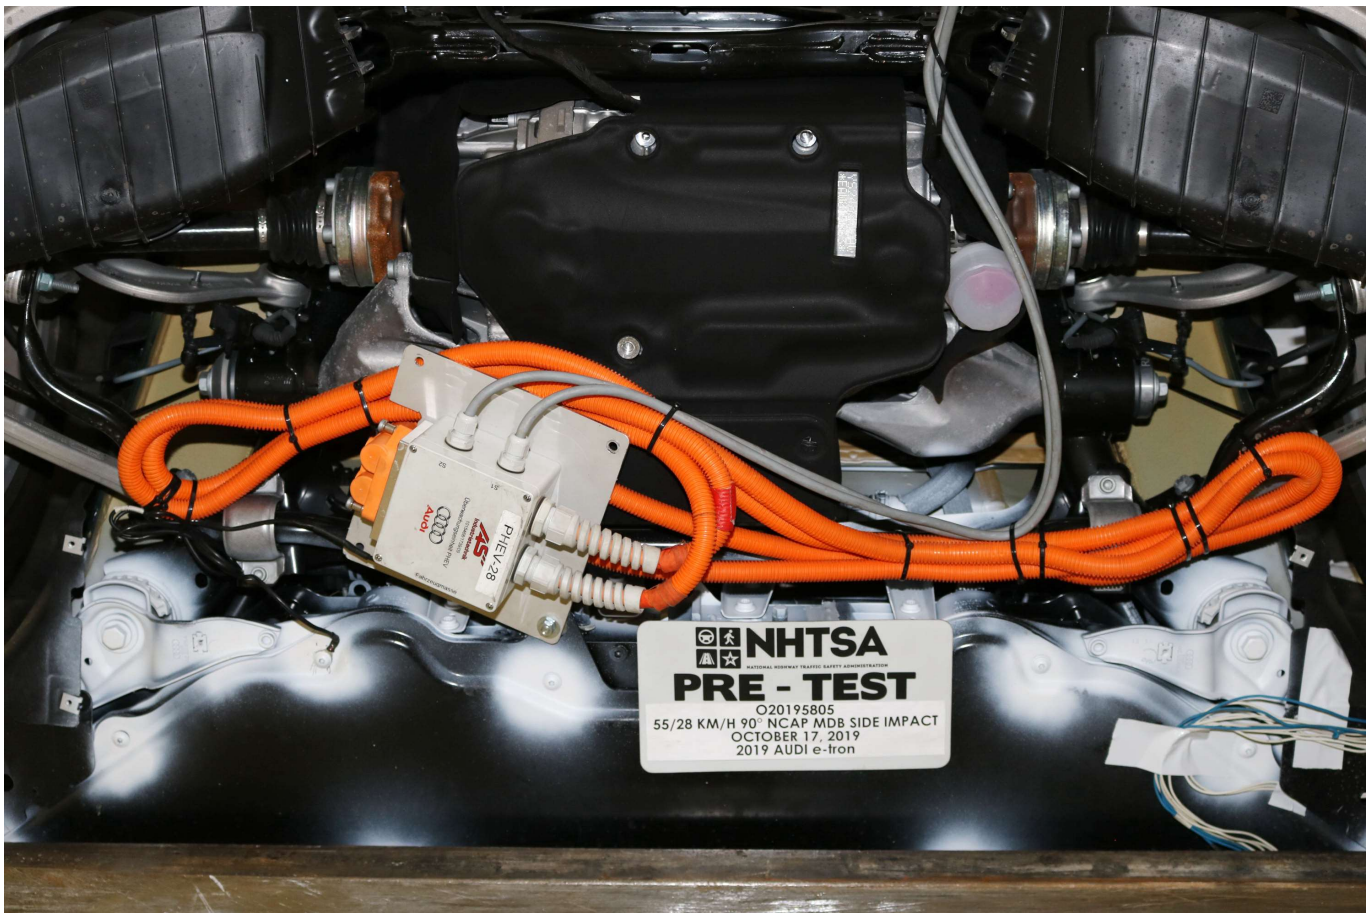
Photo No. 019 - Pre-Impact View of Other Visible Electric Propulsion Components

| | | <u>Page No.</u> |
|---|---|---|
| Photo No. 019 | Pre-Impact View of Other Visible Electric Propulsion Components | A-11 |

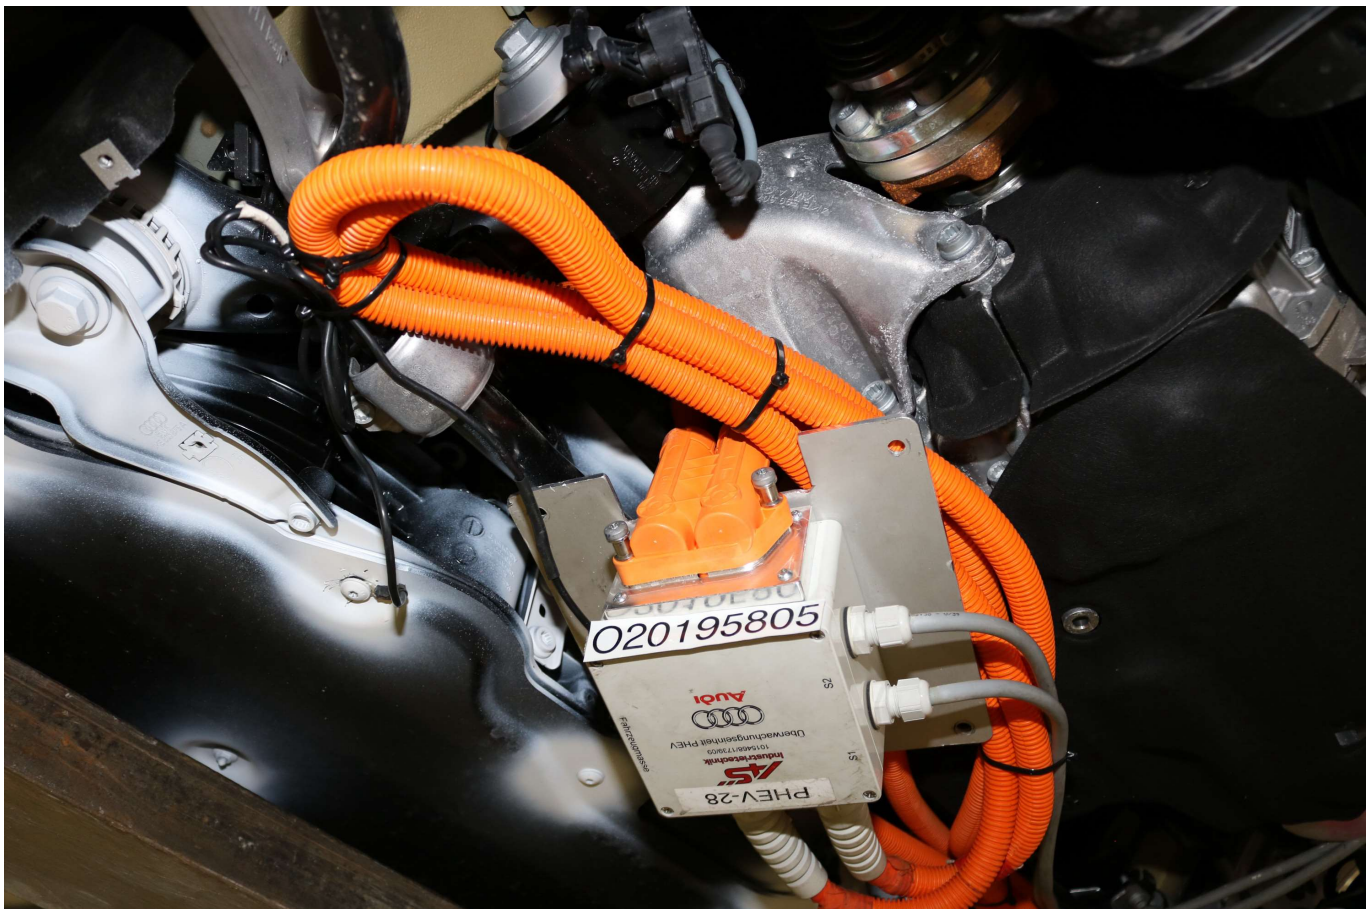
Photo No. 020 - Pre-Impact View of Ground Lead Attached

| | | <u>Page No.</u> |
|---|---|---|
| Photo No. 020 | Pre-Impact View of Ground Lead Attached | A-12 |

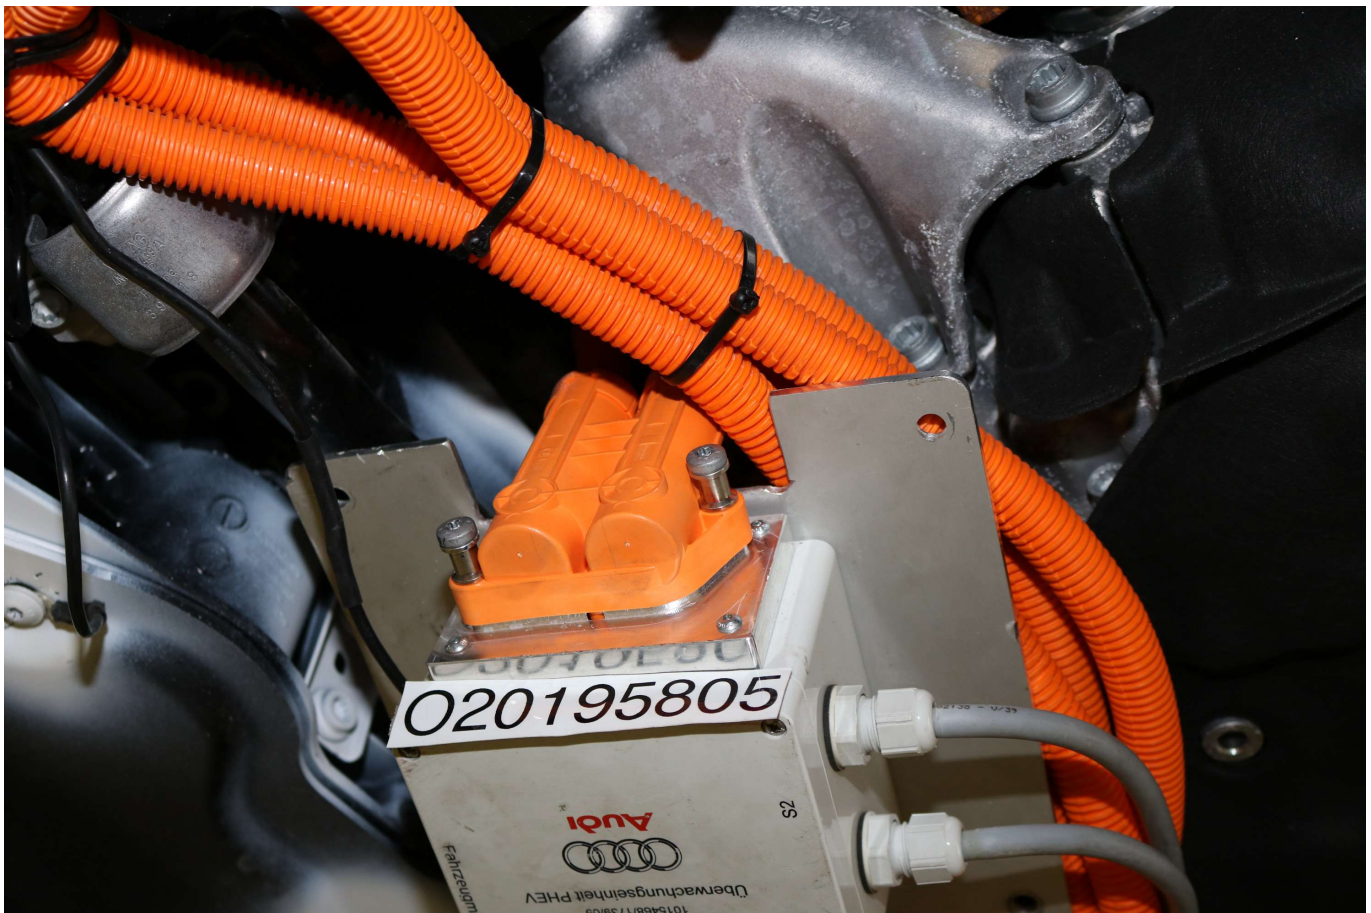
Photo No. 021 - Pre-Impact View of High Voltage Leads Attached

| | | <u>Page No.</u> |
|---|---|---|
| Photo No. 021 | Pre-Impact View of High Voltage Leads Attached | A-12 |

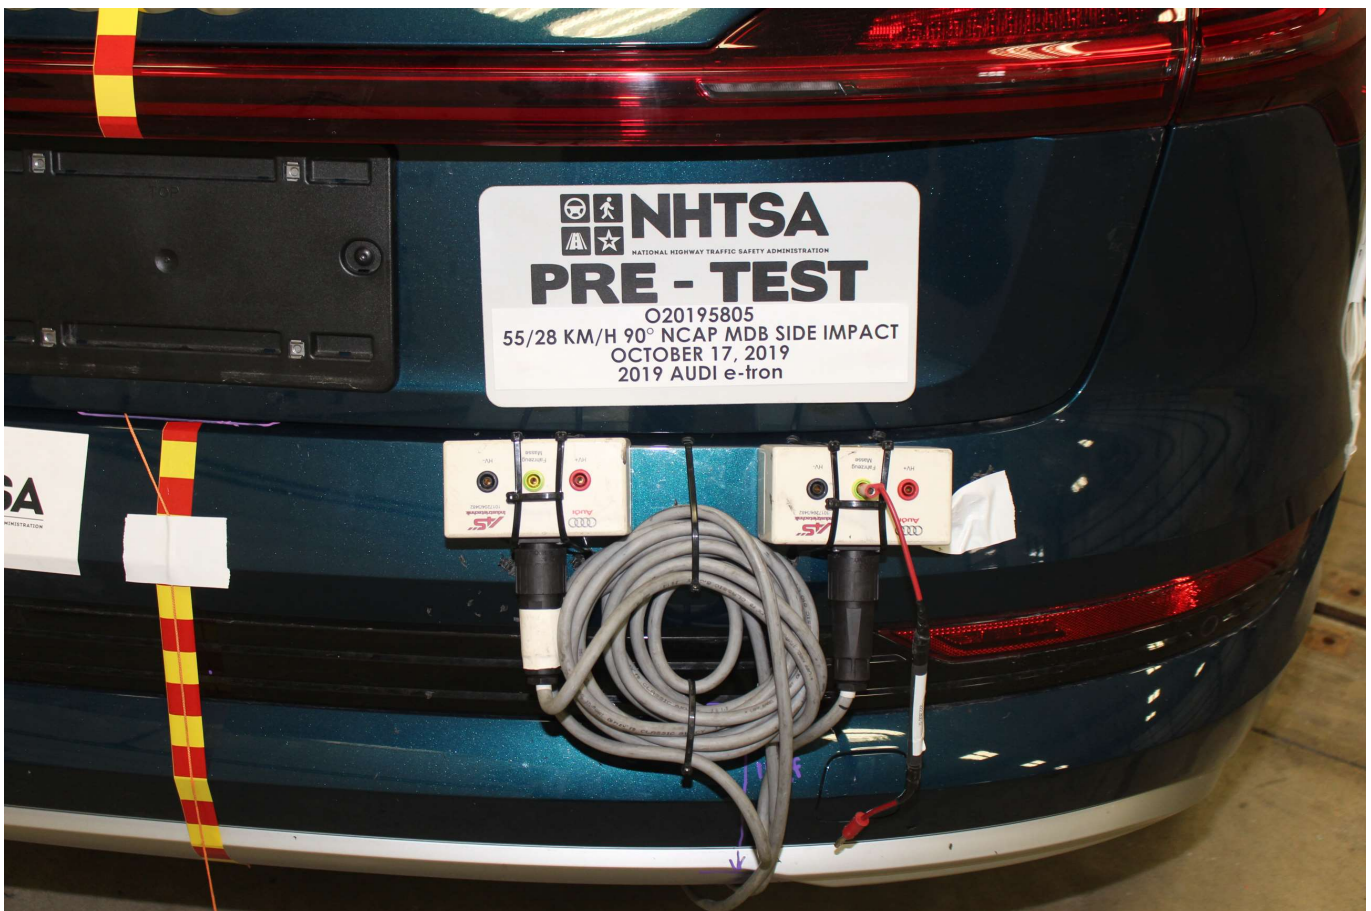
Photo No. 022 - Pre-Impact Close-Up View of High Voltage Leads Attached

| | | <u>Page No.</u> |
|---|---|---|
| Photo No. 022 | Pre-Impact Close-Up View of High Voltage Leads Attached | A-13 |

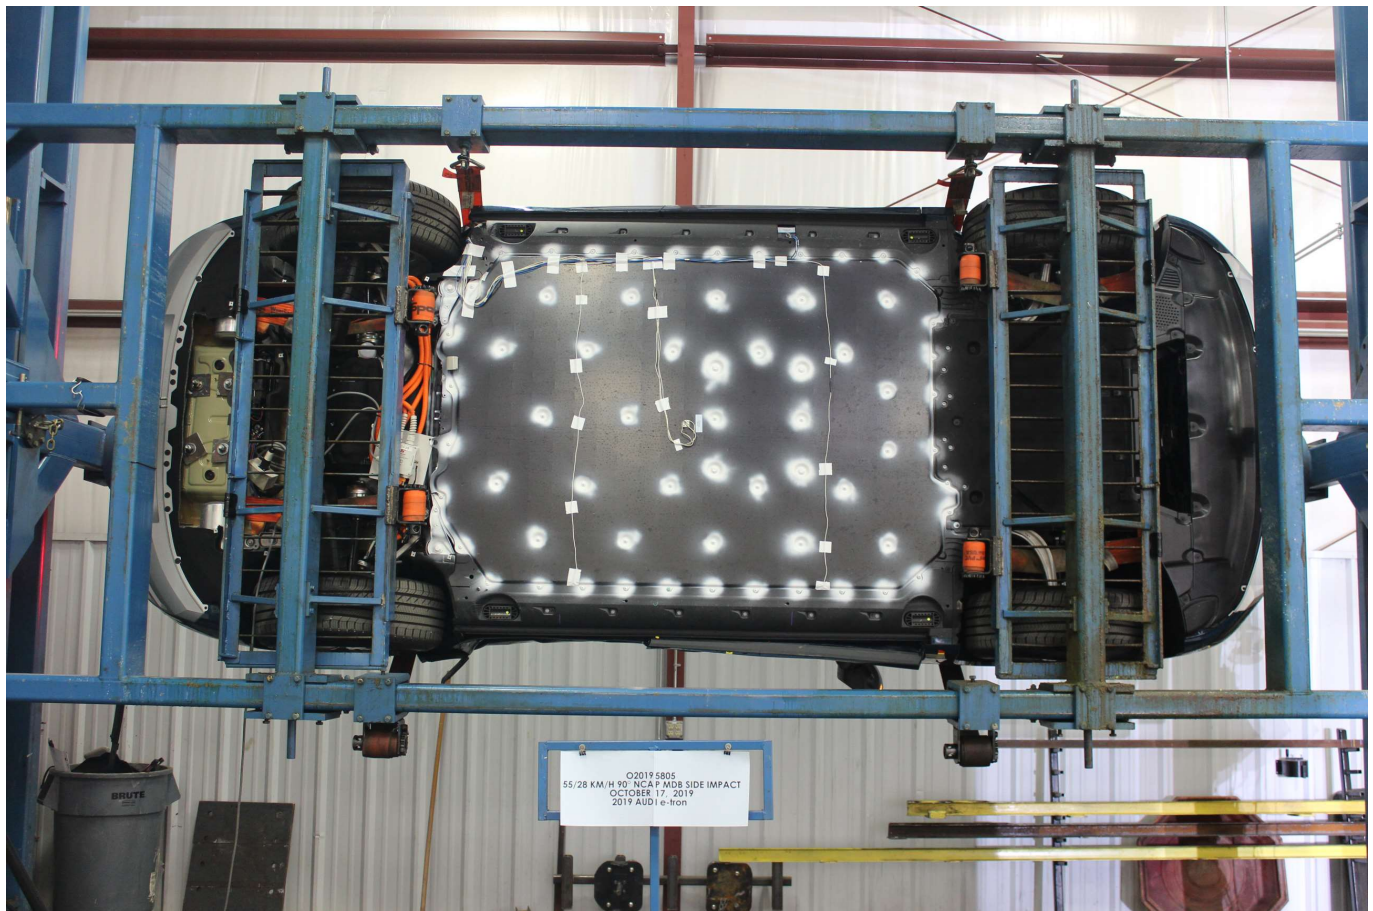
Photo No. 026 - Post-Impact View of Other Test Devices

| | | <u>Page No.</u> |
|---|---|---|
| Photo No. 026 | Post-Impact View of Other Test Devices | A-15 |

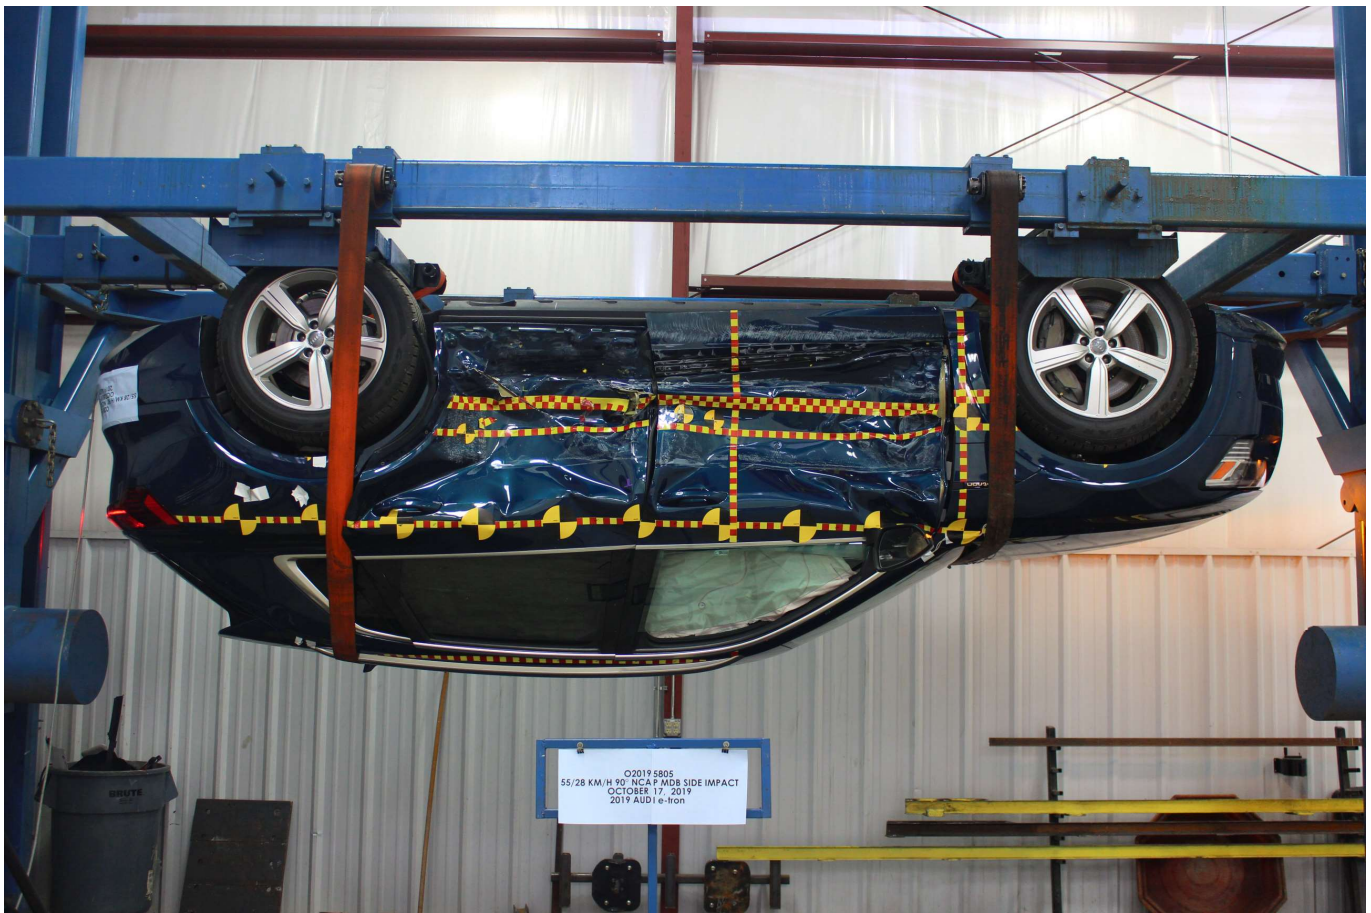
Photo No. 027 - FMVSS No. 305 Static Rollover at 90°

| | | <u>Page No.</u> |
|---|---|---|
| Photo No. 027 | FMVSS No. 305 Static Rollover at 90° | A-15 |

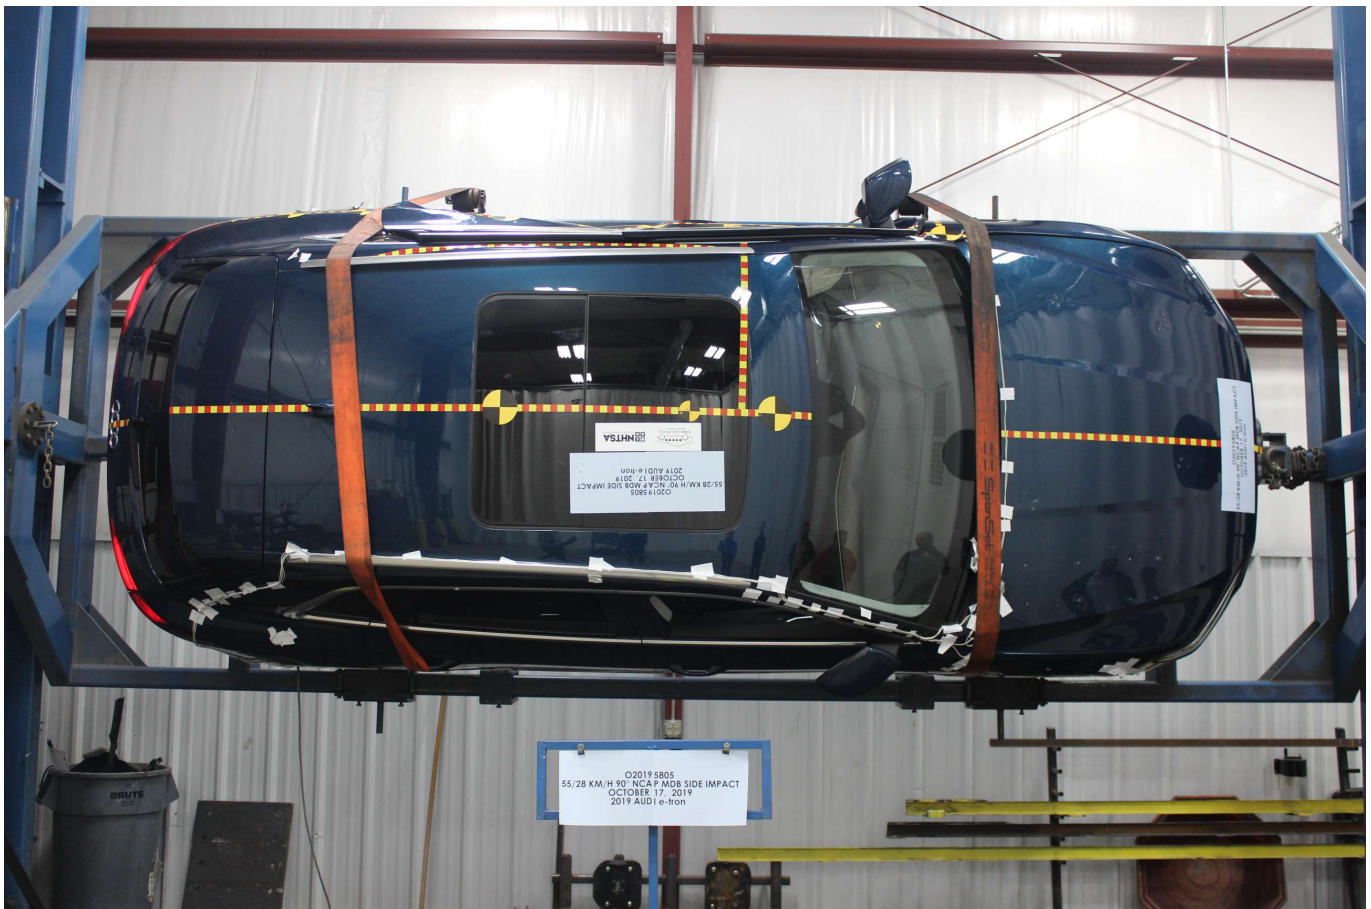
Photo No. 028 - FMVSS No. 305 Static Rollover at 180°

| | | <u>Page No.</u> |
|---|---|---|
| Photo No. 028 | FMVSS No. 305 Static Rollover at 180° | A-16 |
