**REPORT NUMBER: NCAP305I-MGA-2019-005**

**NEW CAR ASSESSMENT PROGRAM (NCAP)  
FMVSS No. 305 Indicant Test**

**AUDI AG  
2019 Audi e-tron quattro 5-Door SUV  
NHTSA NUMBER: O20195805**

**MGA RESEARCH CORPORATION  
5000 Warren Road  
Burlington, WI 53105**

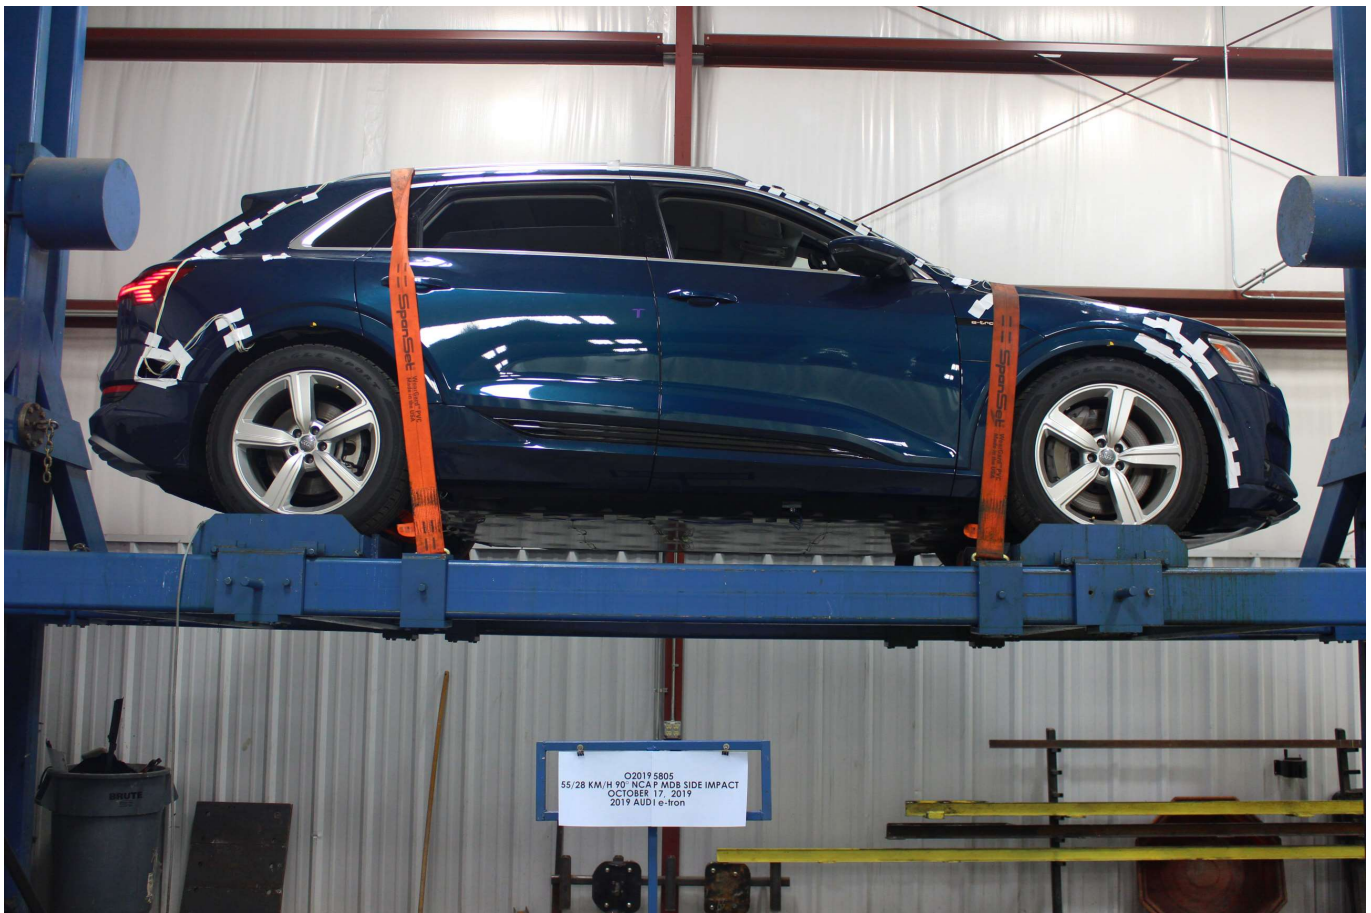
Photo No. 029 - FMVSS No. 305 Static Rollover at 270°

| | | <u>Page No.</u> |
|---|---|---|
| Photo No. 029 | FMVSS No. 305 Static Rollover at 270° | A-16 |
