Report Number 301-75-DYS-78-005

FMVSS 301-75 STANDARDS ENFORCEMENT TESTING  
OF FUEL SYSTEM INTEGRITY

General Motors Corporation  
1978 Chevrolet G-10 Van  
NHTSA 780625

| 4. Title and Subtitle FINAL REPORT OF FMVSS 301-75<br>STANDARDS ENFORCEMENT TESTING OF FUEL SYSTEM<br>INTEGRITY - 1978 CHEVROLET G-10 VAN - NHTSA 780625 | | | | 5. Report Date<br>March 1978 | |

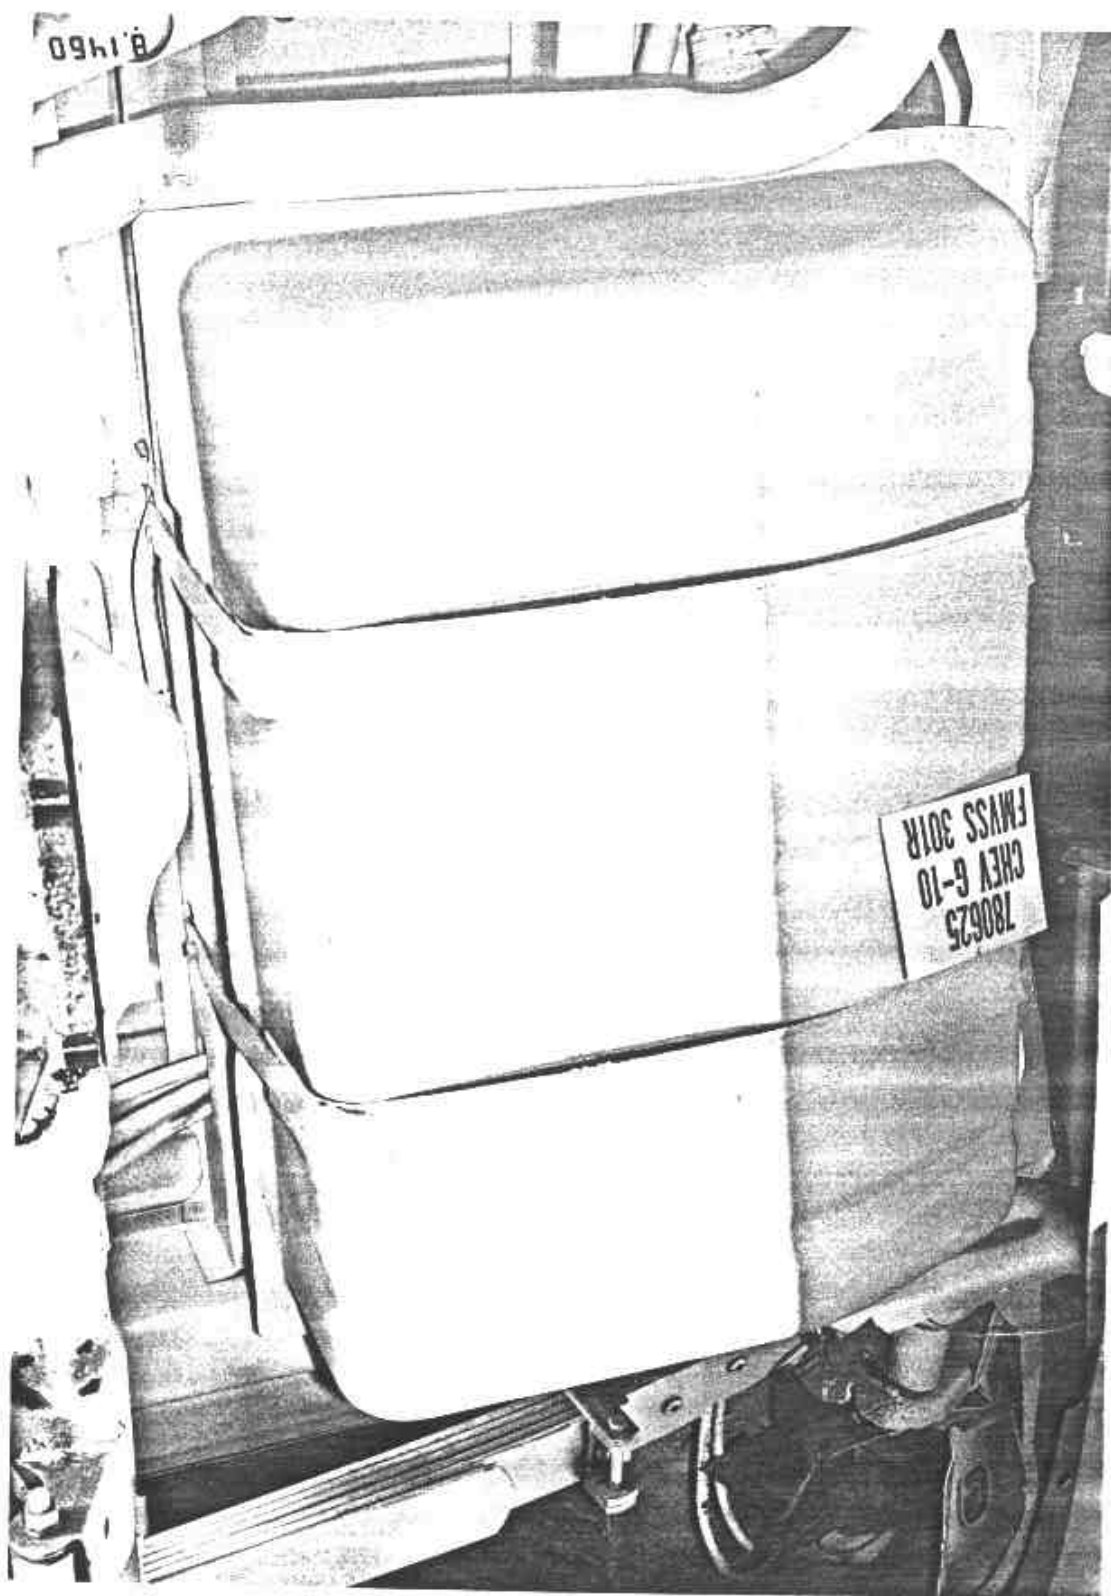
No fuel spillage occurred during and following barrier impact or static rollover.

Figure 4-6. Post-test View of Fuel Tank - 1978 Chevrolet G-10 Van - NHTSA 780625.
