**REPORT NO. 208-MGA-2005-DC019**

**DUMMY PERFORMANCE CALIBRATIONS**  
**FMVSS 208**

**DaimlerChrysler Corp.  
2005 Mercedes C230 Passenger Car  
NHTSA No.: C50500**

**PREPARED BY:  
MGA RESEARCH CORPORATION  
5000 WARREN ROAD  
BURLINGTON, WI 53105**

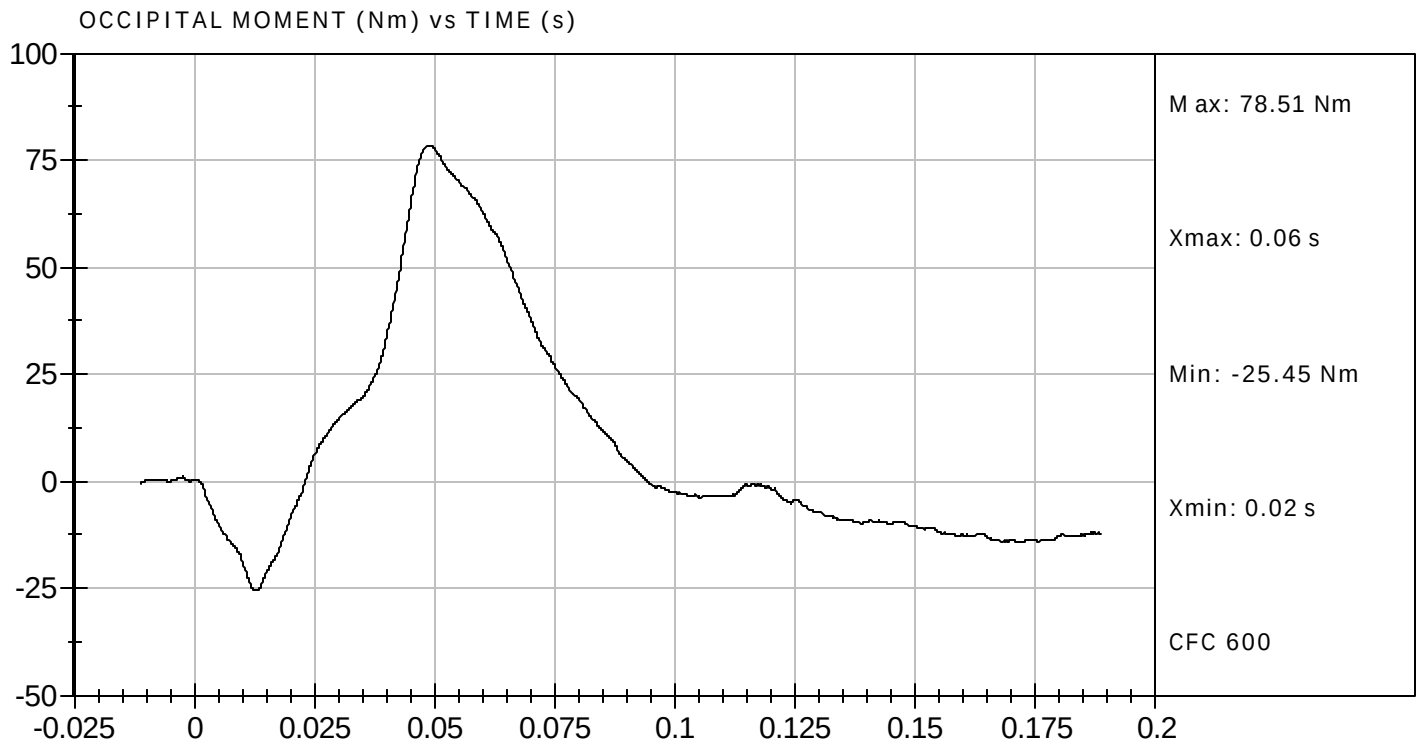
Test Desc: Neck Flexion  
Componet ID: D05492

Test Date: 02/24/2005  
Velocity: 23.15 ft/s, 7.06 m/s

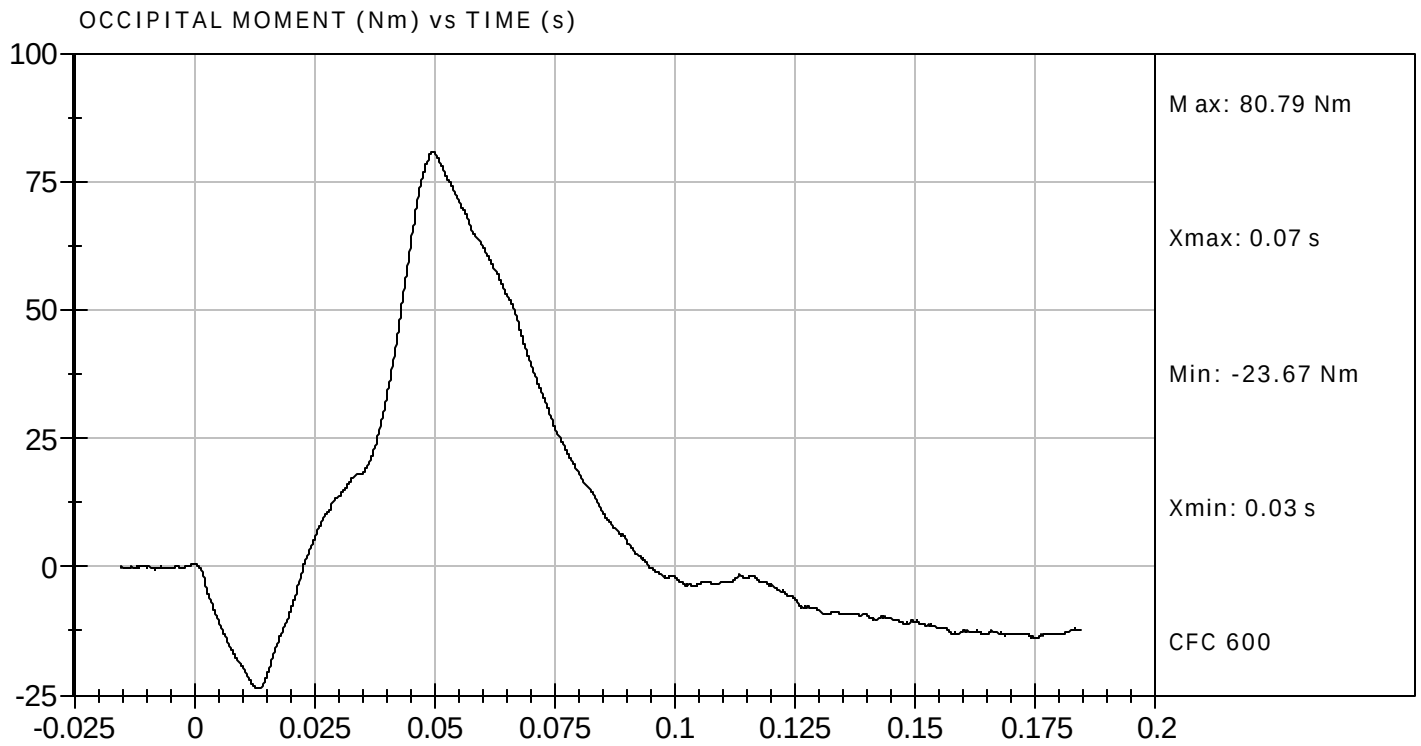
Test Desc: Neck Flexion  
Componet ID: D05722

Test Date: 03/10/2005  
Velocity: 22.97 ft/s, 7.00 m/s

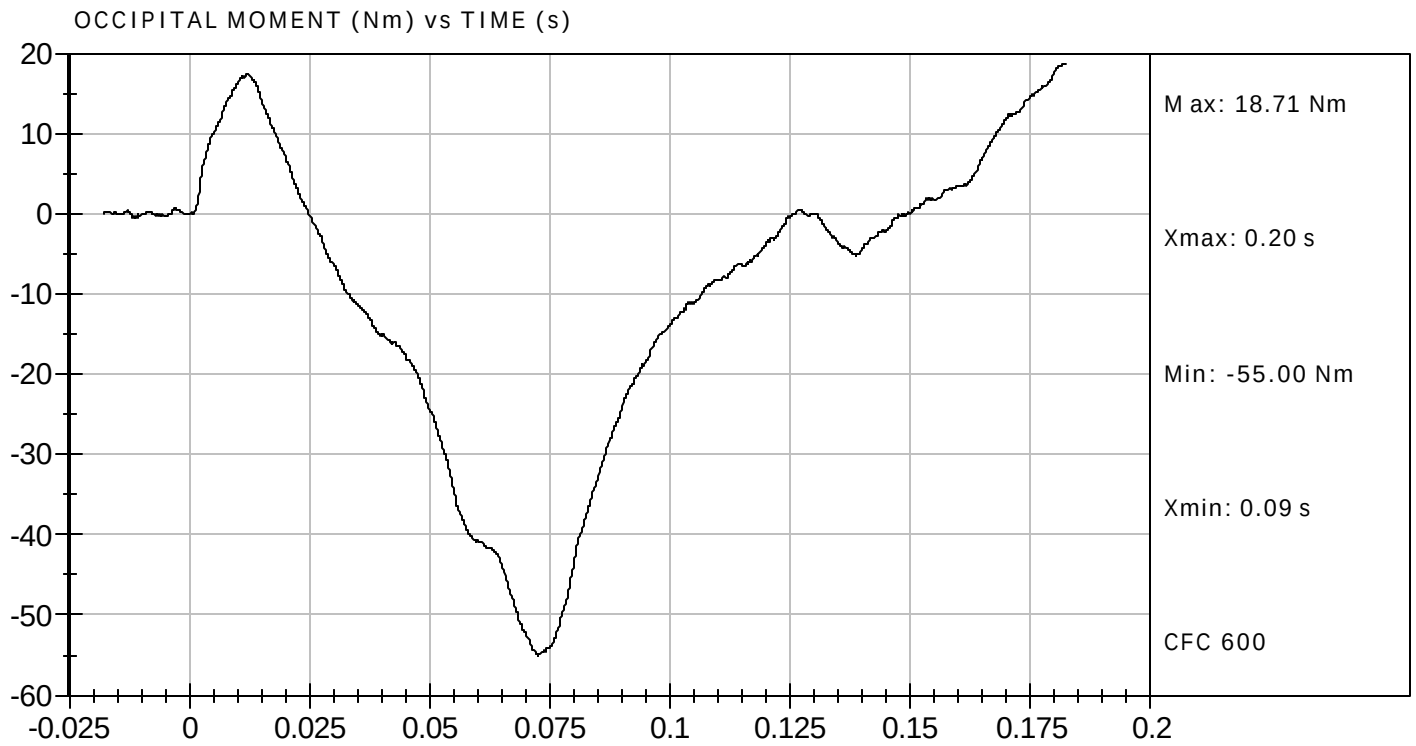
Test Desc: Neck Extension  
Componet ID: D05723

Test Date: 03/10/2005  
Velocity: 19.89 ft/s, 6.06 m/s

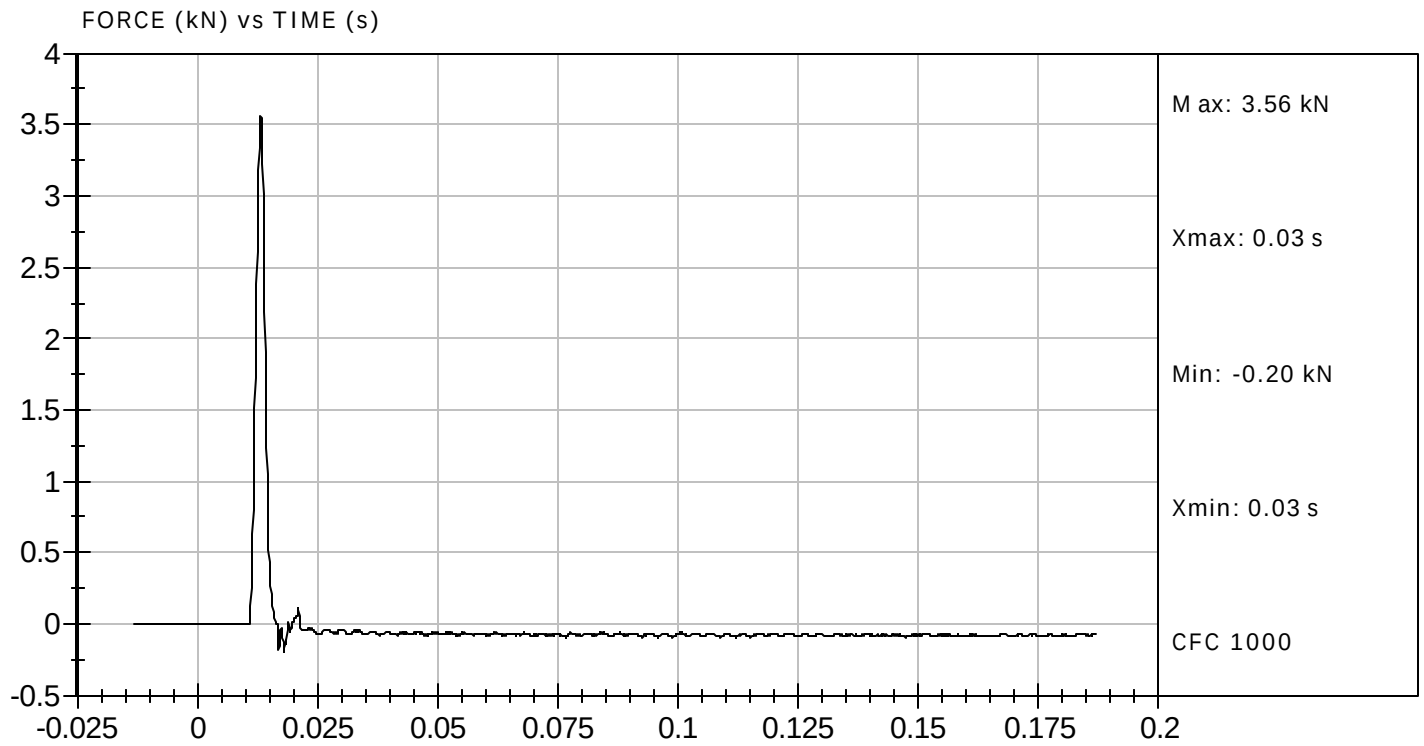
Test Desc: Left Knee  
Componet ID: D05726

Test Date: 03/10/2005  
Velocity: 6.79 ft/s, 2.07 m/s

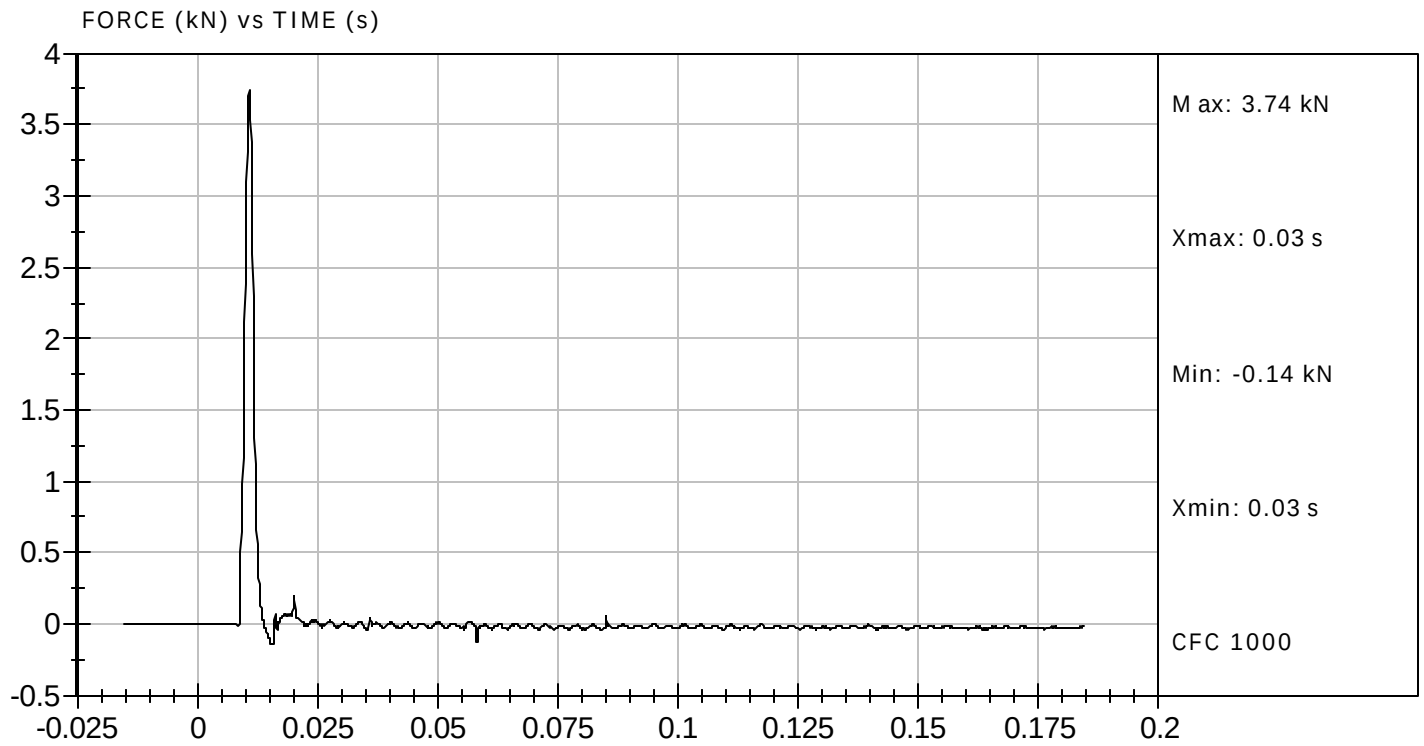
Test Desc: Right Knee  
Componet ID: D05725

Test Date: 03/10/2005  
Velocity: 6.82 ft/s, 2.08 m/s

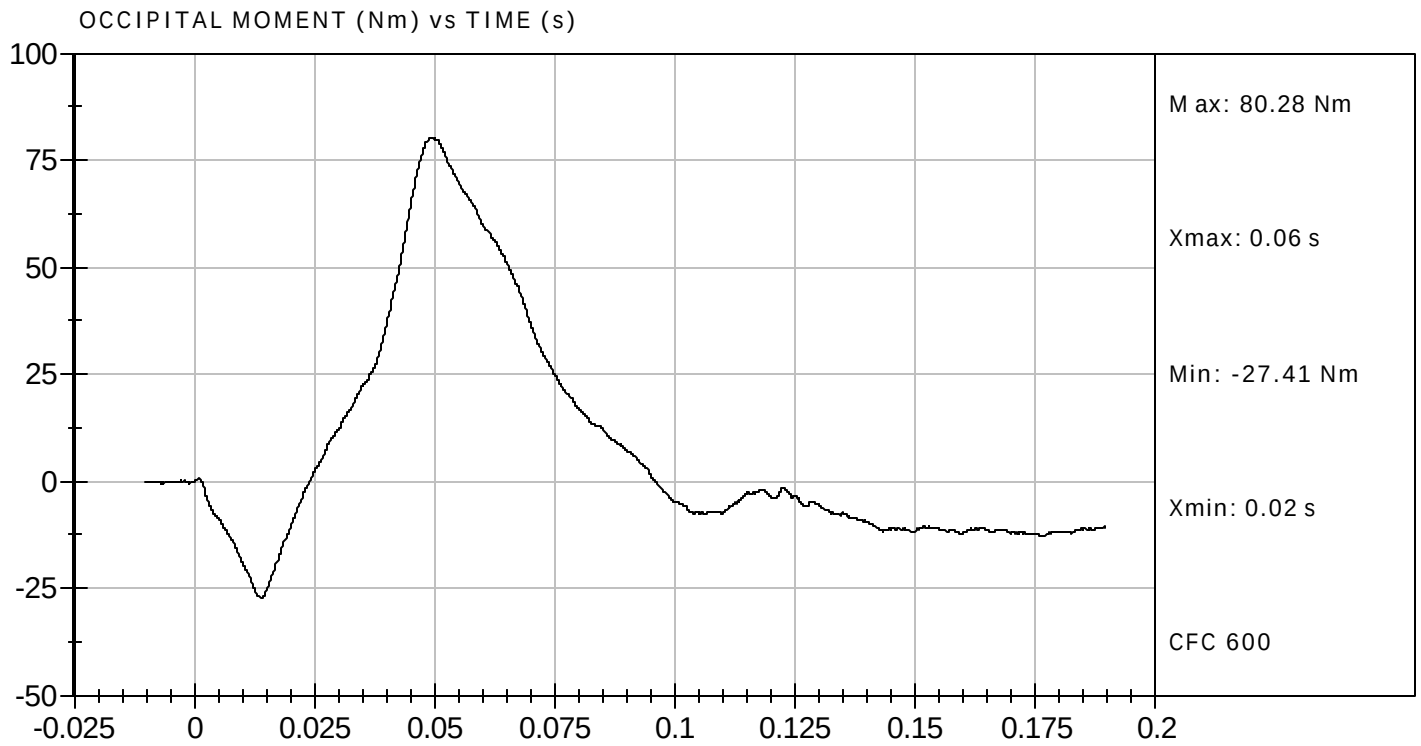
Test Desc: Neck Flexion  
Componet ID: D05842

Test Date: 03/22/2005  
Velocity: 23.07 ft/s, 7.03 m/s

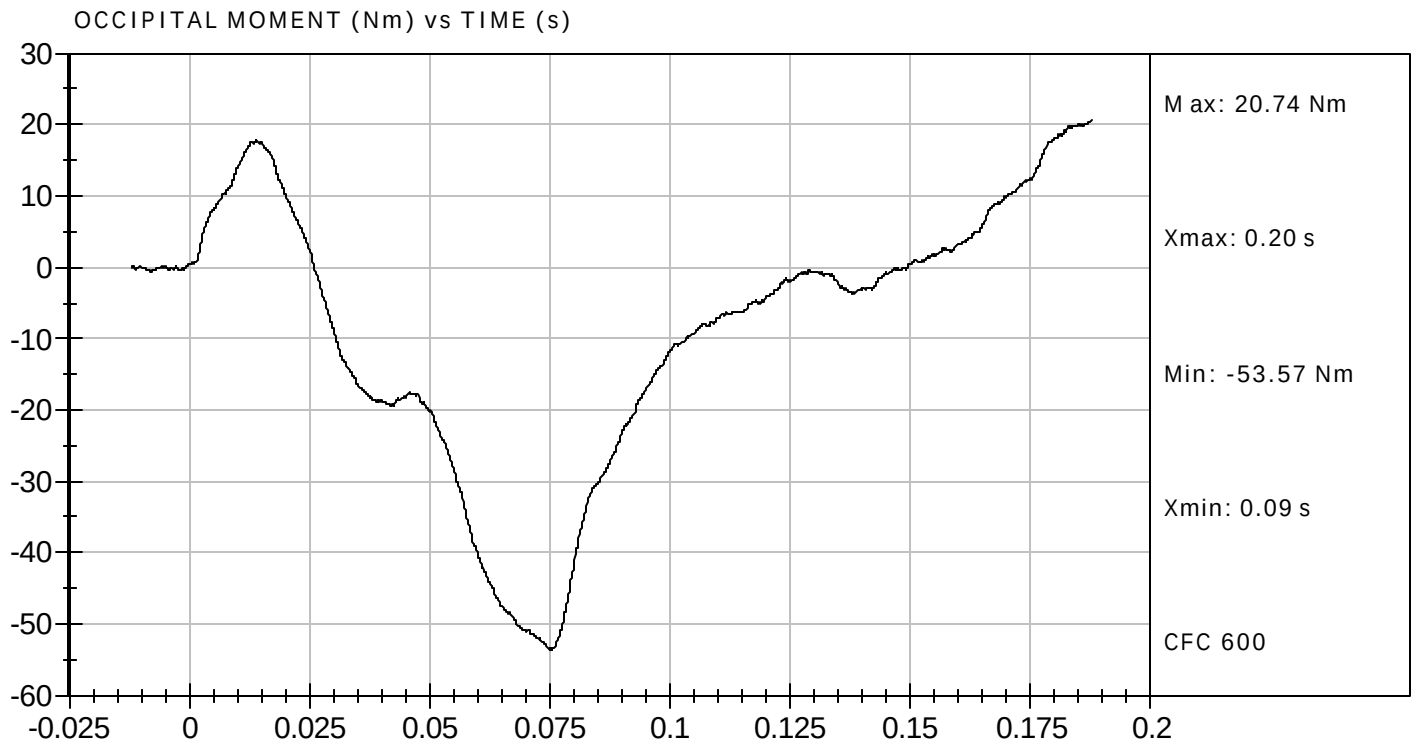
Test Desc: Neck Extension  
Componet ID: D05843

Test Date: 03/22/2005  
Velocity: 20.08 ft/s, 6.12 m/s

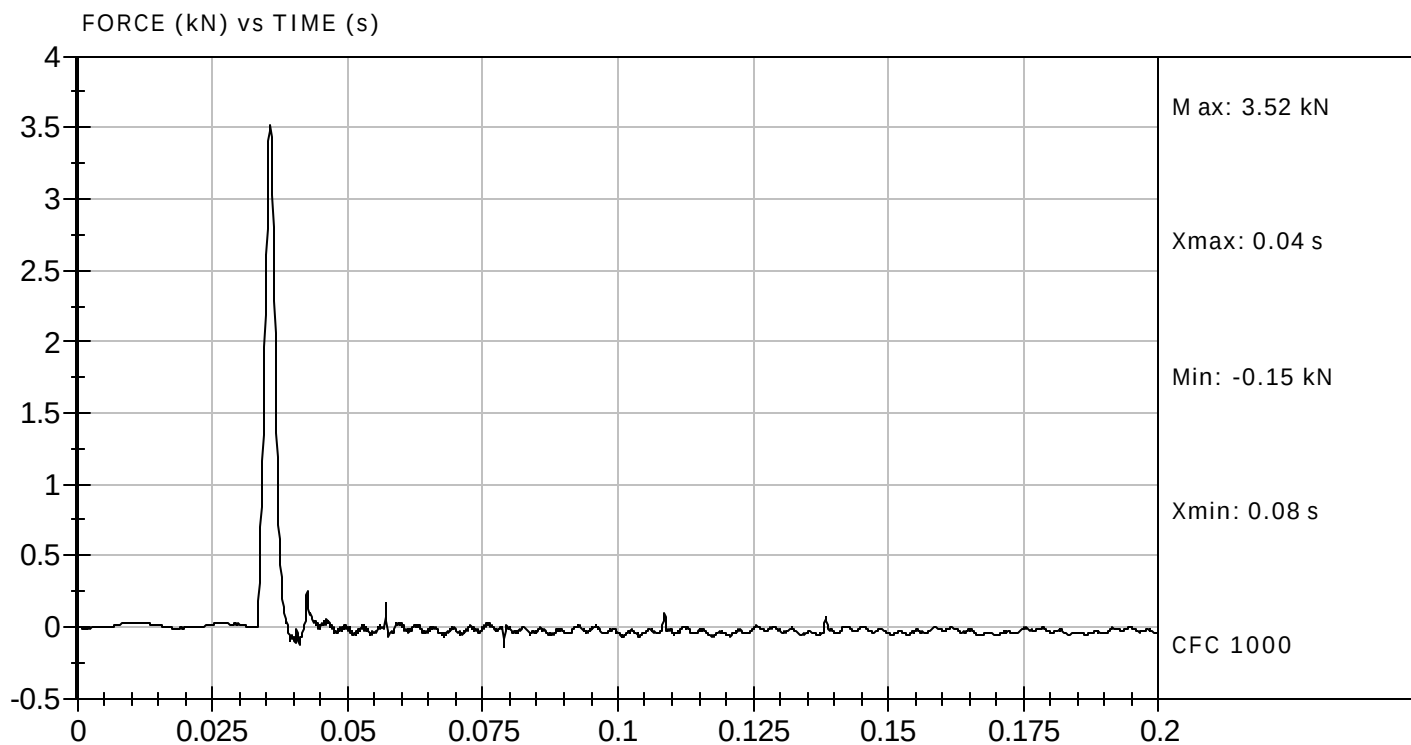
Test Desc: Left Knee  
Componet ID: D05846

Test Date: 03/22/2005  
Velocity: 6.99 ft/s, 2.13 m/s

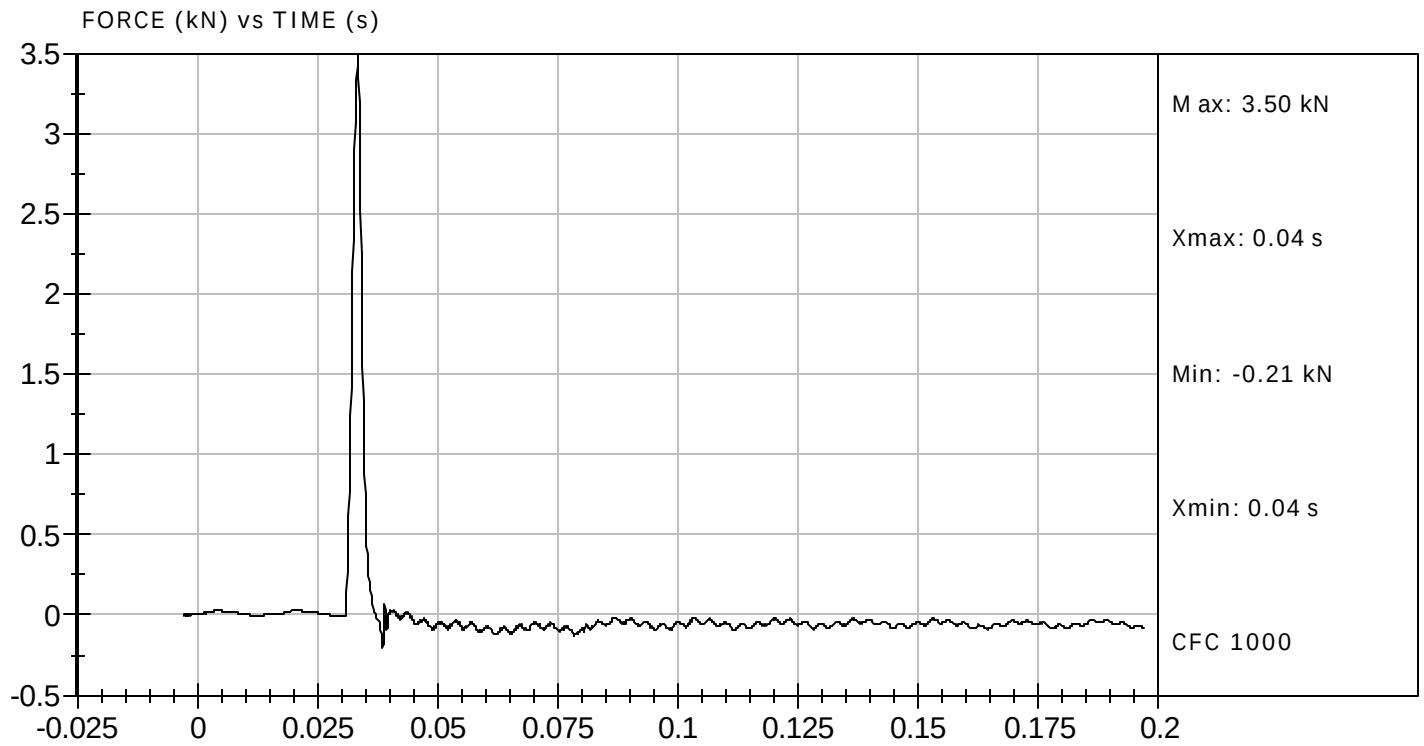
Test Desc: Right Knee  
Componet ID: D05845

Test Date: 03/22/2005  
Velocity: 6.95 ft/s, 2.12 m/s

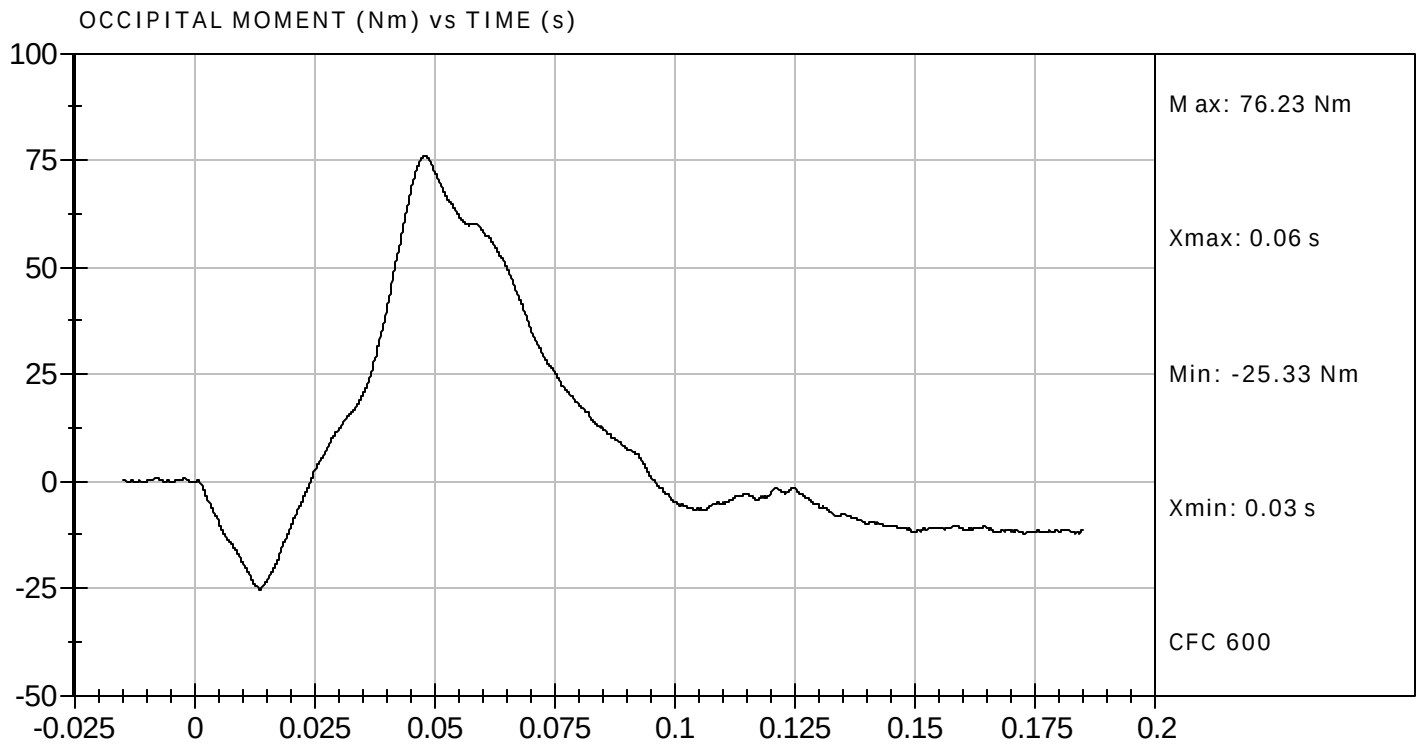
Test Desc: Neck Flexion  
Componet ID: D05962

Test Date: 04/07/2005  
Velocity: 23.17 ft/s, 7.06 m/s

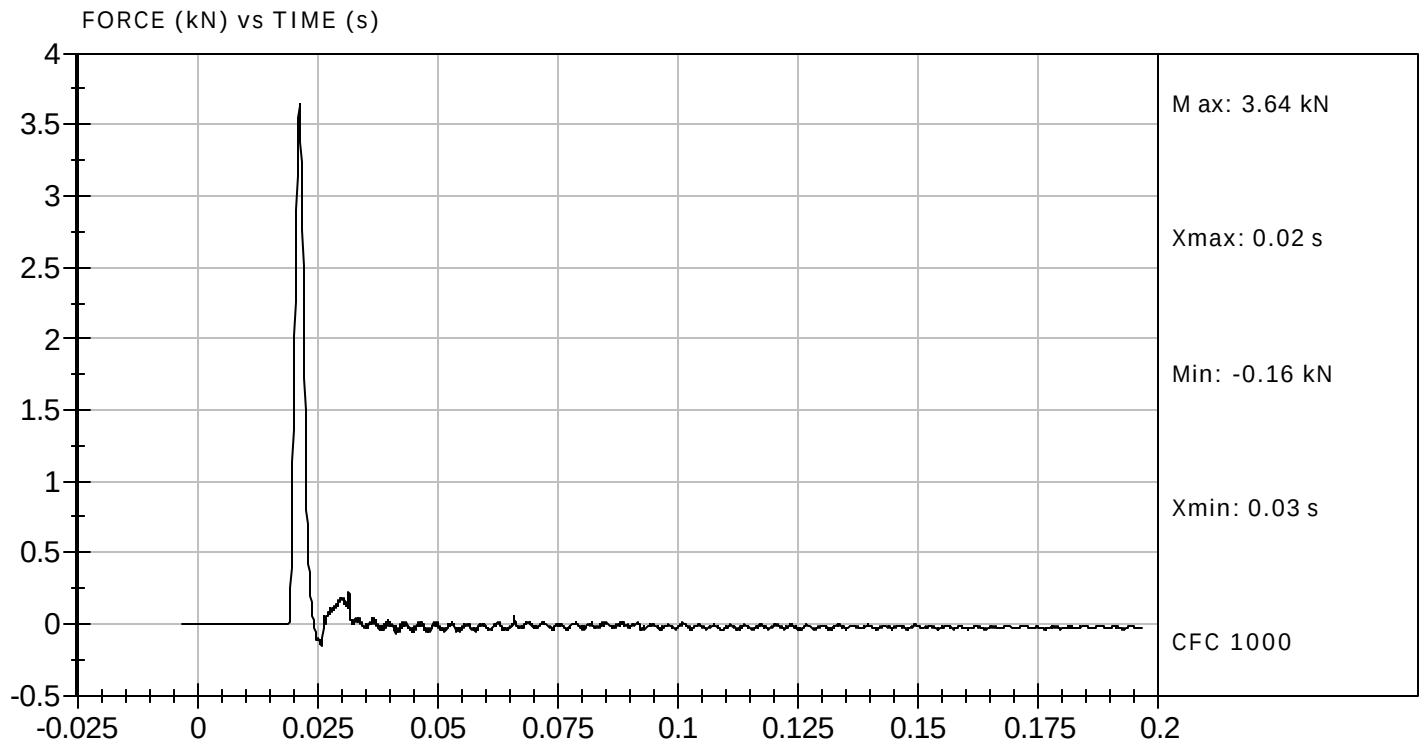
Test Desc: Left Knee  
Componet ID: D05966

Test Date: 04/08/2005  
Velocity: 6.81 ft/s, 2.08 m/s

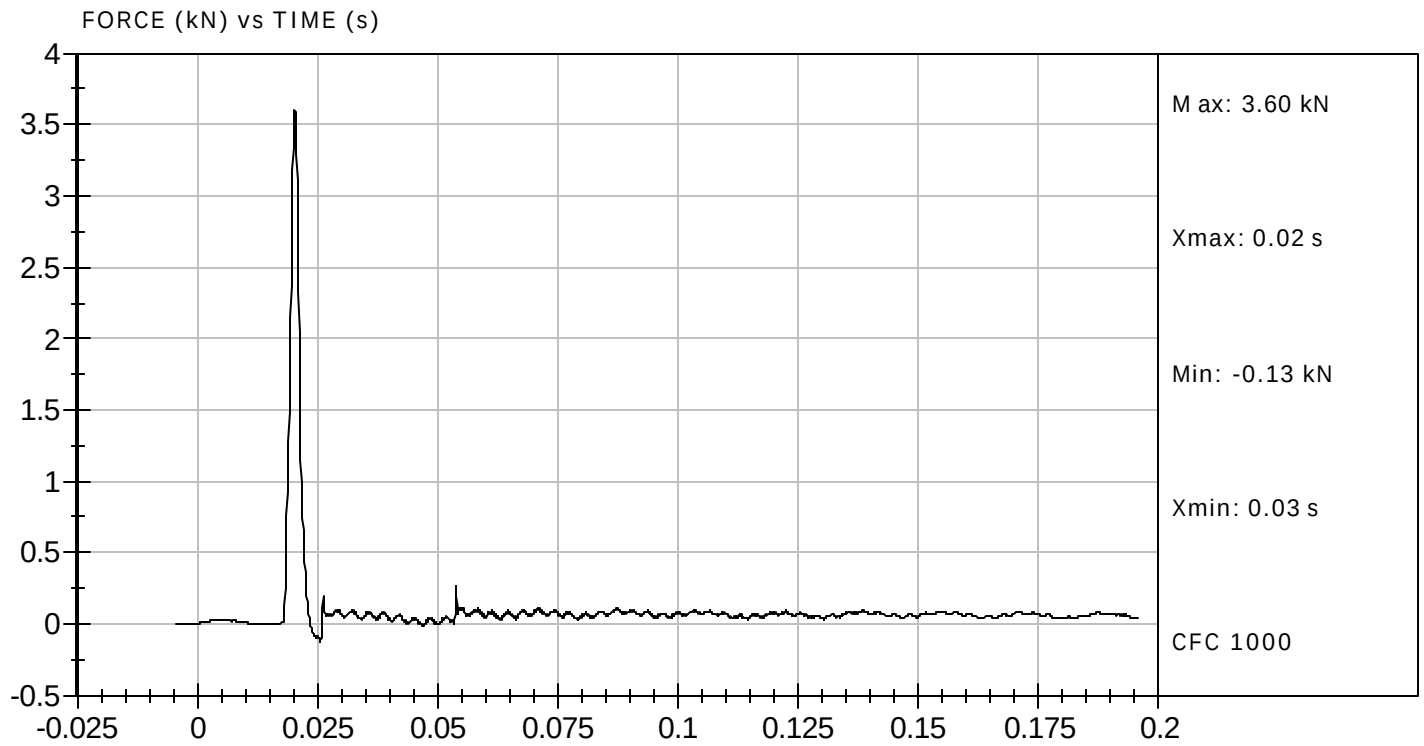
Test Desc: Right Knee  
Componet ID: D05965

Test Date: 04/07/2005  
Velocity: 6.82 ft/s, 2.08 m/s

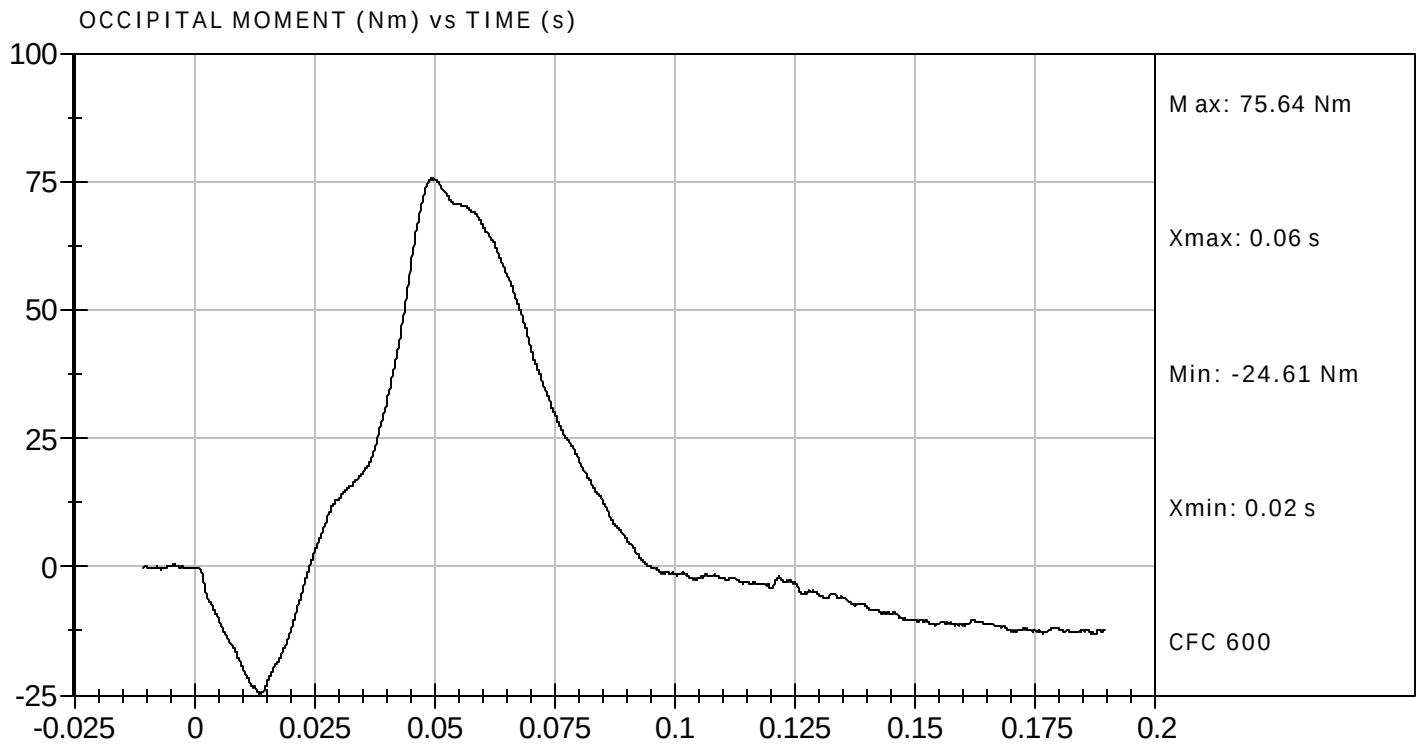
Test Desc: Neck Flexion  
Componet ID: D05862

Test Date: 03/22/2005  
Velocity: 22.79 ft/s, 6.95 m/s

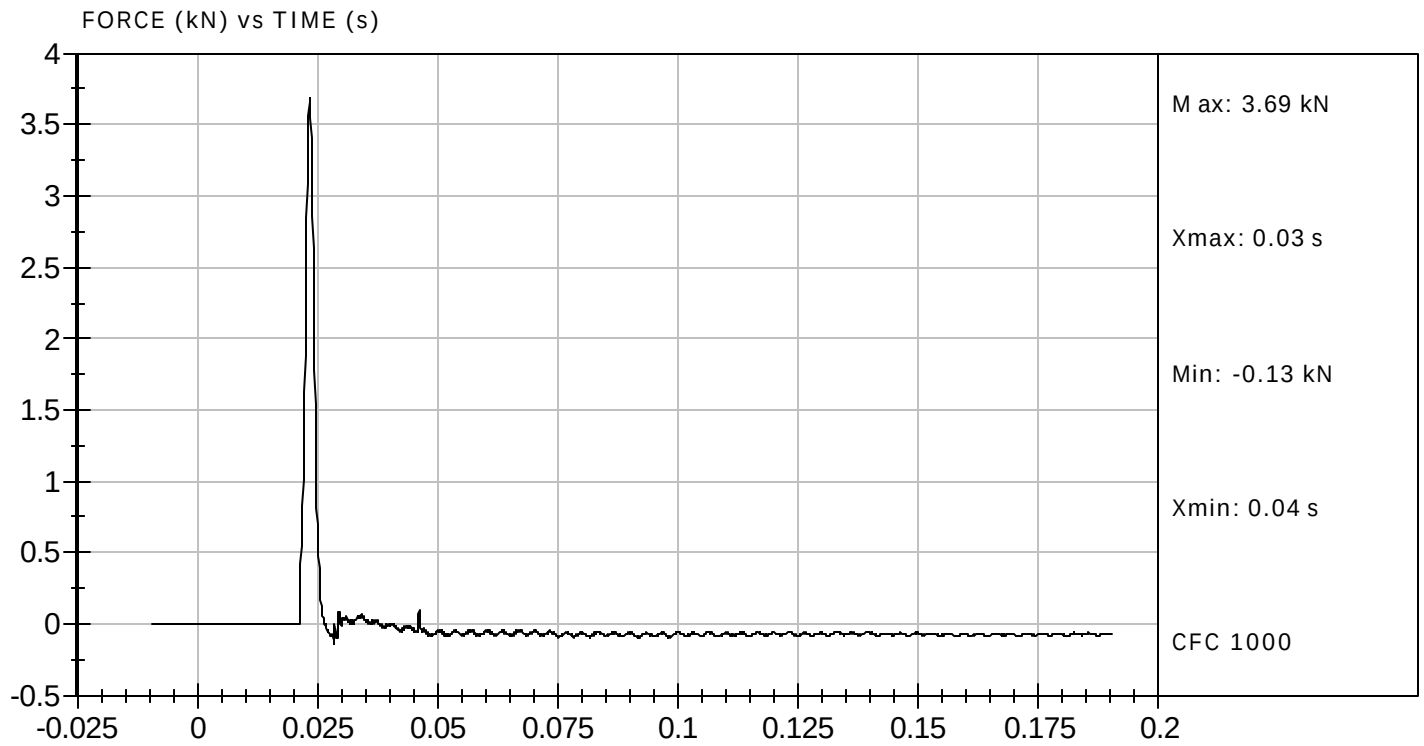
Test Desc: Left Knee  
Componet ID: D05866

Test Date: 03/23/2005  
Velocity: 6.91 ft/s, 2.11 m/s

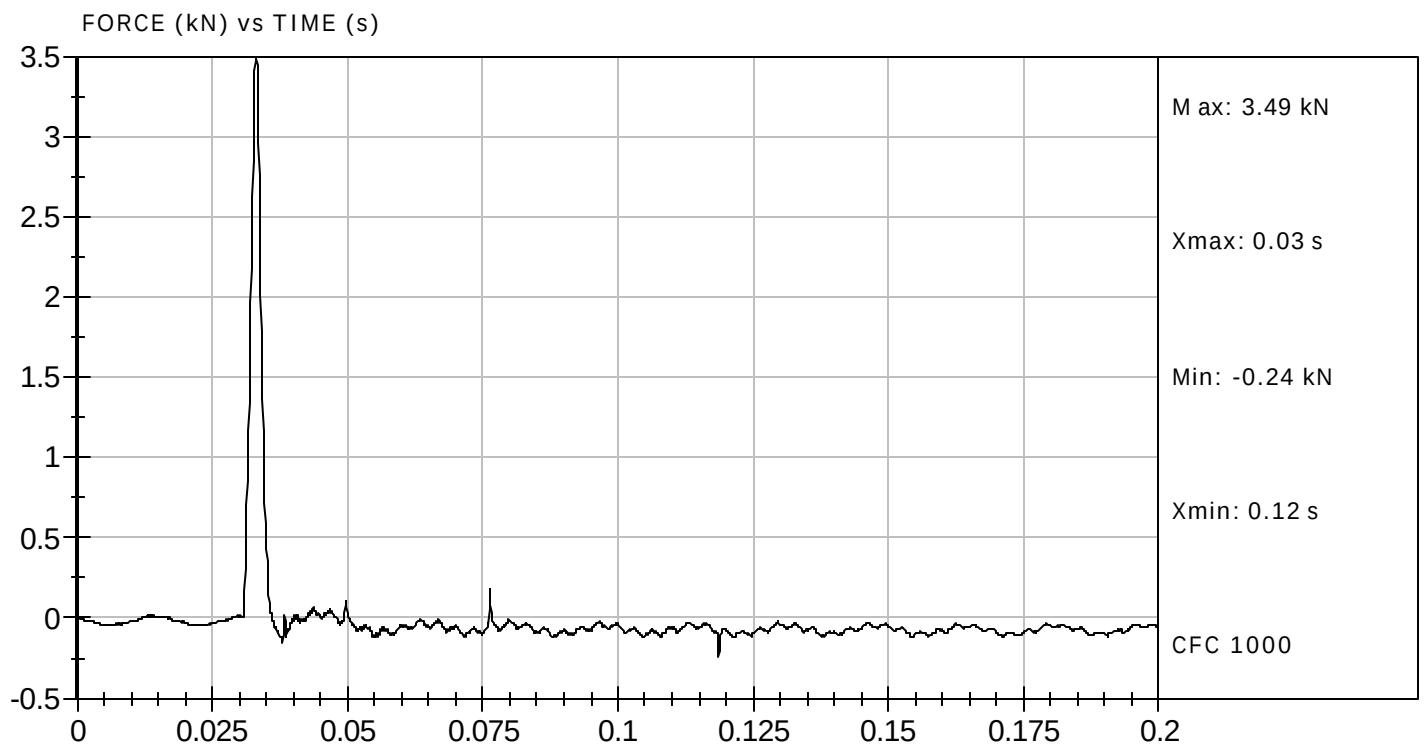
Test Desc: Right Knee  
Componet ID: D05865

Test Date: 03/23/2005  
Velocity: 6.88 ft/s, 2.10 m/s

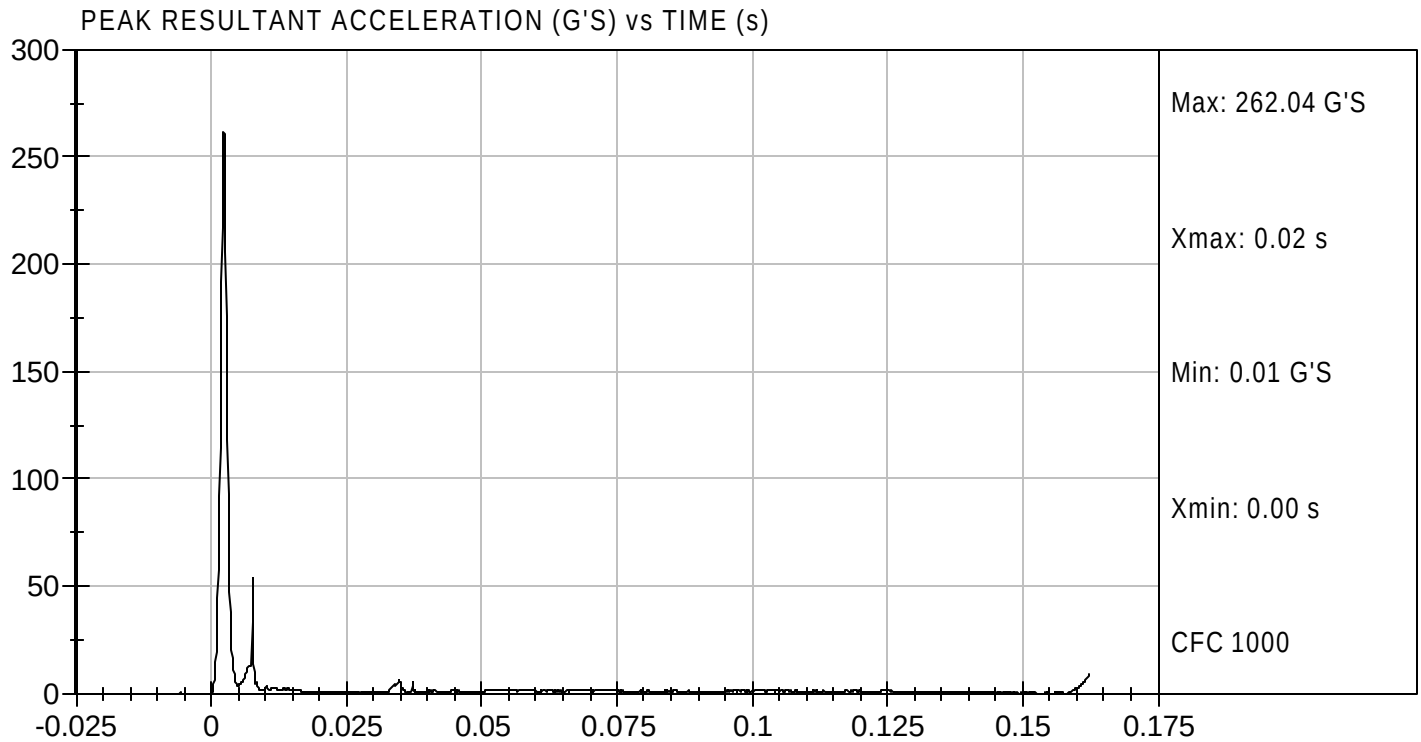
Test Desc: Head Drop  
Componet ID: D051101

Test Date: 04/22/2005  
Velocity: 0 ft/s, 0.00 m/s

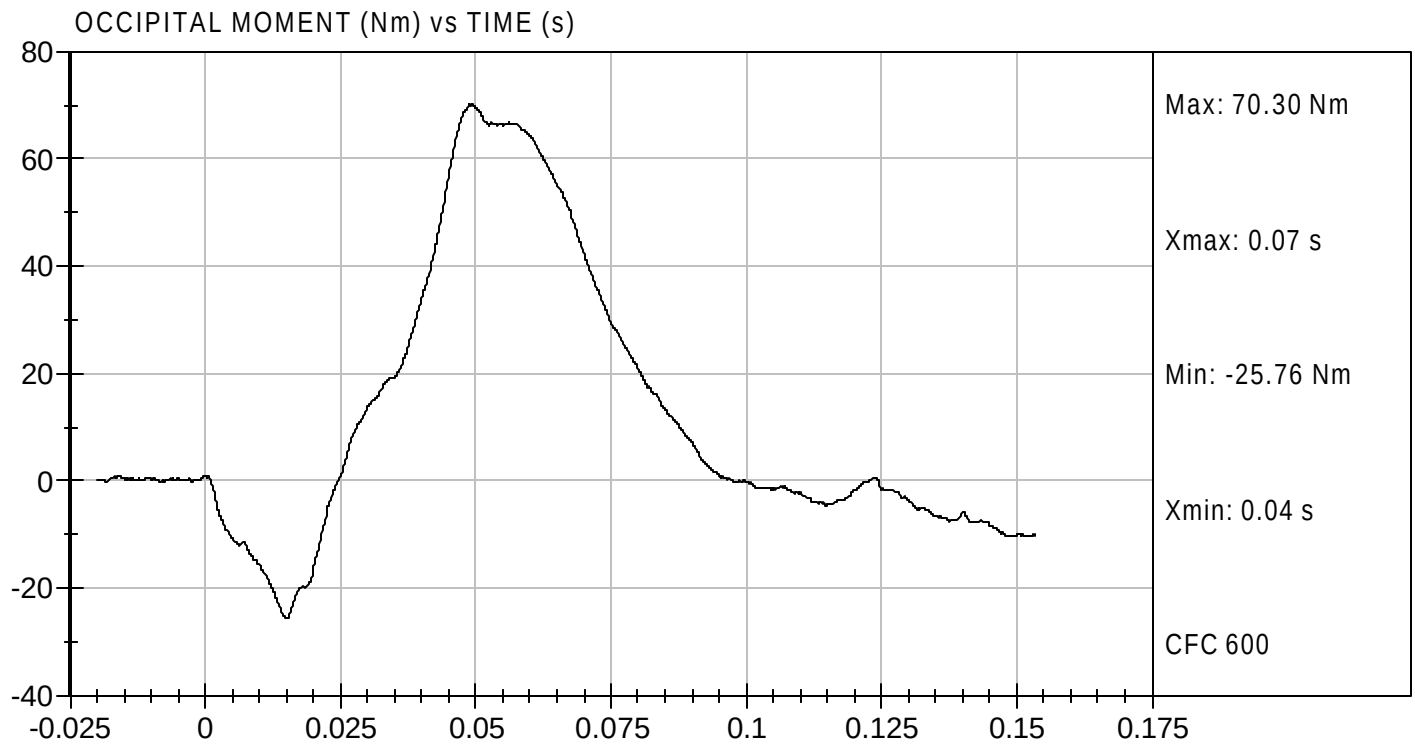
Test Desc: Neck Flexion  
Componet ID: D051102

Test Date: 04/25/2005  
Velocity: 23.01 ft/s, 7.01 m/s

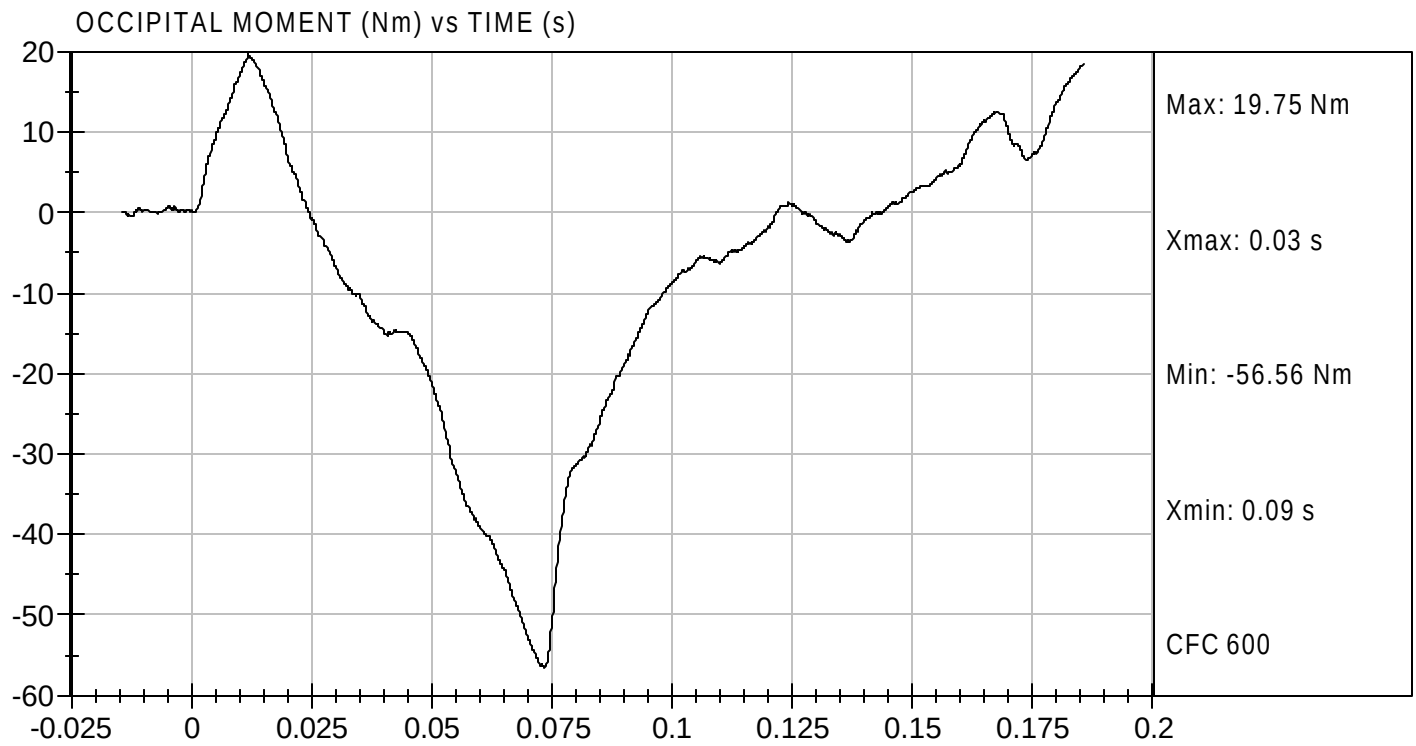
Test Desc: Neck Extension  
Componet ID: D051103

Test Date: 04/25/2005  
Velocity: 20.3 ft/s, 6.19 m/s

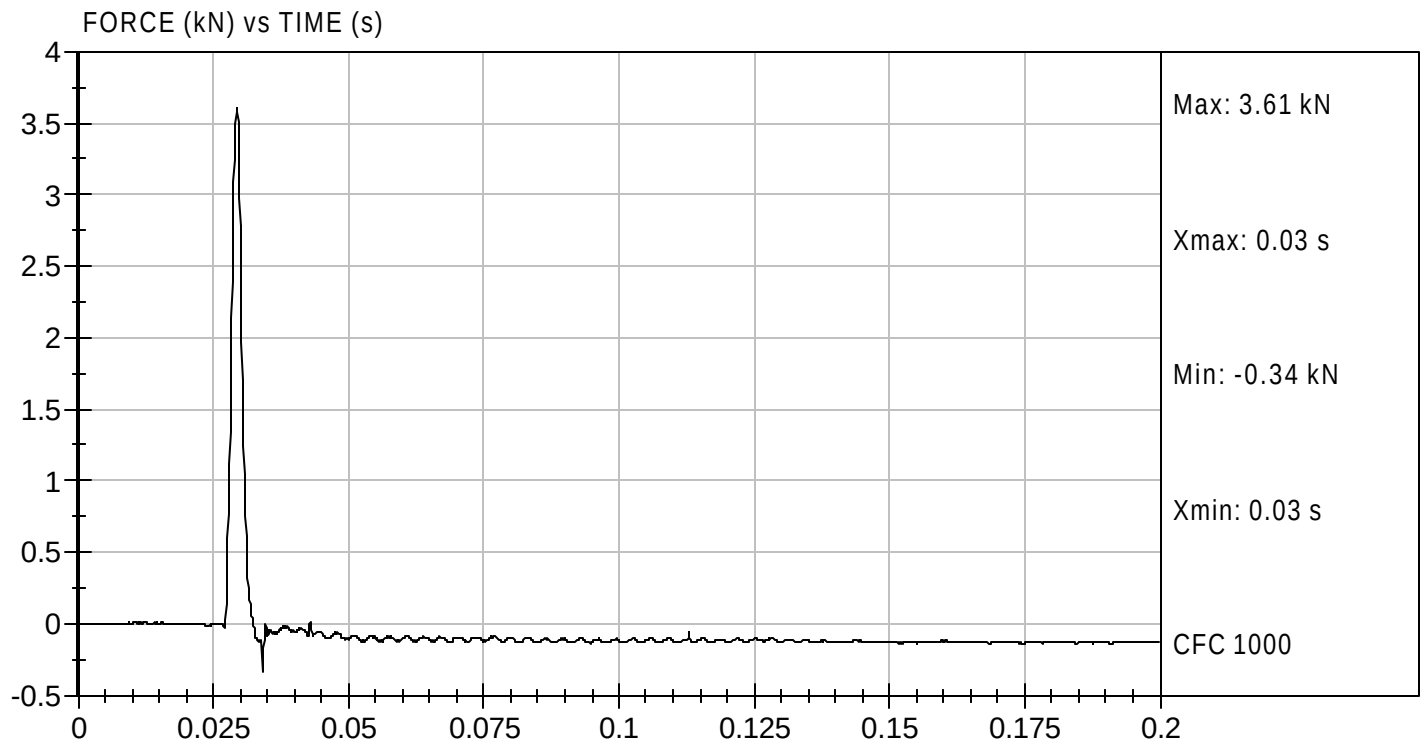
Test Desc: Left Knee  
Componet ID: D051106

Test Date: 04/25/2005  
Velocity: 6.97 ft/s, 2.12 m/s

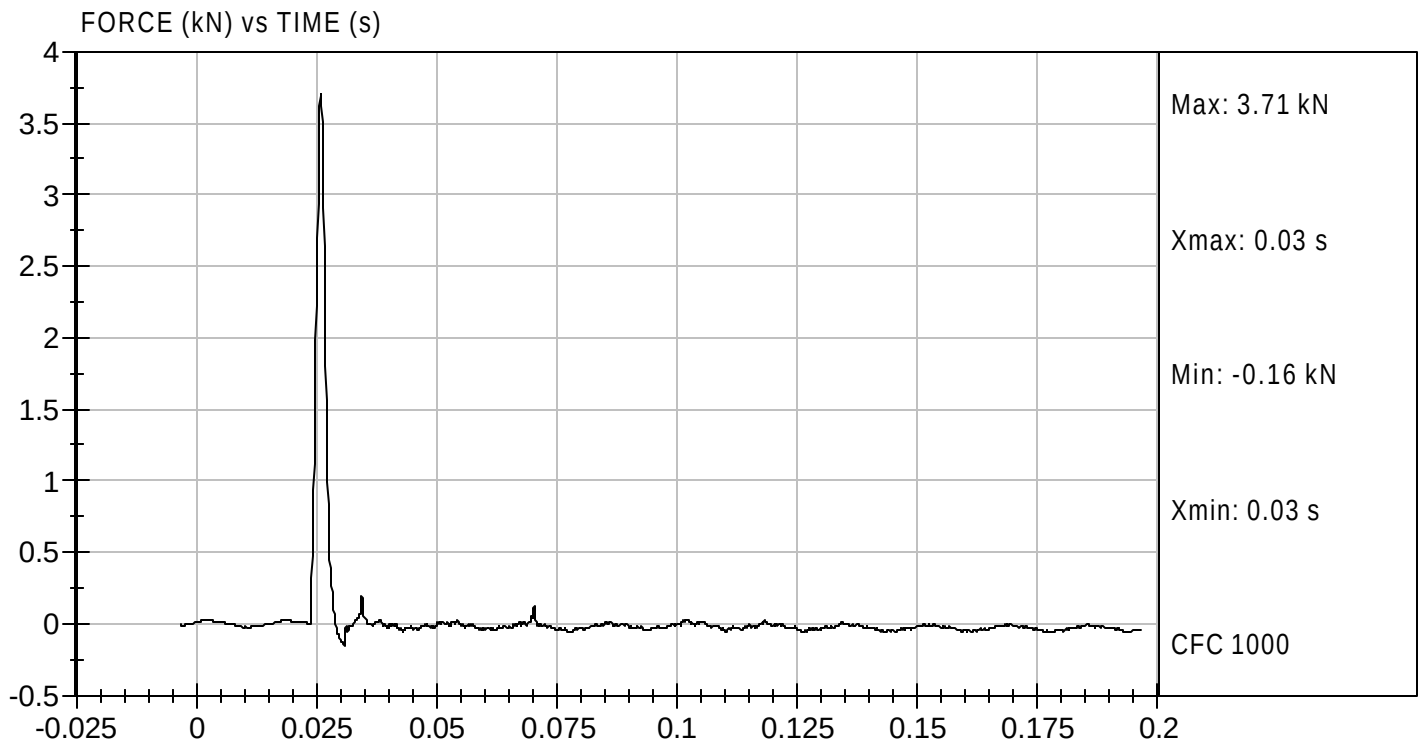
Test Desc: Right Knee  
Componet ID: D051105

Test Date: 04/25/2005  
Velocity: 6.94 ft/s, 2.12 m/s

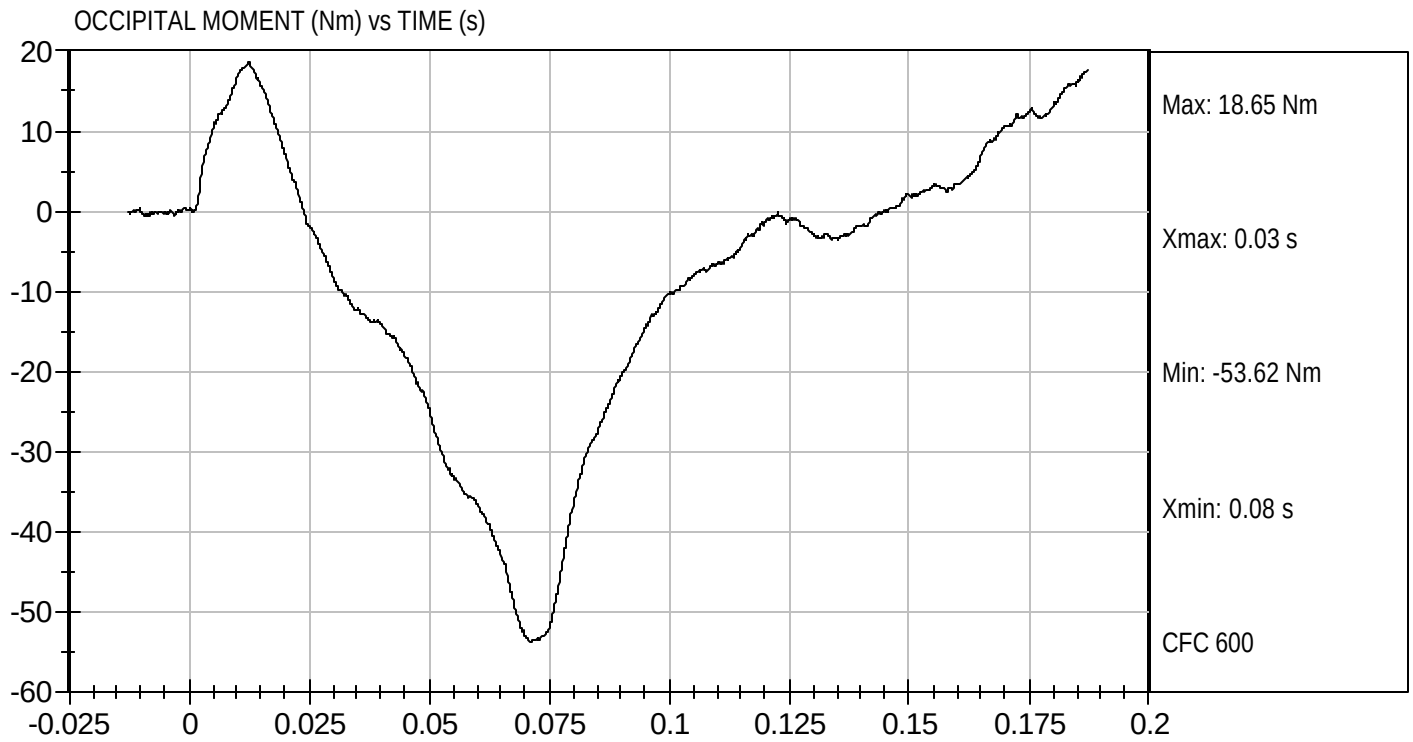
Test Desc: Neck Extension  
Componet ID: D051793

Test Date: 06/27/2005  
Velocity: 19.9 ft/s, 6.07 m/s
