**REPORT NO. 208-MGA-2005-DC019**

**DUMMY PERFORMANCE CALIBRATIONS**  
**FMVSS 208**

**DaimlerChrysler Corp.  
2005 Mercedes C230 Passenger Car  
NHTSA No.: C50500**

**PREPARED BY:  
MGA RESEARCH CORPORATION  
5000 WARREN ROAD  
BURLINGTON, WI 53105**

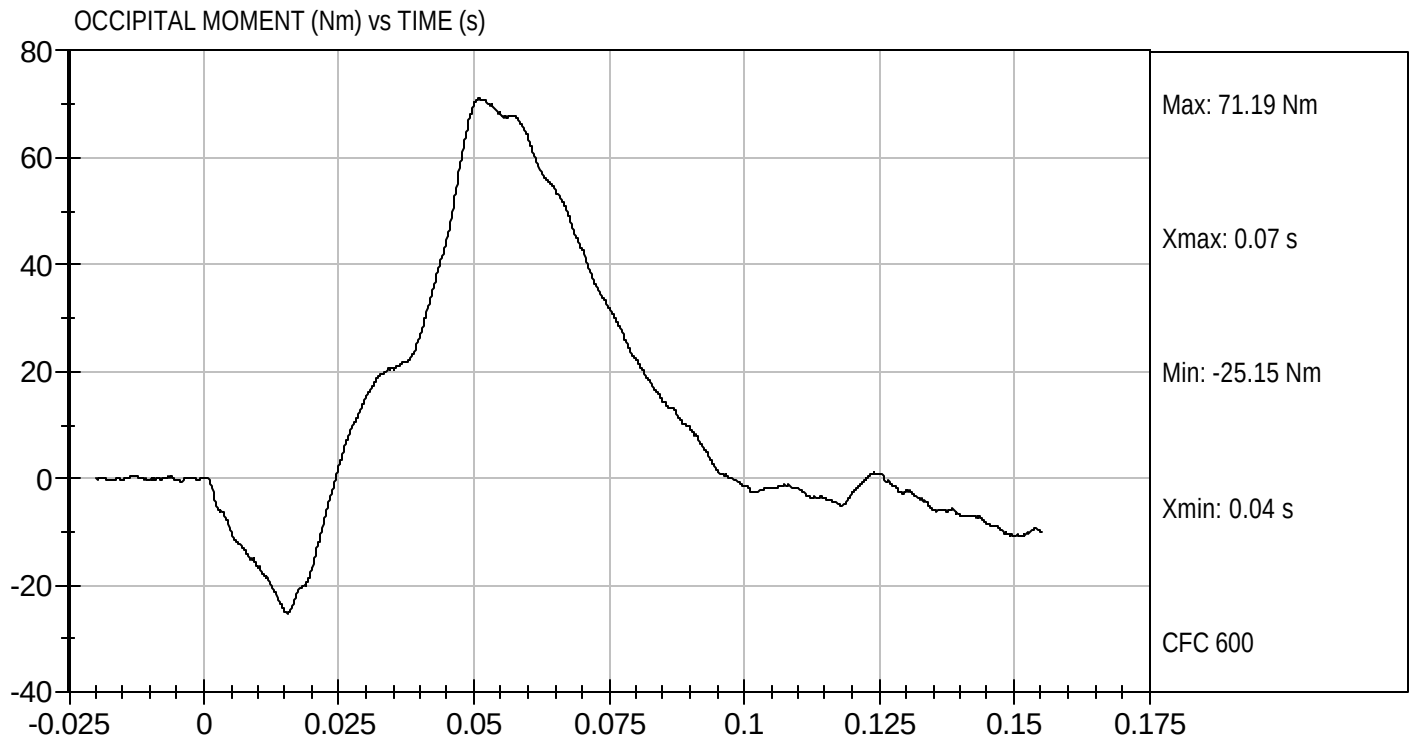
Test Desc: Neck Flexion  
Componet ID: D051892

Test Date: 07/07/2005  
Velocity: 23.29 ft/s, 7.10 m/s

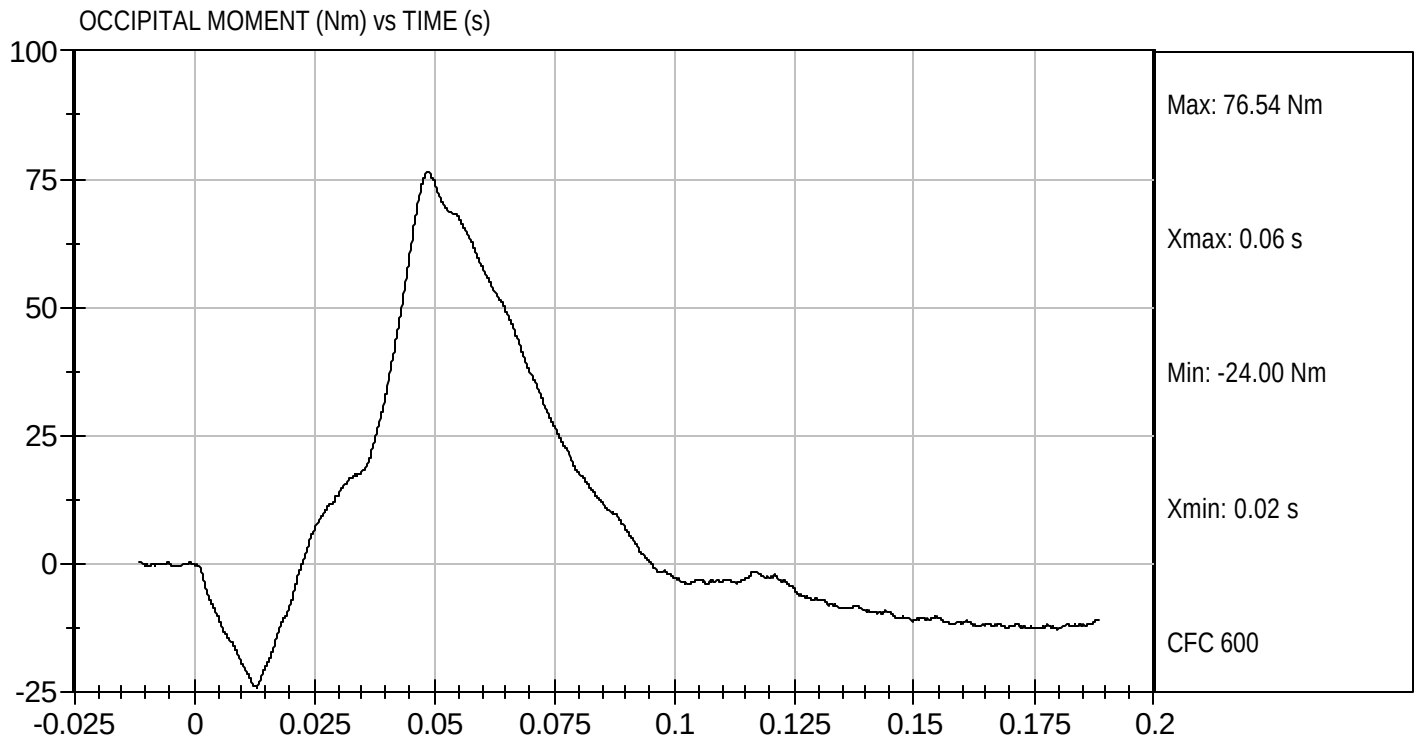
Test Desc: Neck Flexion  
Componet ID: D051802

Test Date: 06/27/2005  
Velocity: 23.01 ft/s, 7.01 m/s

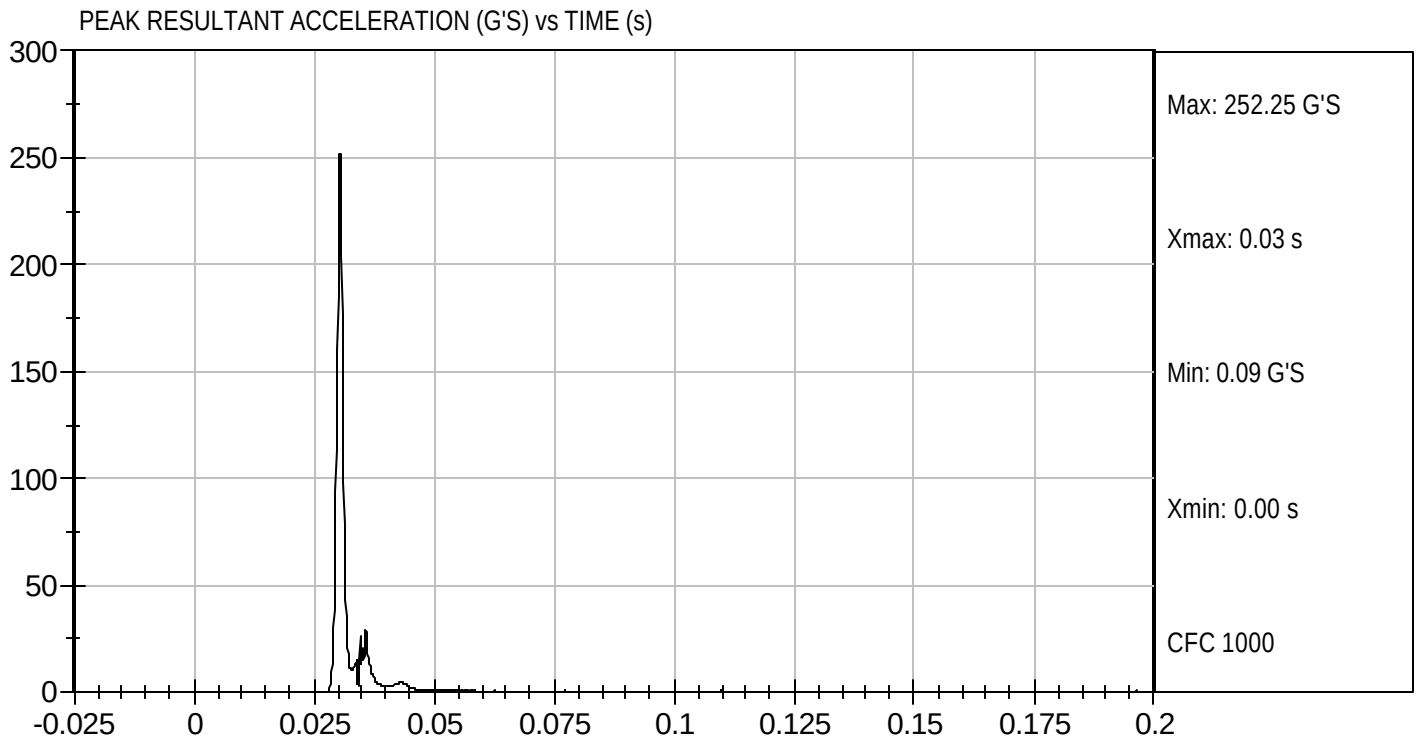
Test Desc: Head Drop  
Componet ID: D051901

Test Date: 07/08/2005  
Velocity: 0 ft/s, 0 m/s

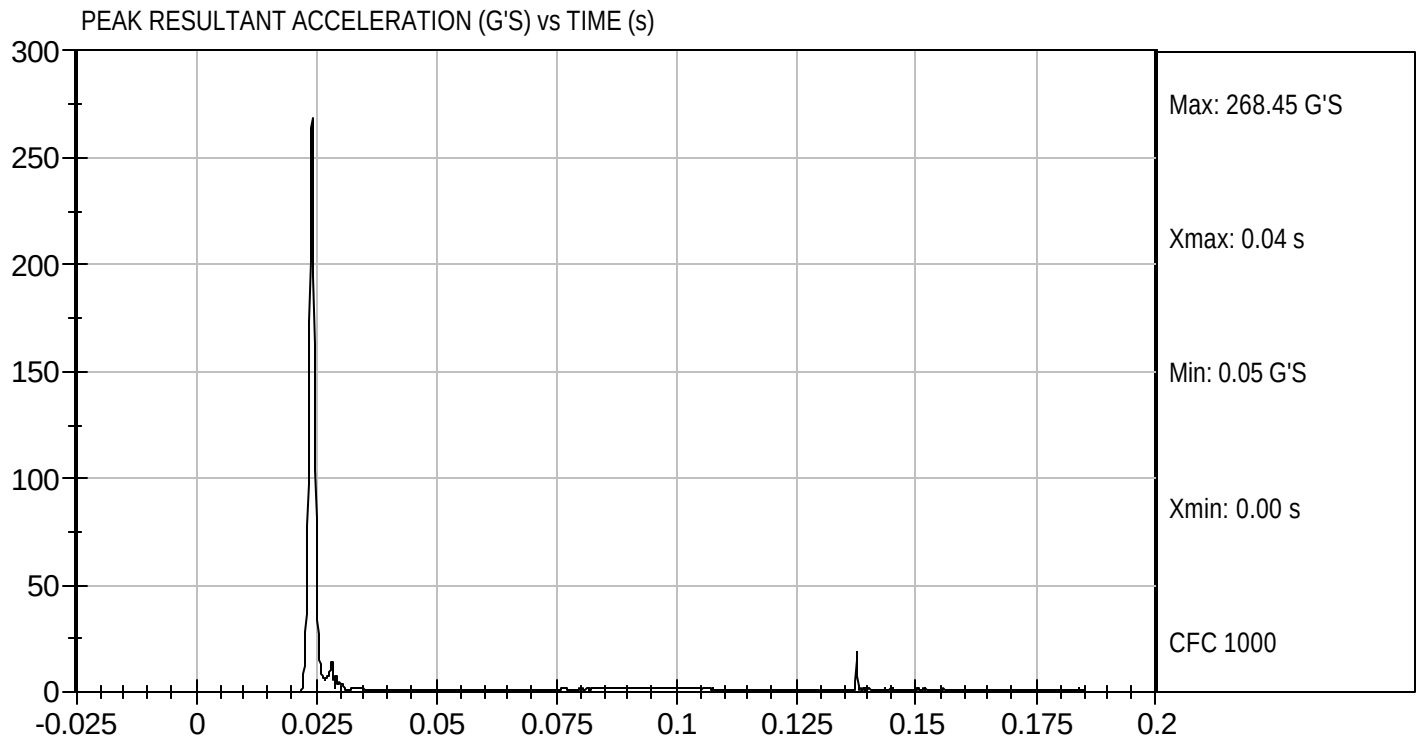
Test Desc: Head Drop  
Componet ID: D051721

Test Date: 06/21/2005  
Velocity: 0 ft/s, 0 m/s

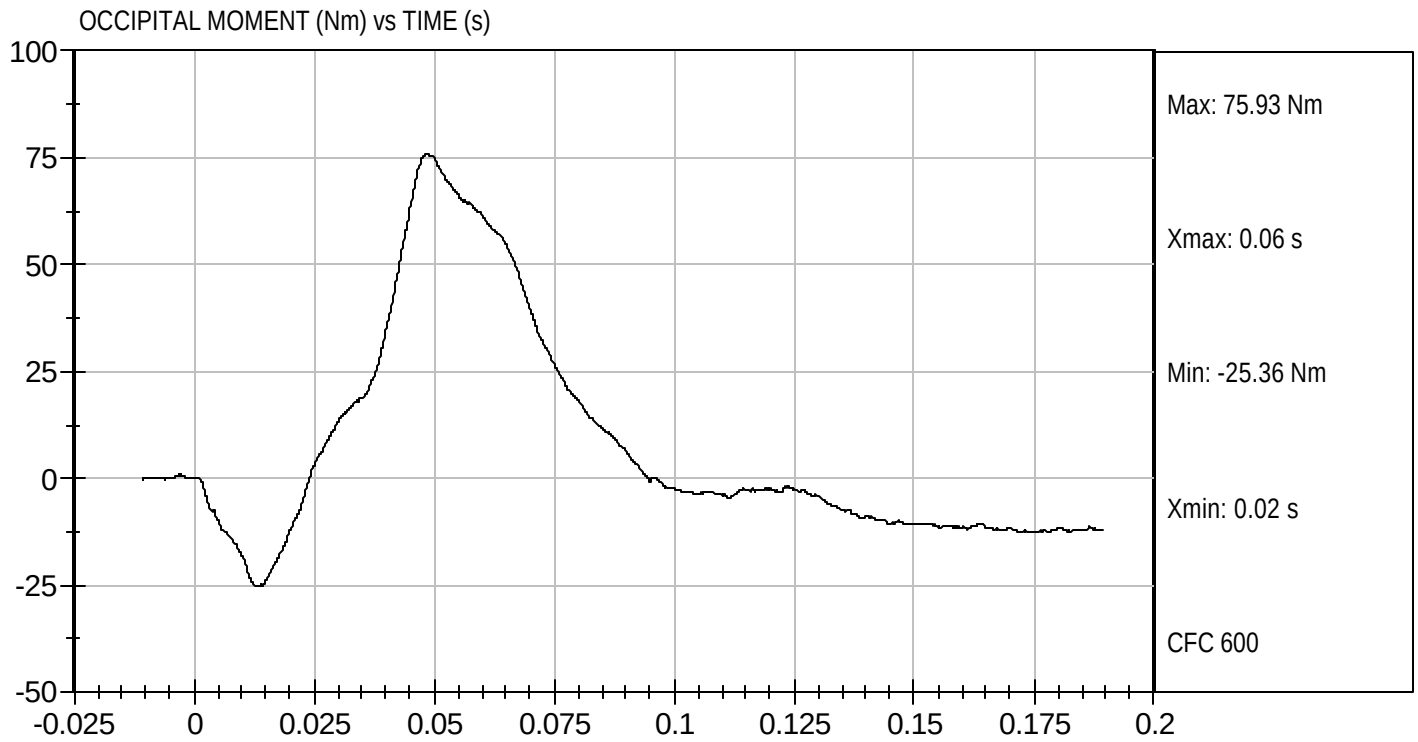
Test Desc: Neck Flexion  
Componet ID: D051722

Test Date: 06/22/2005  
Velocity: 22.8 ft/s, 6.95 m/s

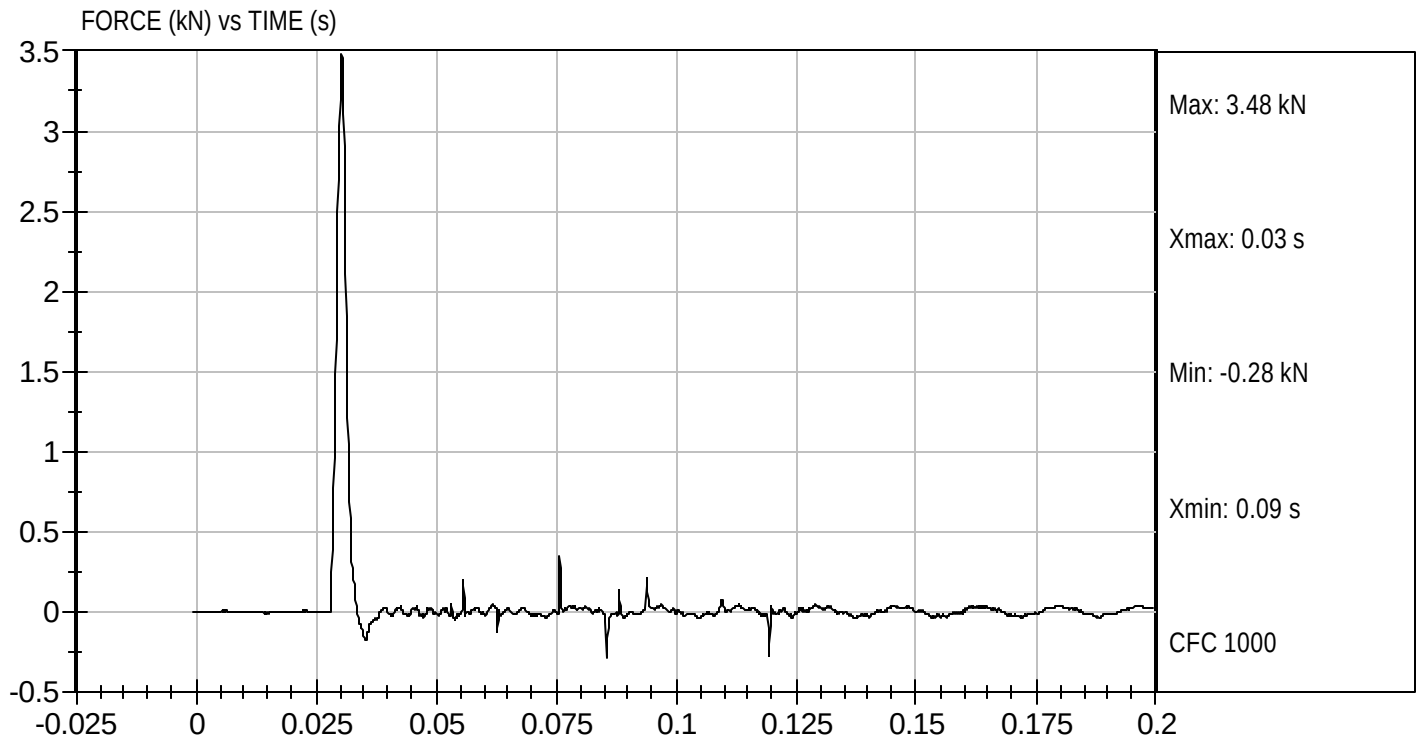
Test Desc: Left Knee  
Componet ID: D051726

Test Date: 06/21/2005  
Velocity: 6.81 ft/s, 2.08 m/s

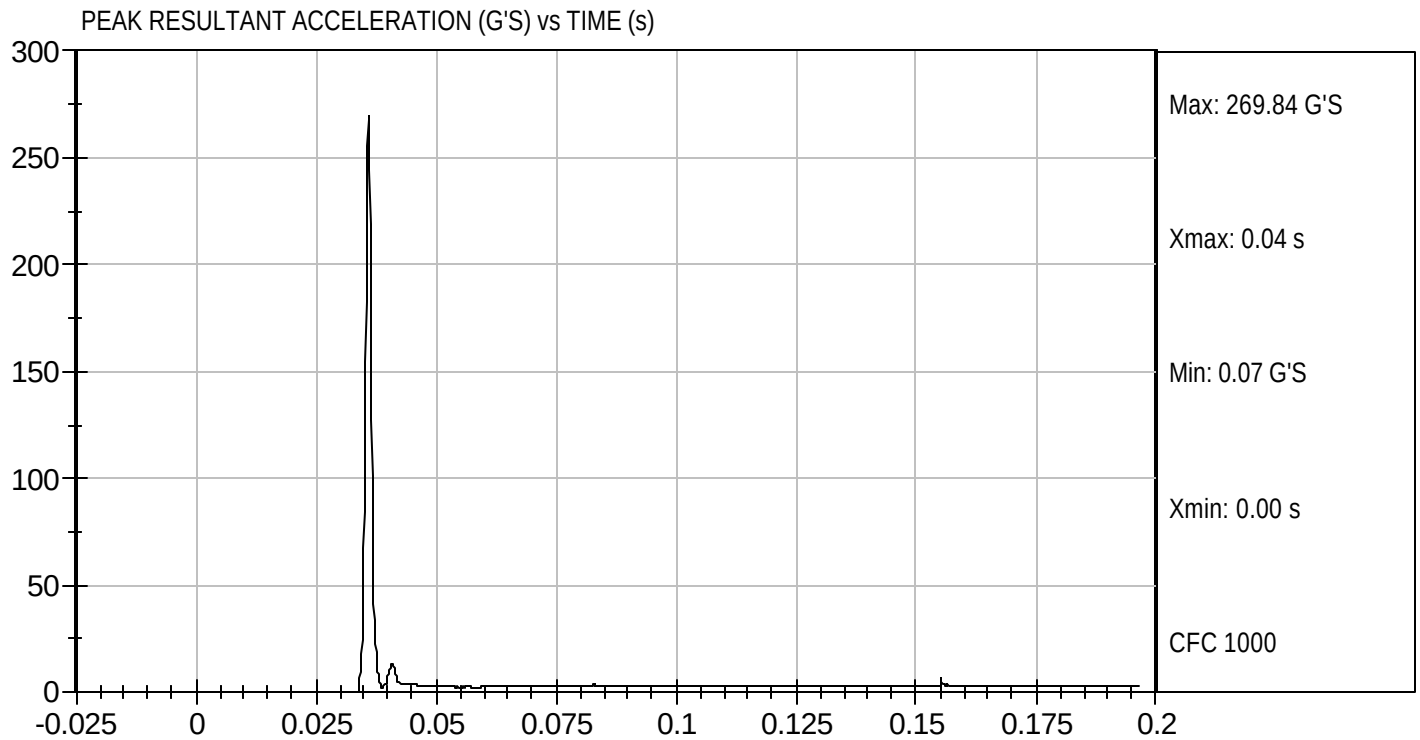
Test Desc: Head Drop  
Componet ID: D051711

Test Date: 06/21/2005  
Velocity: 0 ft/s, 0 m/s

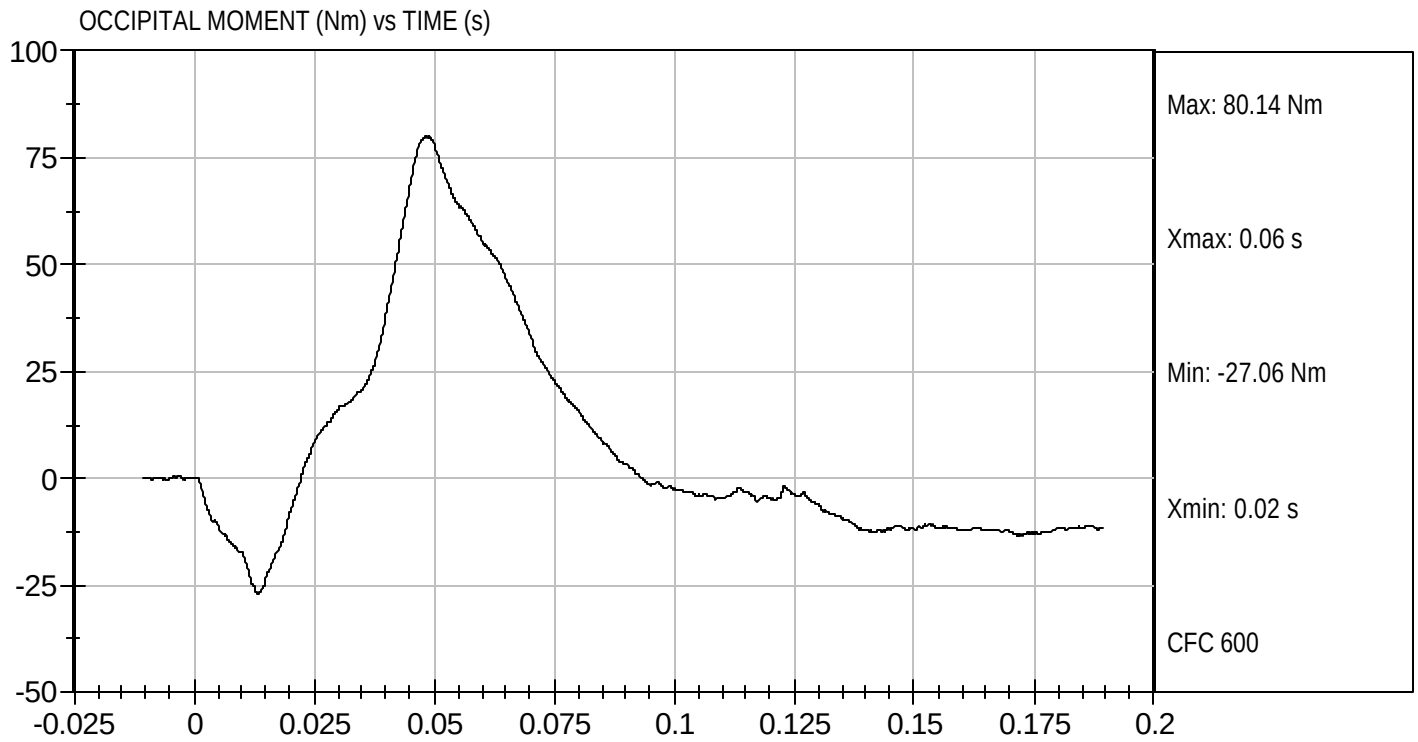
Test Desc: Neck Flexion  
Componet ID: D051712

Test Date: 06/22/2005  
Velocity: 23.06 ft/s, 7.03 m/s

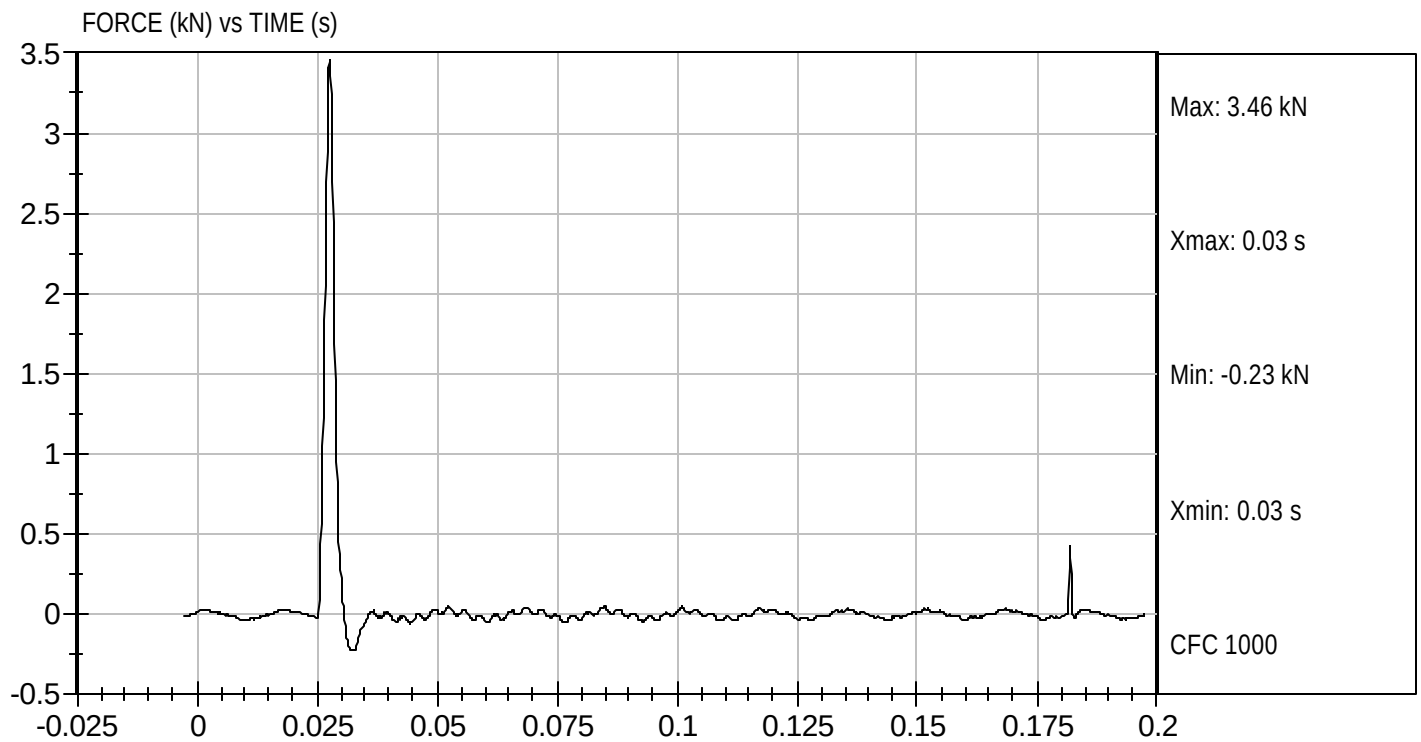
Test Desc: Left Knee  
Componet ID: D051716

Test Date: 06/21/2005  
Velocity: 6.96 ft/s, 2.12 m/s

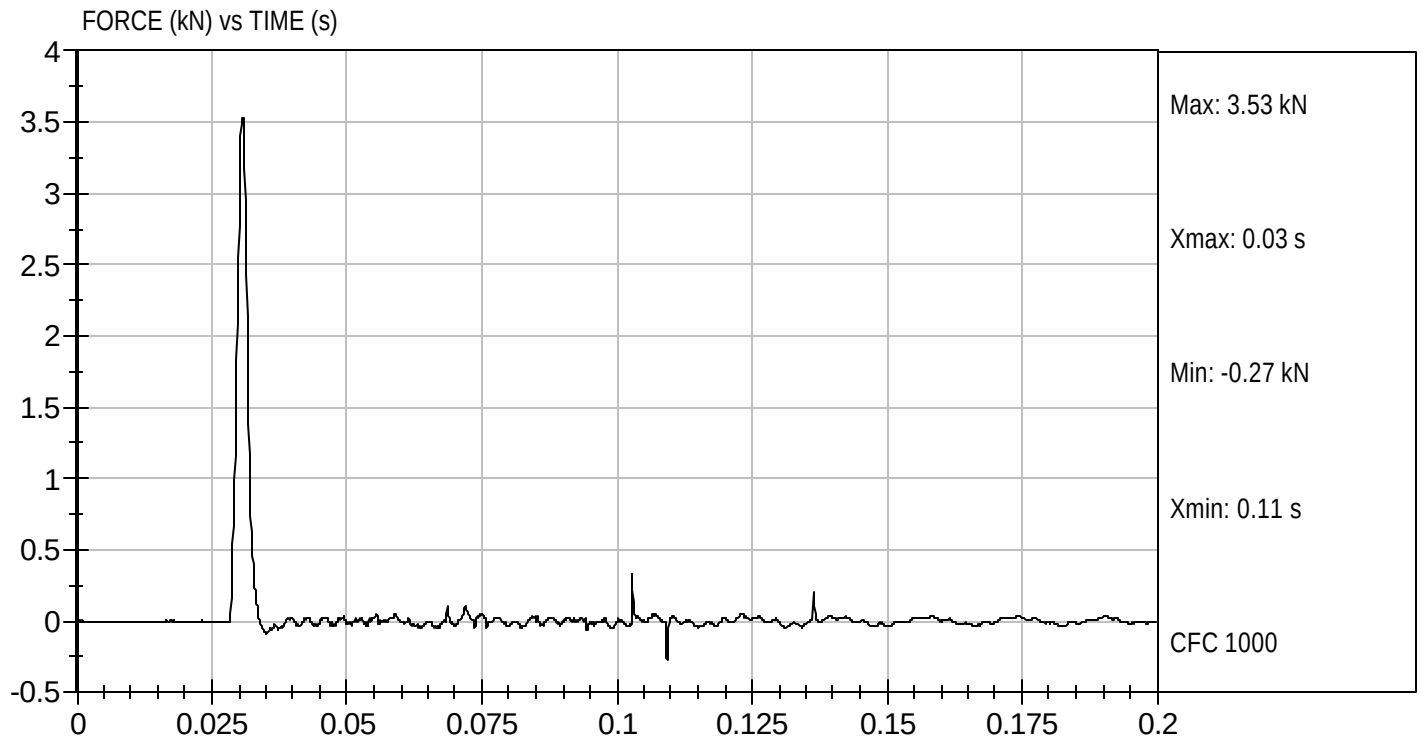
Test Desc: Right Knee  
Componet ID: D051715

Test Date: 06/21/2005  
Velocity: 6.87 ft/s, 2.09 m/s

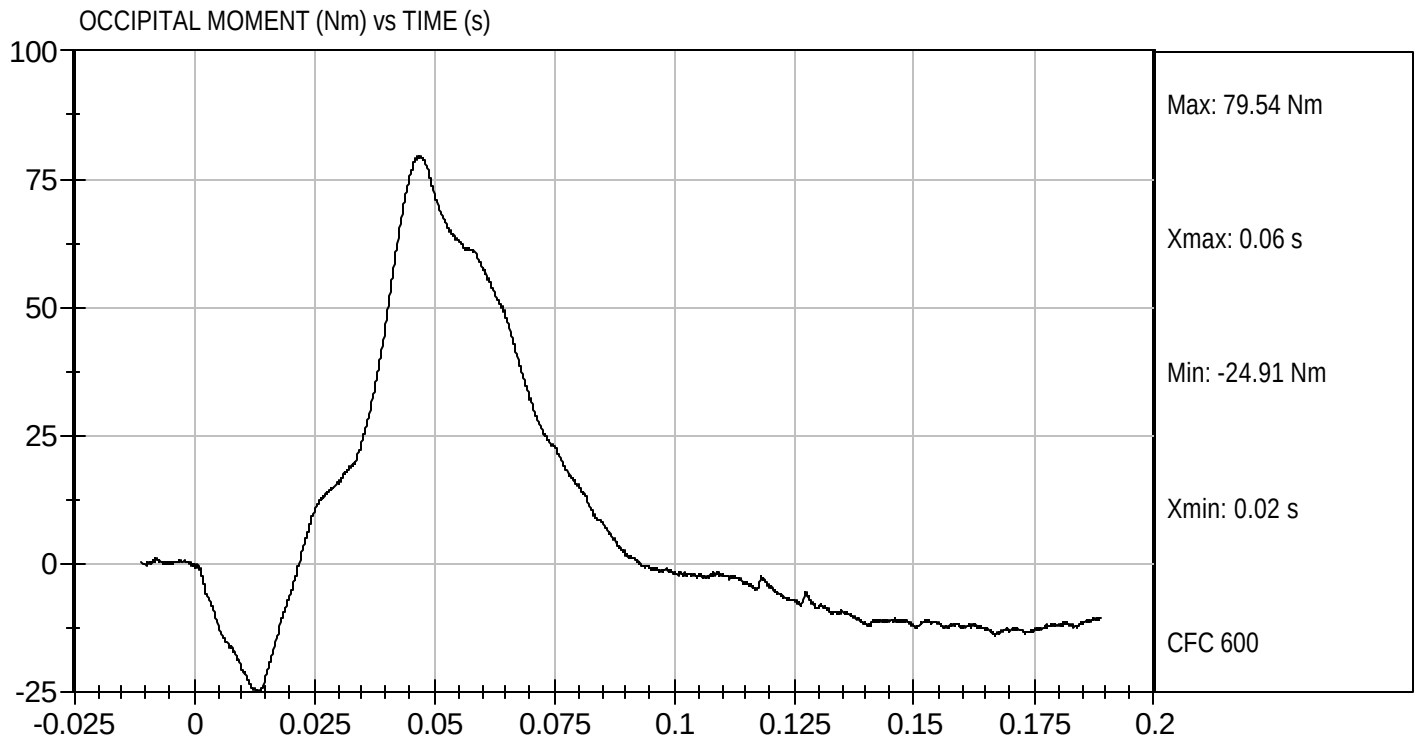
Test Desc: Neck Flexion  
Componet ID: D052602

Test Date: 09/23/2005  
Velocity: 22.96 ft/s, 7.00 m/s

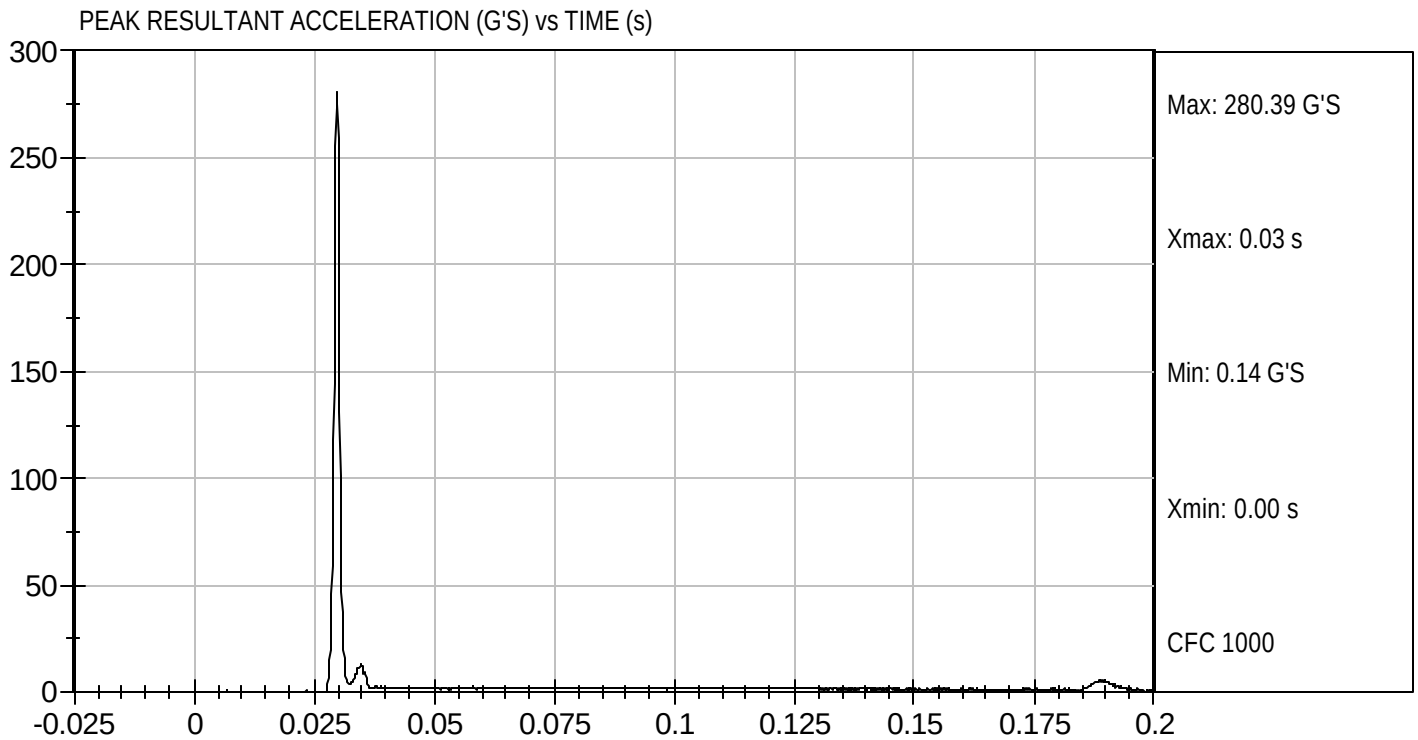
Test Desc: Head Drop  
Componet ID: D052621

Test Date: 09/26/2005  
Velocity: 0 ft/s, 0 m/s

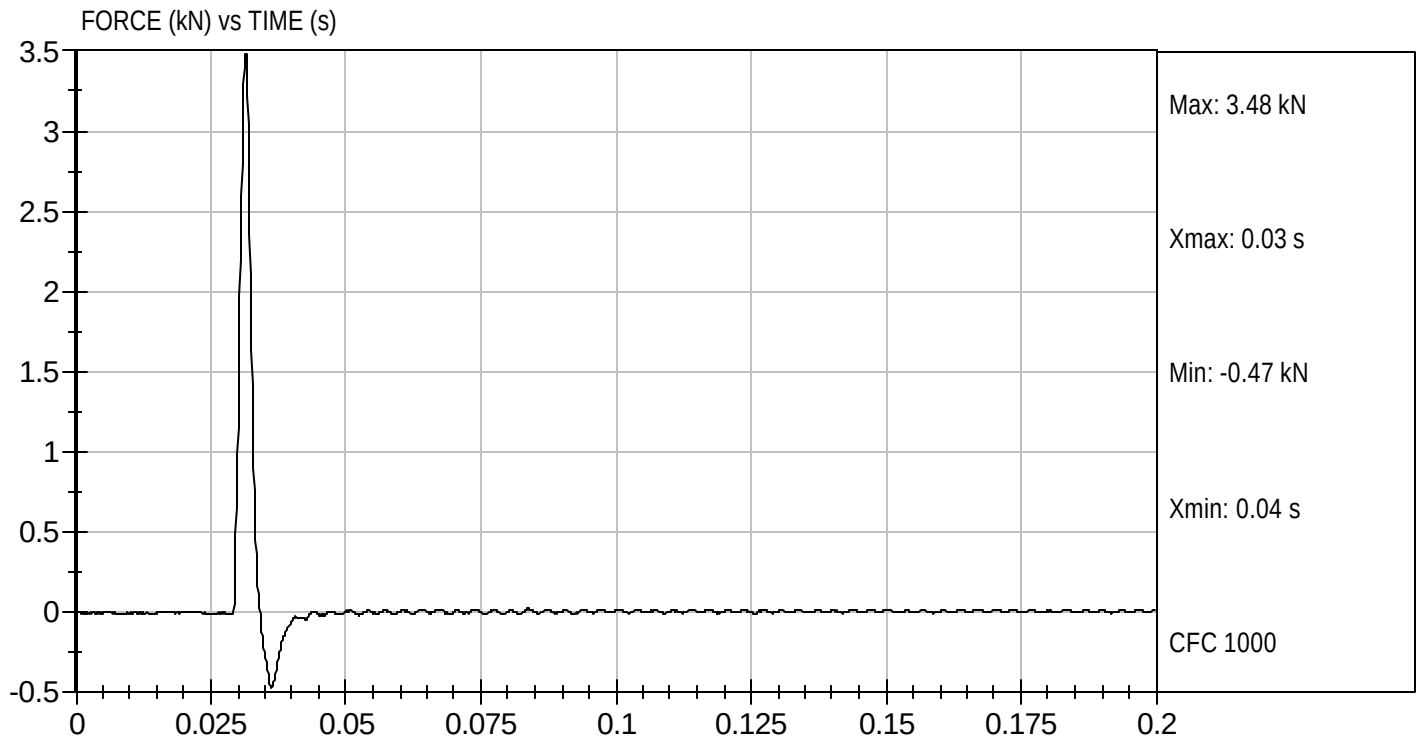
Test Desc: Right Knee  
Componet ID: D052625

Test Date: 09/26/2005  
Velocity: 6.87 ft/s, 2.09 m/s

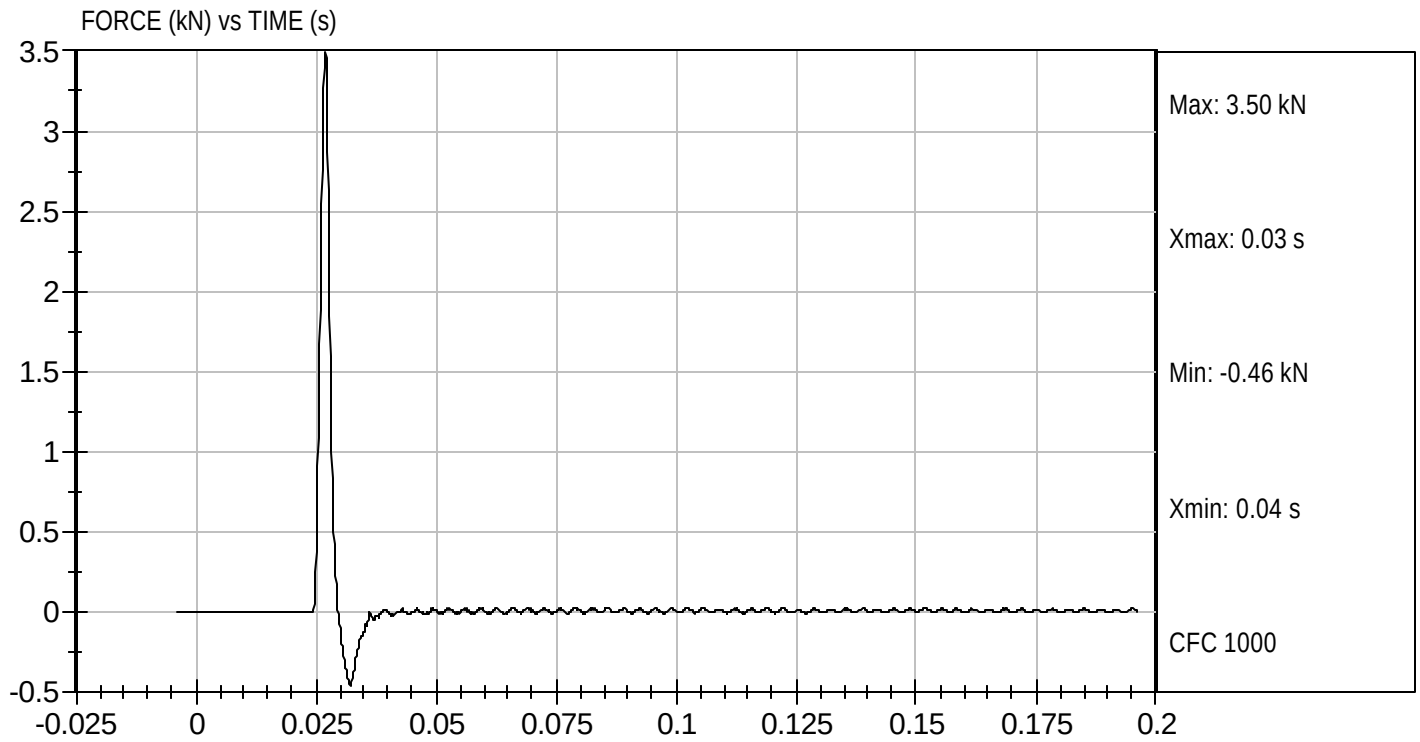
Test Desc: Left Knee  
Componet ID: D052026

Test Date: 07/22/2005  
Velocity: 6.83 ft/s, 2.08 m/s

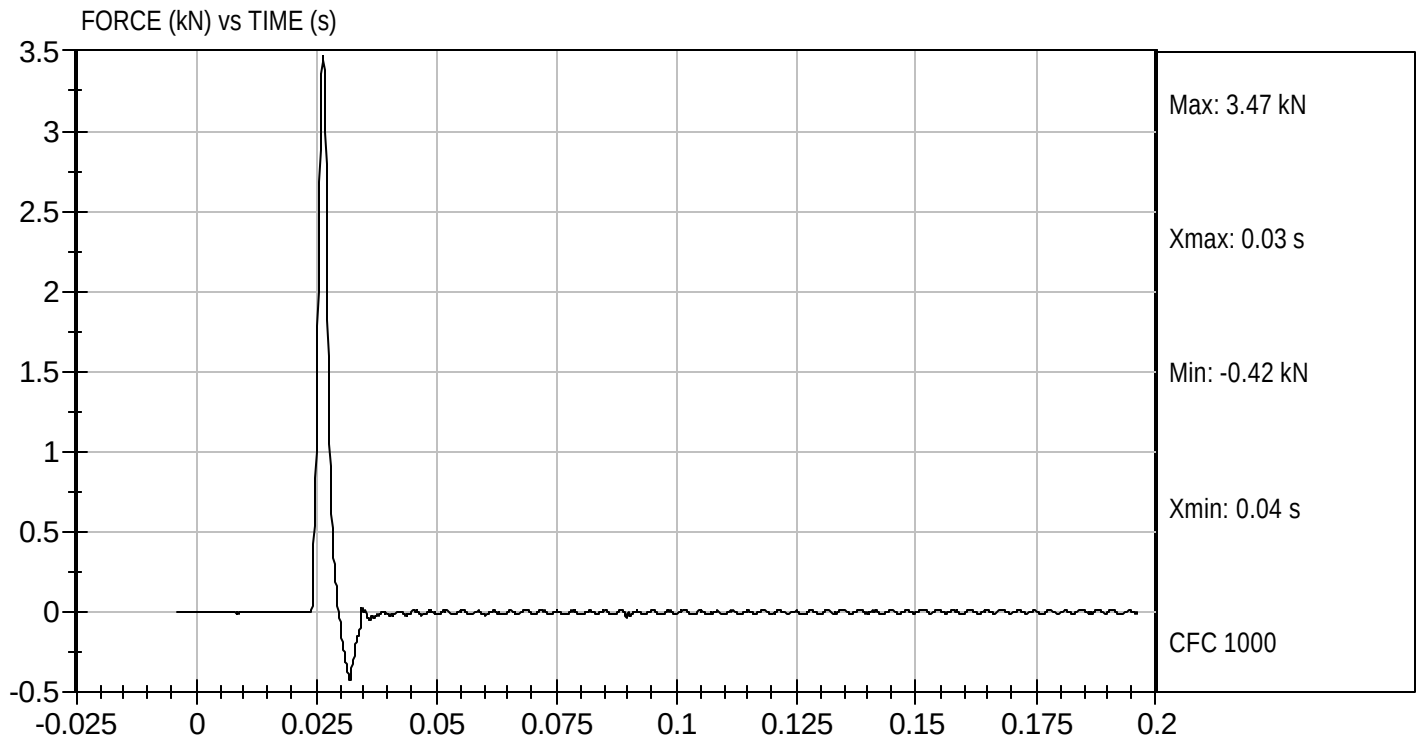
Test Desc: Right Knee  
Componet ID: D052025

Test Date: 07/22/2005  
Velocity: 6.91 ft/s, 2.11 m/s

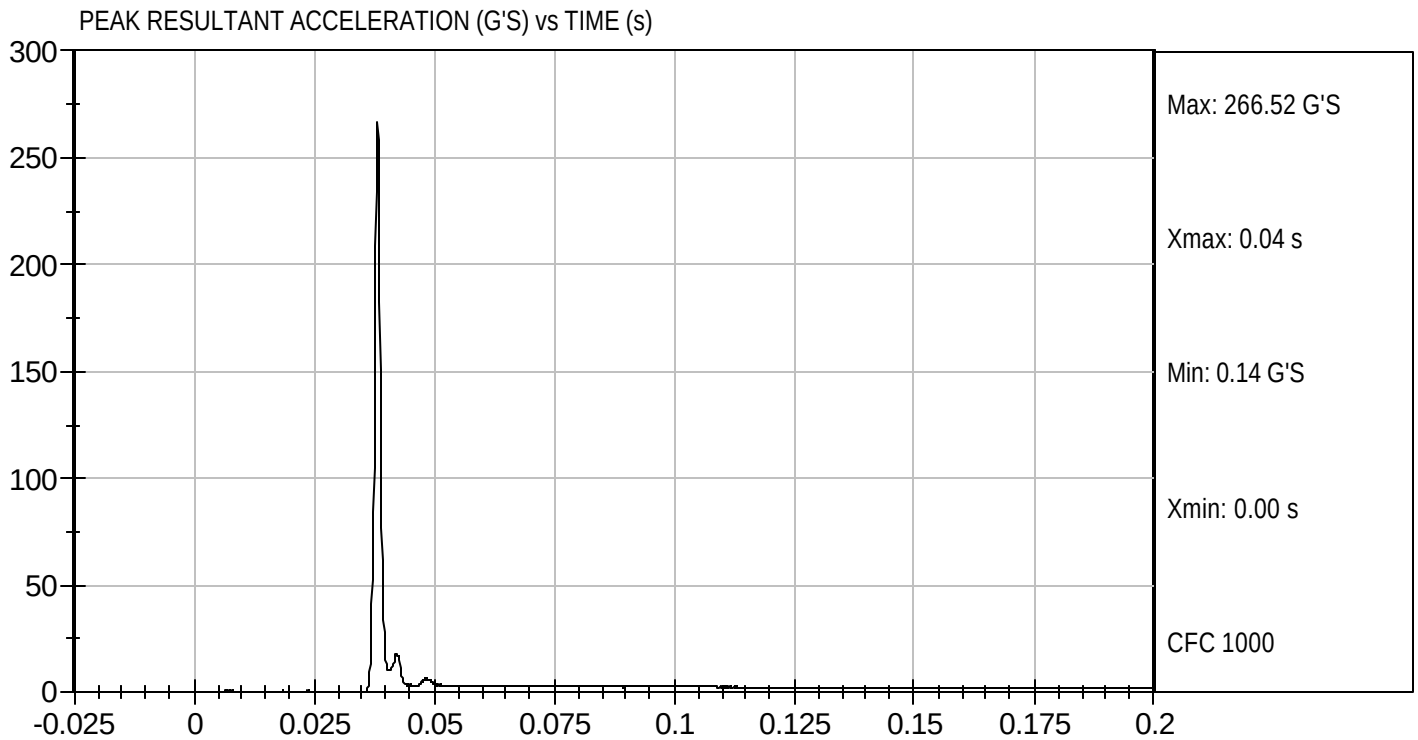
Test Desc: Head Drop  
Componet ID: D052631

Test Date: 09/26/2005  
Velocity: 0 ft/s,0 m/s

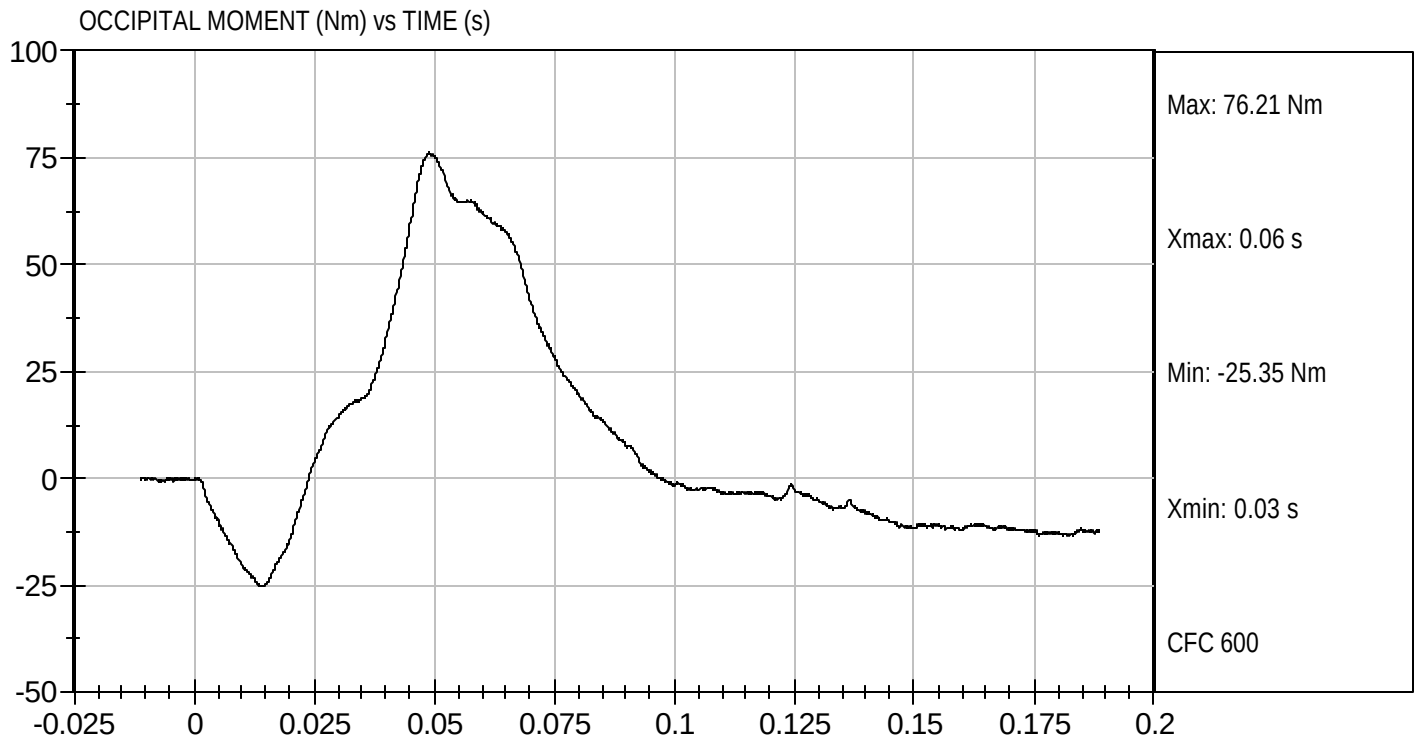
Test Desc: Neck Flexion  
Componet ID: D052632

Test Date: 09/26/2005  
Velocity: 23.16 ft/s, 7.06 m/s

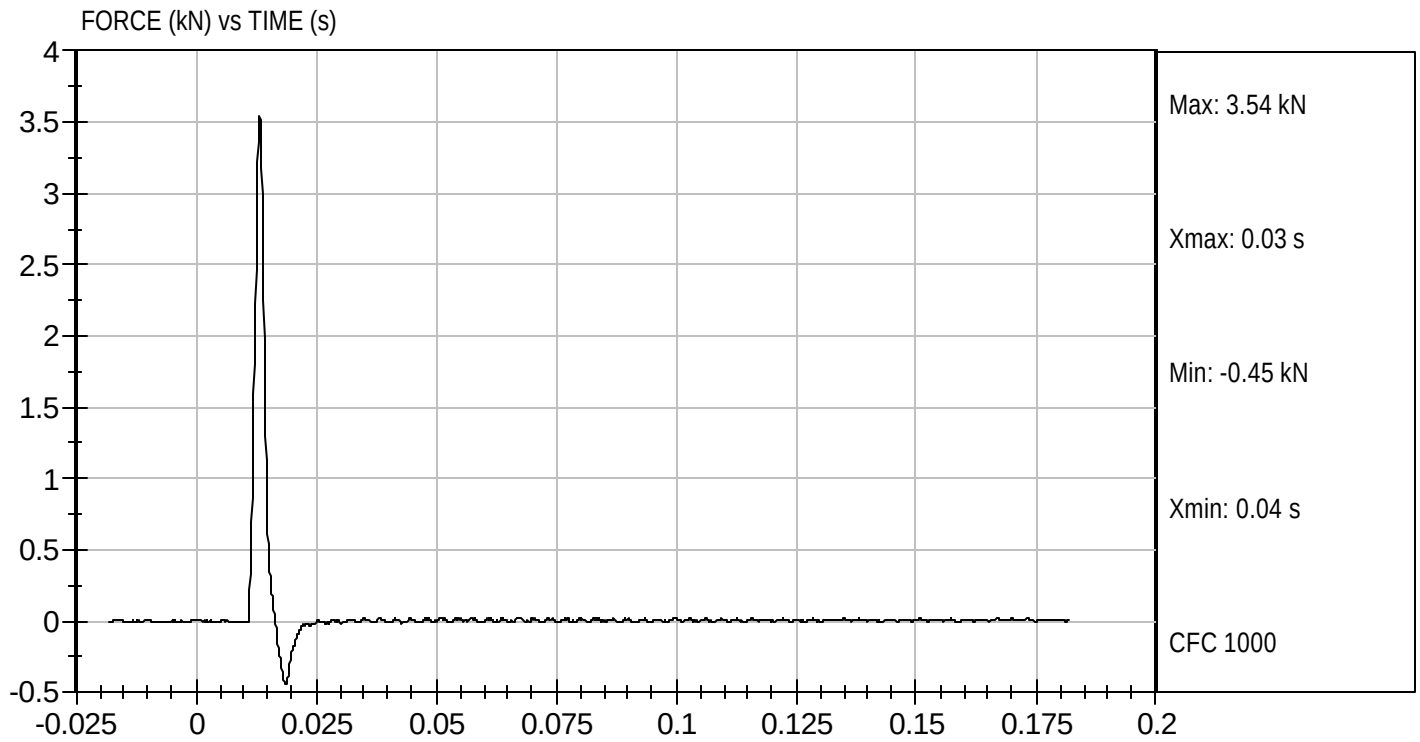
Test Desc: Left Knee  
Componet ID: D052636

Test Date: 09/26/2005  
Velocity: 6.92 ft/s, 2.11 m/s
