**REPORT NUMBER: SNCAP-CAL-07-02**

**NEW CAR ASSESSMENT PROGRAM  
SIDE IMPACT TEST**

**FUJI HEAVY INDUSTRIES, LTD.  
2007 SUBARU LEGACY  
4-DOOR SEDAN**

**FINAL REPORT**

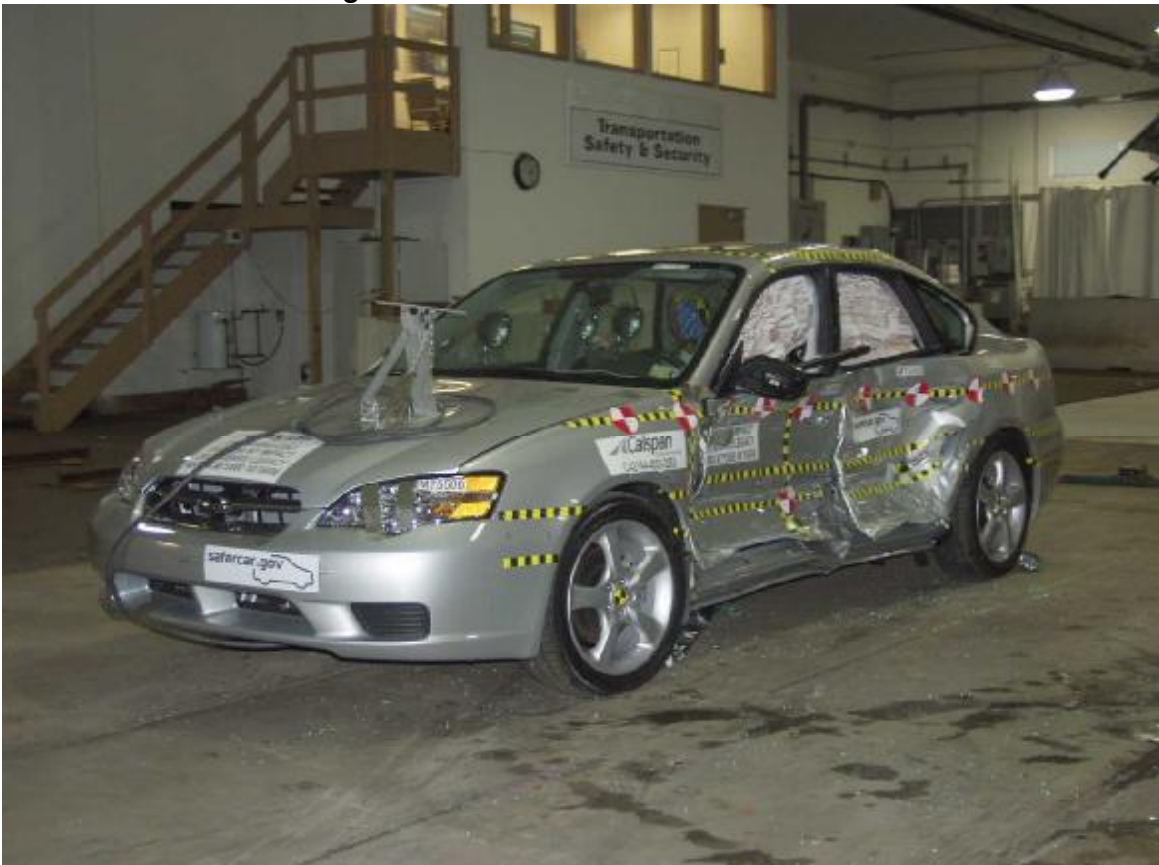
**Figure A-8: Post-Test Left Front  $\frac{3}{4}$  View**

| Critical Areas of Performance | Observations and Conclusions |
|---|---|
| Windshield Damage | Left side of windshield cracked during impact |

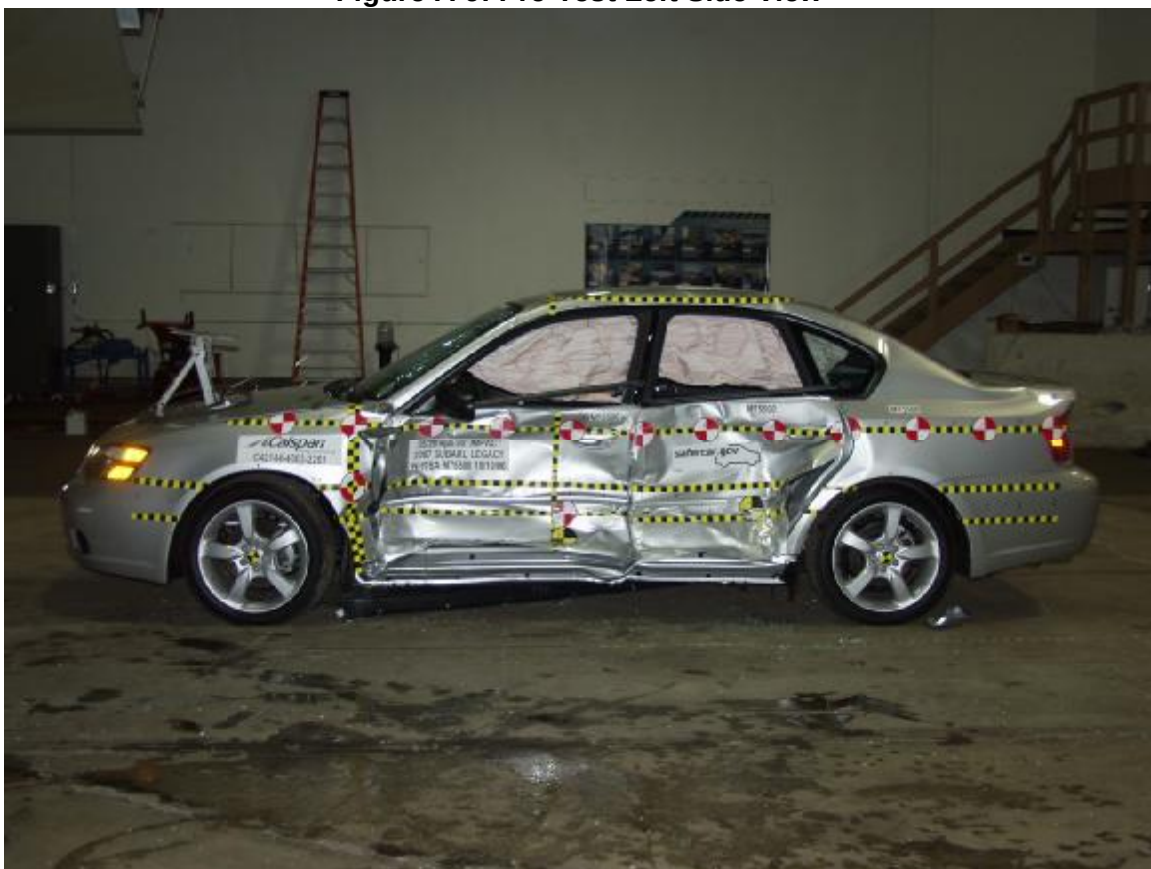
Figure A-10: Post-Test Left Side View

The test vehicle sustained a maximum static crush of 236 mm at level 4, 1500 mm rearward of the left vertical impact point. The driver and passenger SID/HIII's, Serial Nos. 269 and 270 respectively, were calibrated just prior to this test.

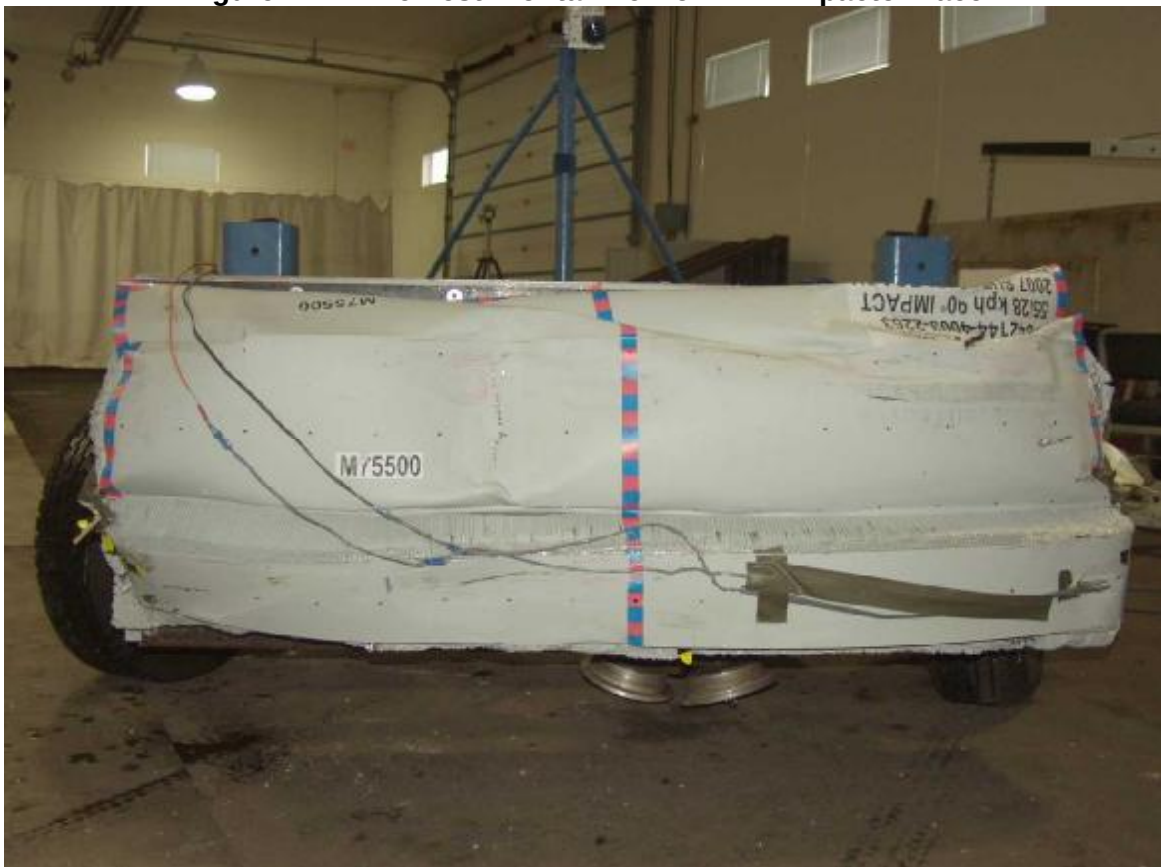
Figure A-22: Post-Test Frontal View of MDB Impactor Face

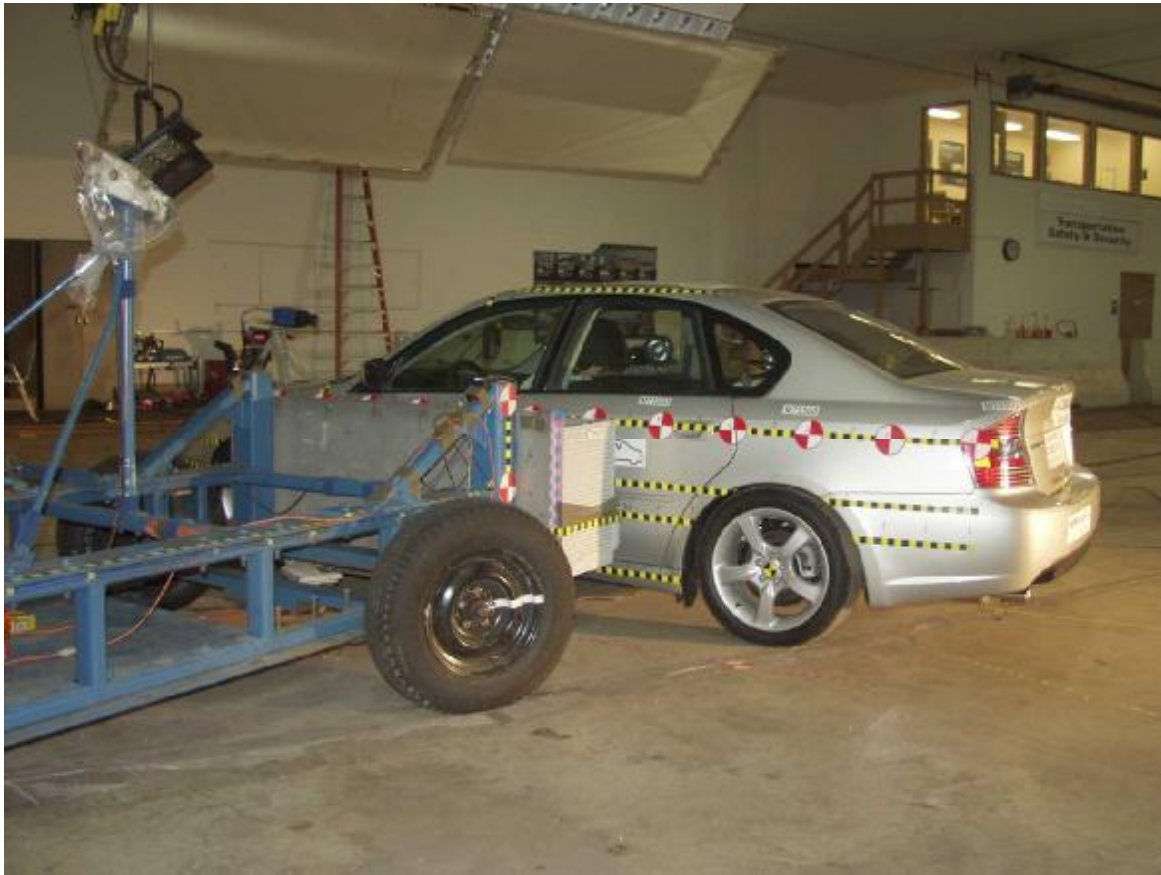
**Figure A-29: Pre-Test Left Side View of Aligned MDB and Vehicle**

A model year 2007 Subaru Legacy 4-Door Sedan was impacted on the left (driver's) side by a Moving Deformable Barrier (MDB) which was moving forward in a 27° crabbed position to the tow road guidance system at a velocity of 61.80 km/h. The specified impact velocity range is from 61.1 to 62.7 km/h. The test (target) vehicle was stationary and positioned 63° to the line of forward motion. The weight of the vehicle as tested was 1725.0 kg and the test weight of the MDB was 1362.5 kg. The test was conducted at the Calspan Corporation Transportation Sciences Center on October 19, 2006.

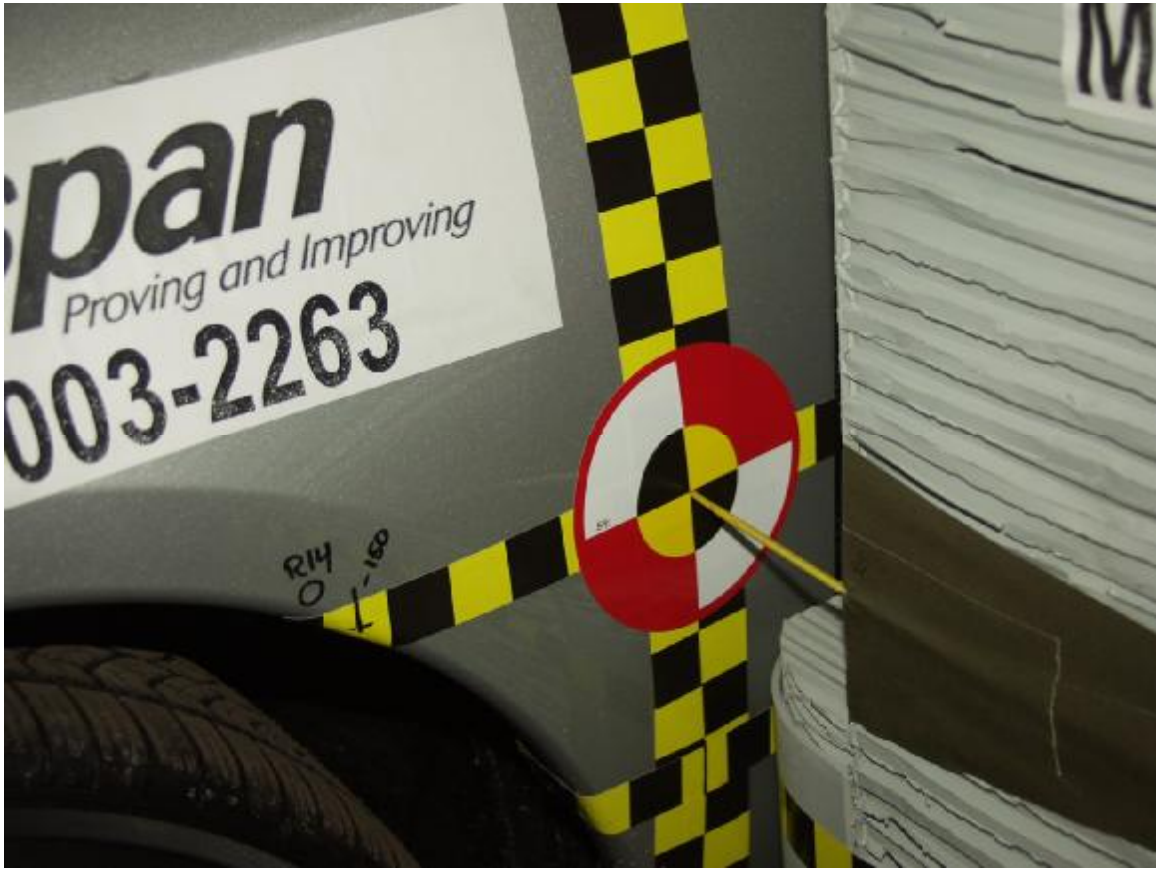
Figure A-33: Pre-Test Close-Up View of Impact Point Target

| Measurement Description | Units | Value |
|---|---|---|
| Actual Impact Point Aft of Front Axle | mm | 375 |

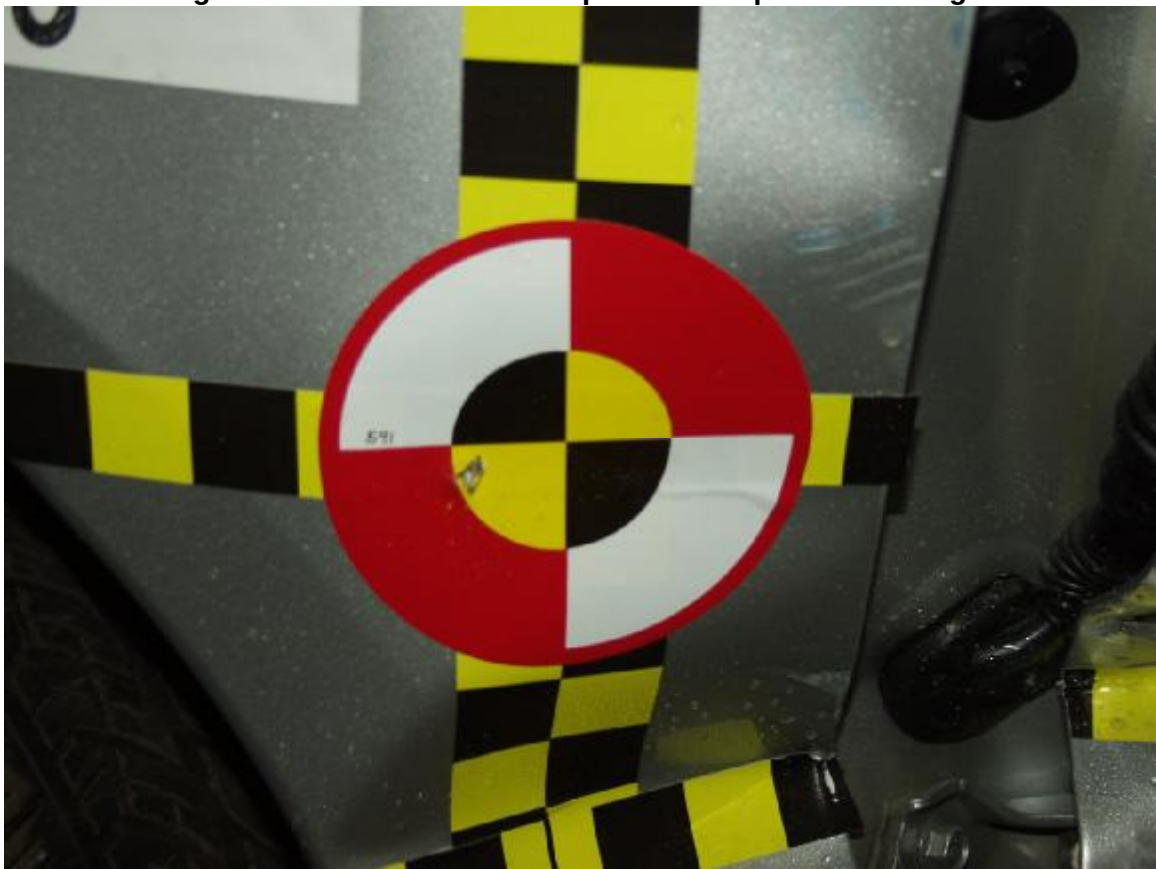
Figure A-34: Post-Test Close-Up View of Impact Point Target

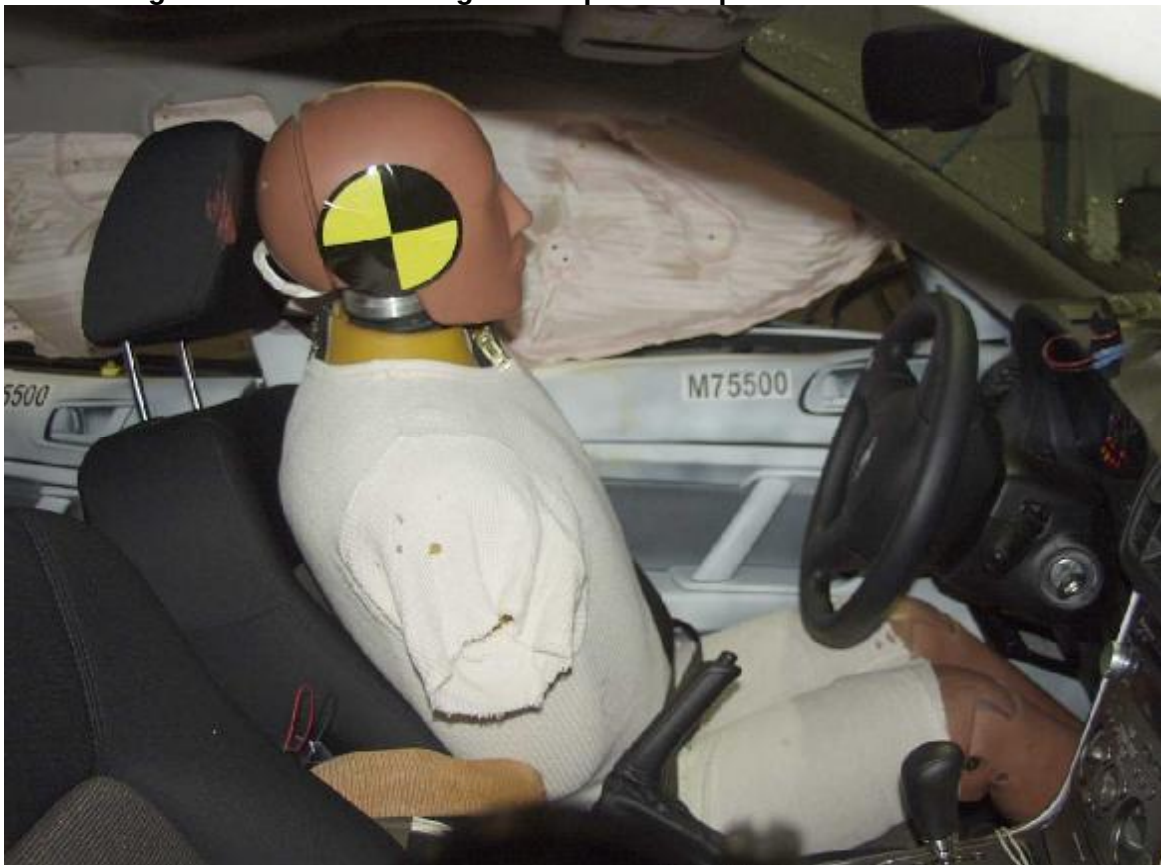
**Figure A-36: Post-Test Right Occupant Compartment View of Driver**

| Restraint Type | Left Front (Driver) | | Left Rear (Passenger) | |
|---|---|---|---|---|
| Side Torso Airbag | Yes | Yes | NA | NA |

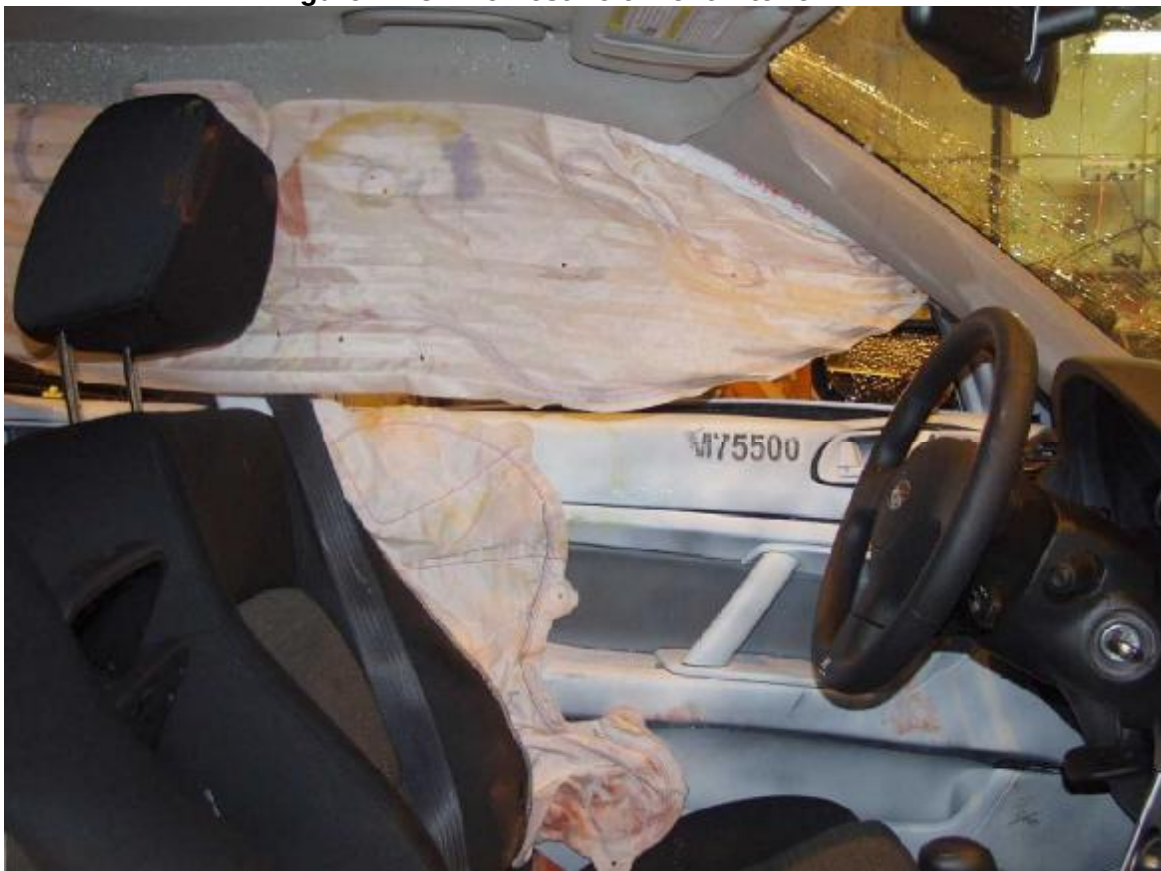
**Figure A-44: Post-Test Left Front Interior Trim**
