**REPORT NUMBER: NCAP-MGA-2007-003**

**NEW CAR ASSESSMENT PROGRAM  
FRONTAL BARRIER IMPACT TEST**

**DAIMLERCHRYSLER CORPORATION  
2007 DODGE NITRO SLT 4X4  
NHTSA NUMBER: M70305**

**PREPARED BY:  
MGA RESEARCH CORPORATION  
5000 WARREN ROAD  
BURLINGTON, WI 53105**

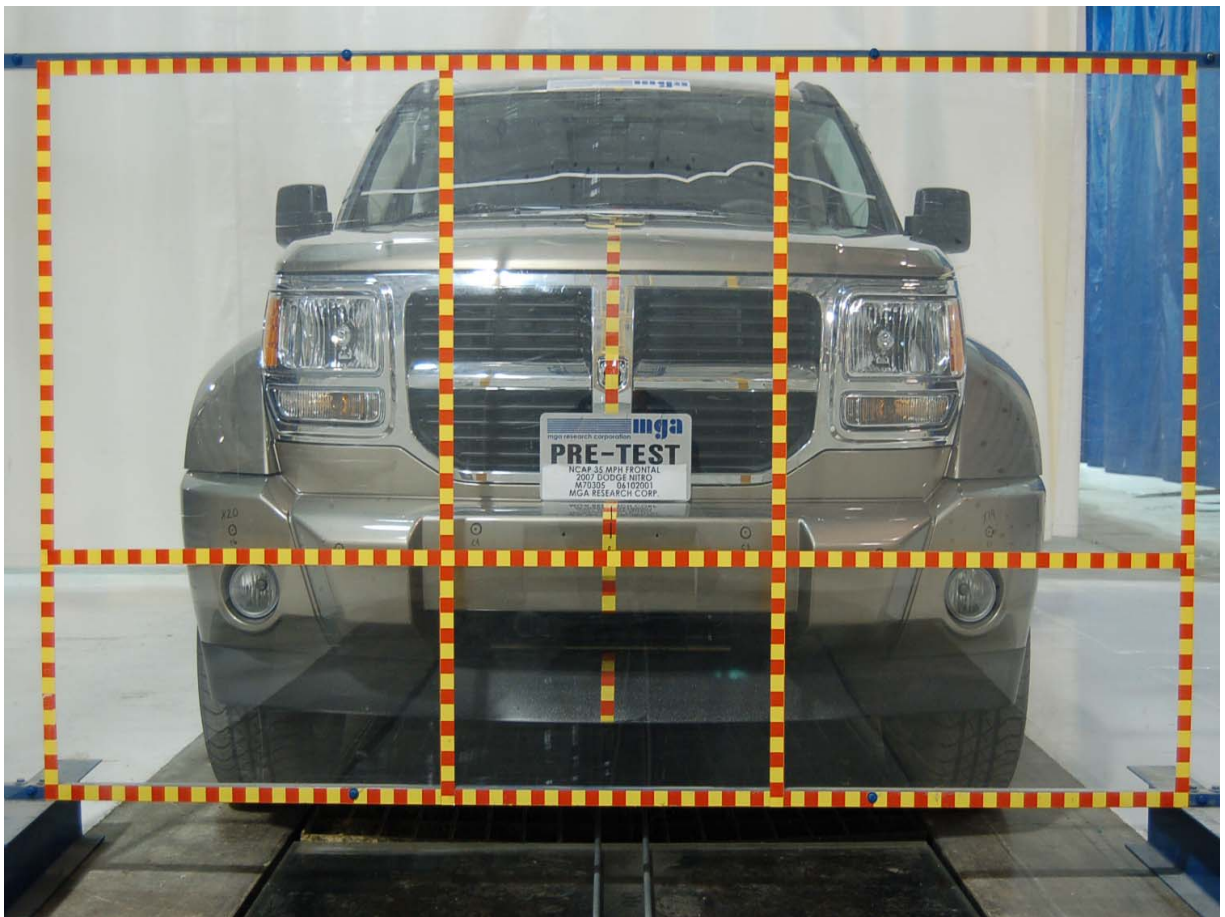
Load Cell Location

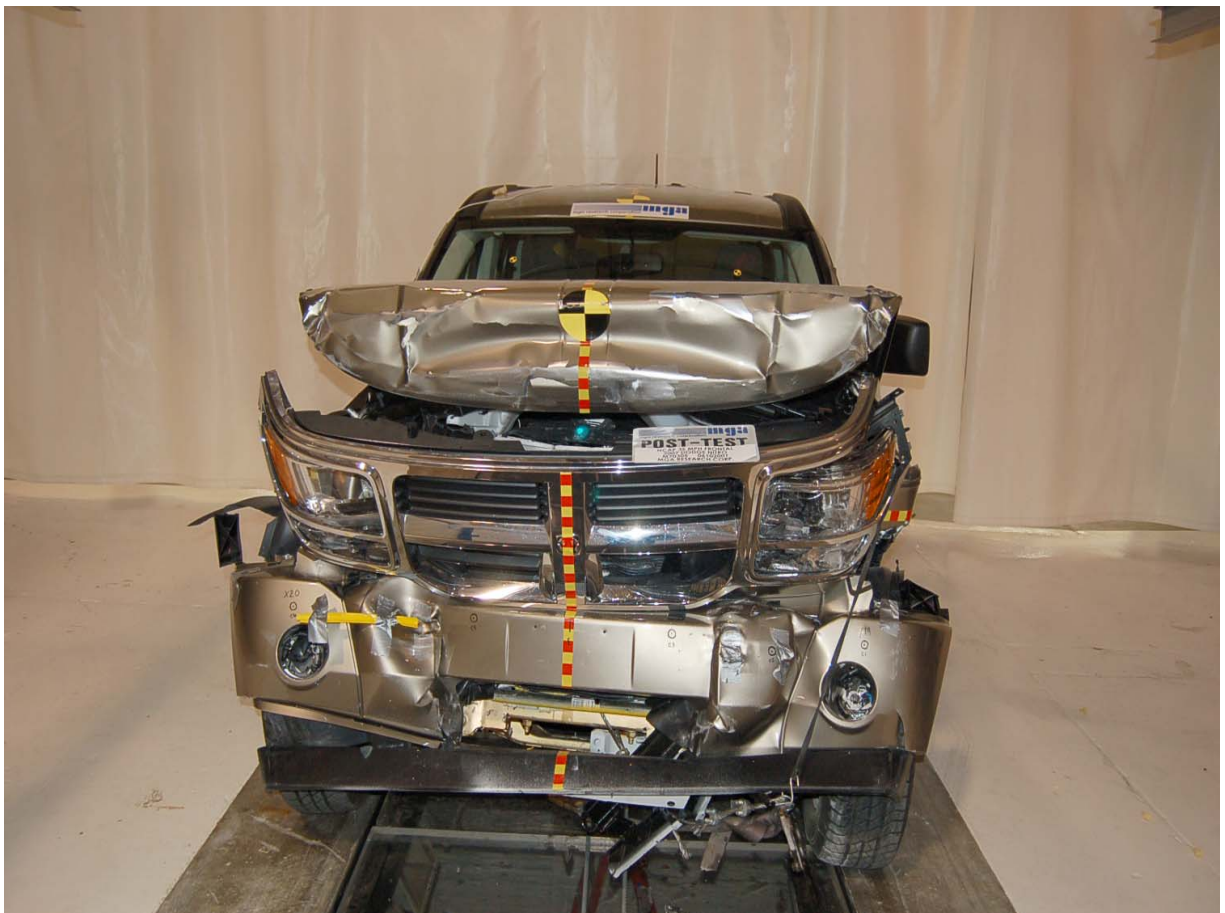
Post-Test Front View

The maximum static crush of the vehicle was 409 mm and both the driver and passenger side doors remained closed and latched during the impact event and were operable after the impact.

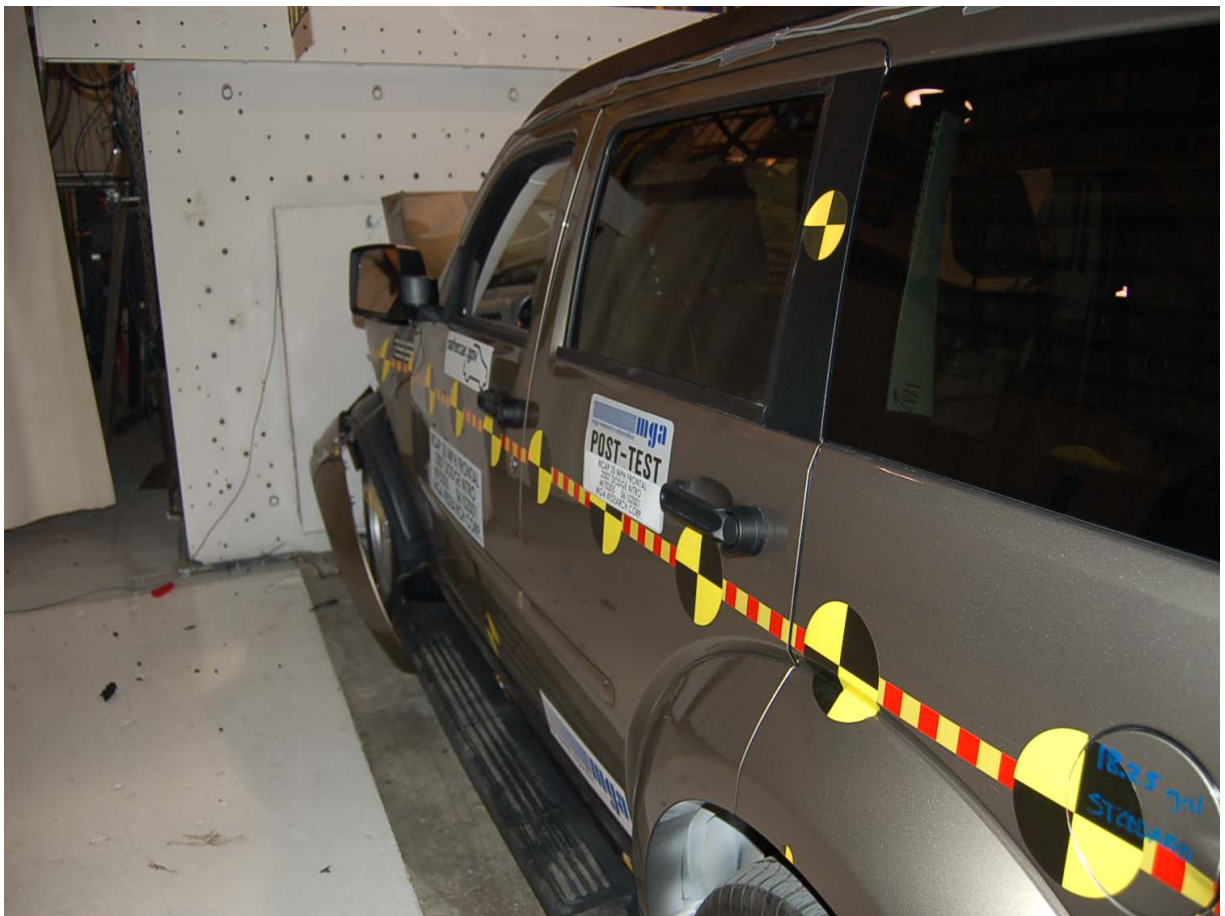
Post-Test Left Side  $\frac{3}{4}$  View of Doors After Impact

| Description | Driver | Passenger |
|---|---|---|
| Front Door Opening | Door remained closed and latched;<br>Door opened without tools | Door remained closed and latched;<br>Door opened without tools |

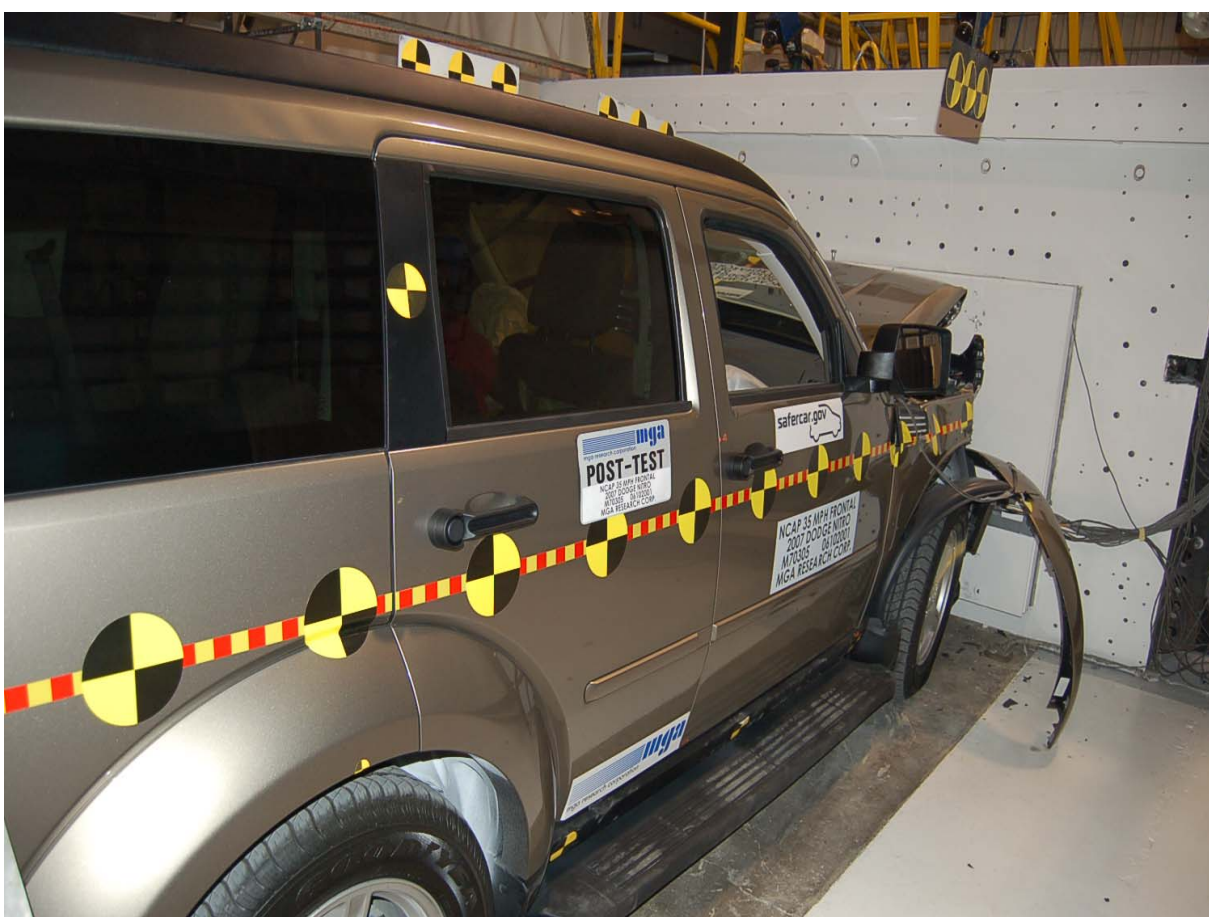
Post-Test Right Side  $\frac{3}{4}$  View of Doors After Impact

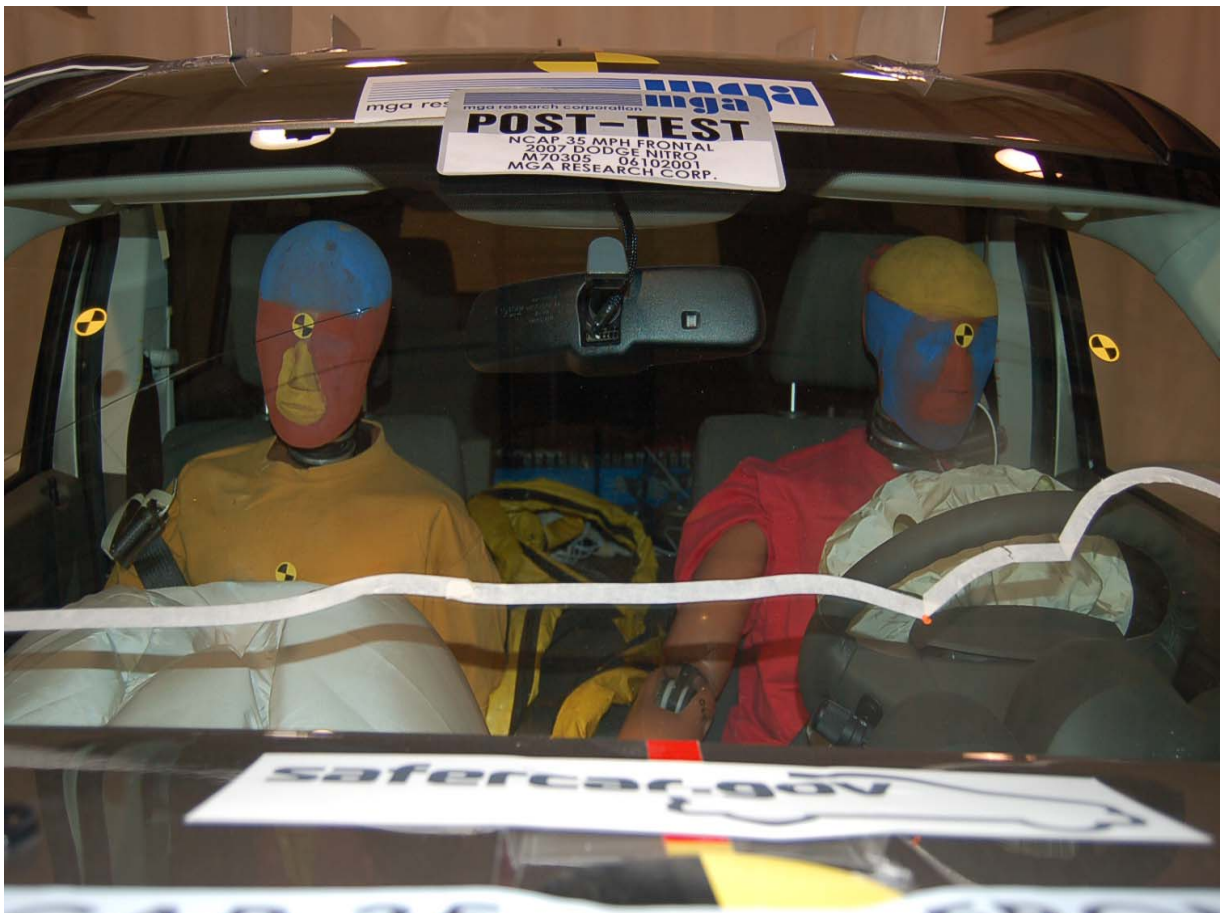
Post-Test Windshield View

There was 100 percent windshield retention and no intrusion into the protected zone of the windshield during the event. There was no Stoddard Solvent leakage after the event or during any phase of the static rollover.

| Description | Driver | Passenger |
|---|---|---|
| Glazing Damage | The windshield was cracked. | |

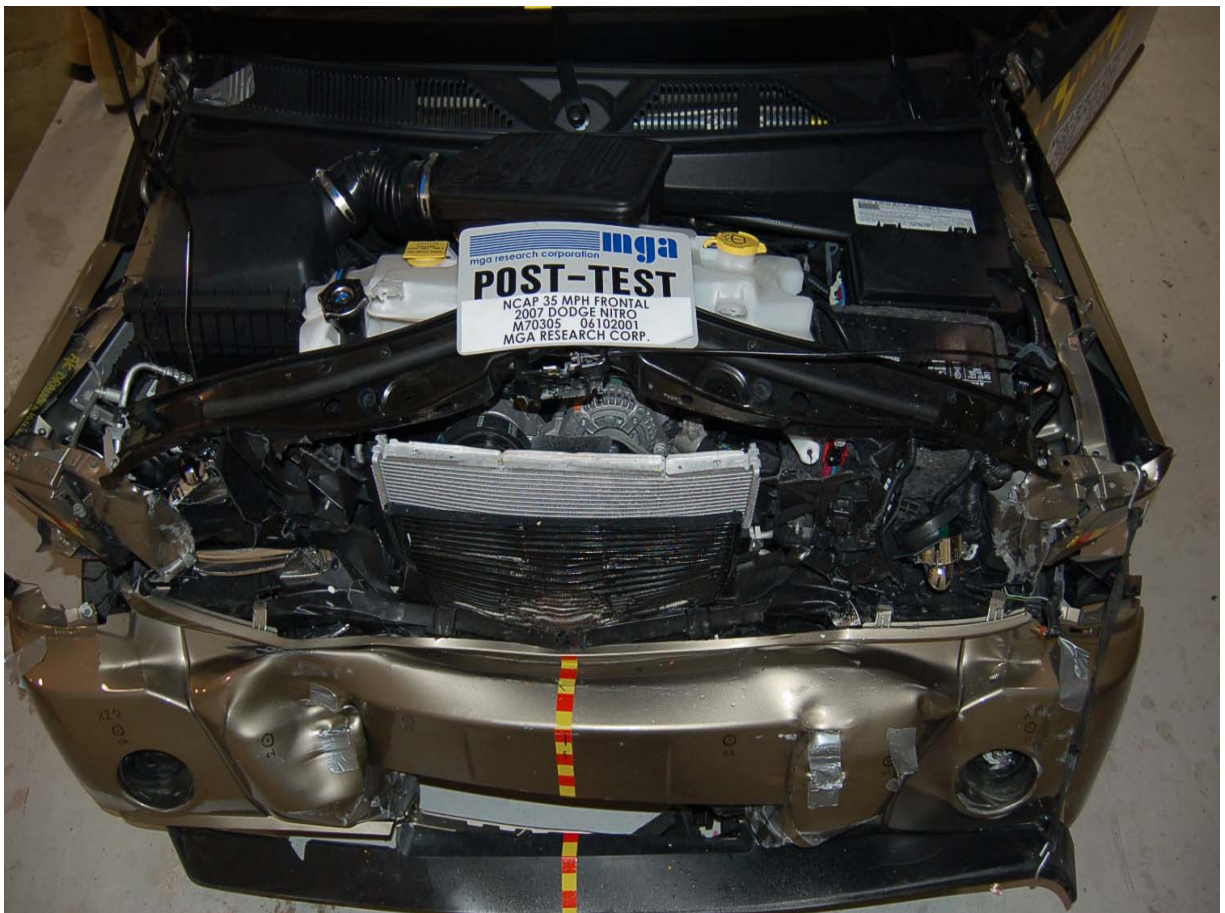
Post-Test Engine Compartment View

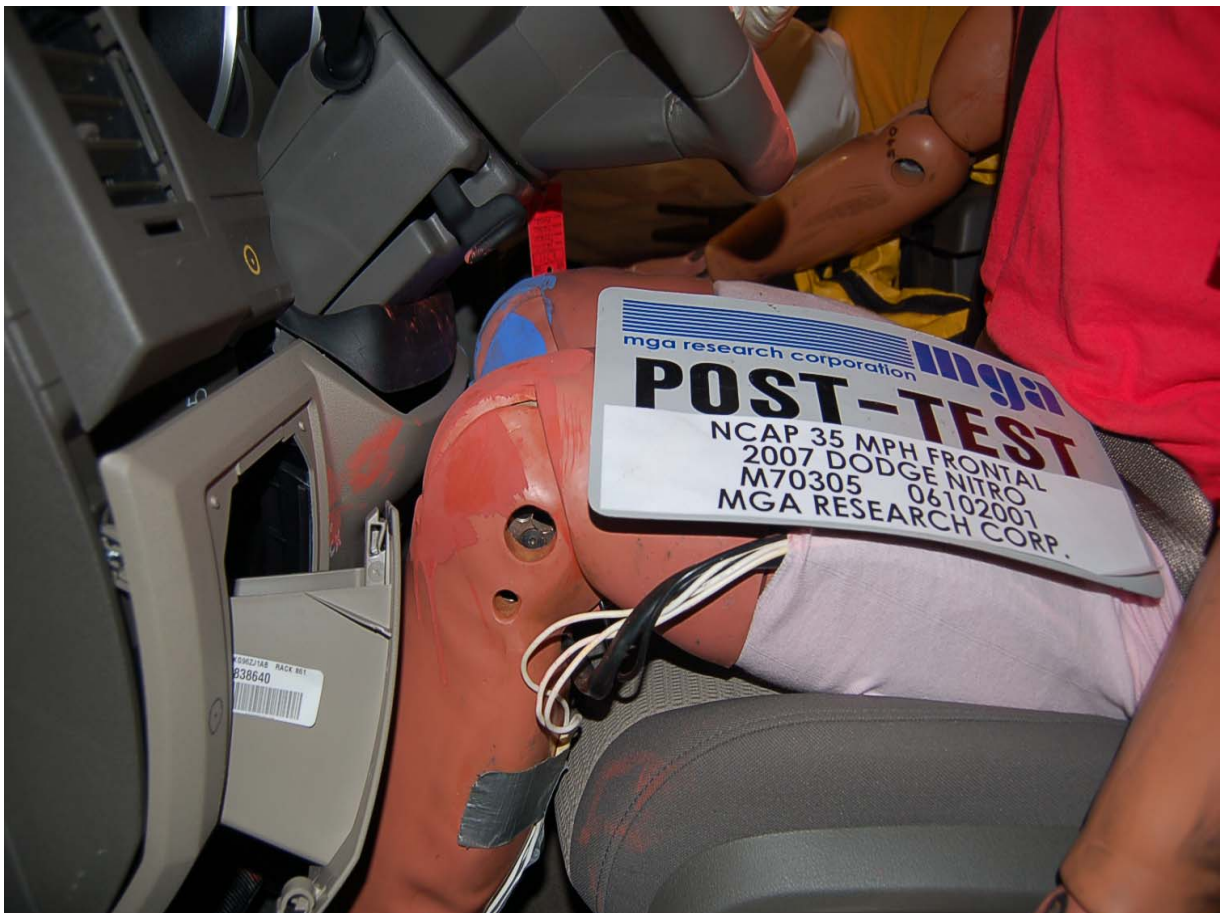
Post-Test Driver Side Knee Bolster

The driver's head and chest contacted the airbag. The driver's head also contacted the headrest. The driver's knees contacted the bolster. The passenger's head and chest contacted the airbag. The passenger's head also contacted the headrest. The passenger's knees contacted the glove box.

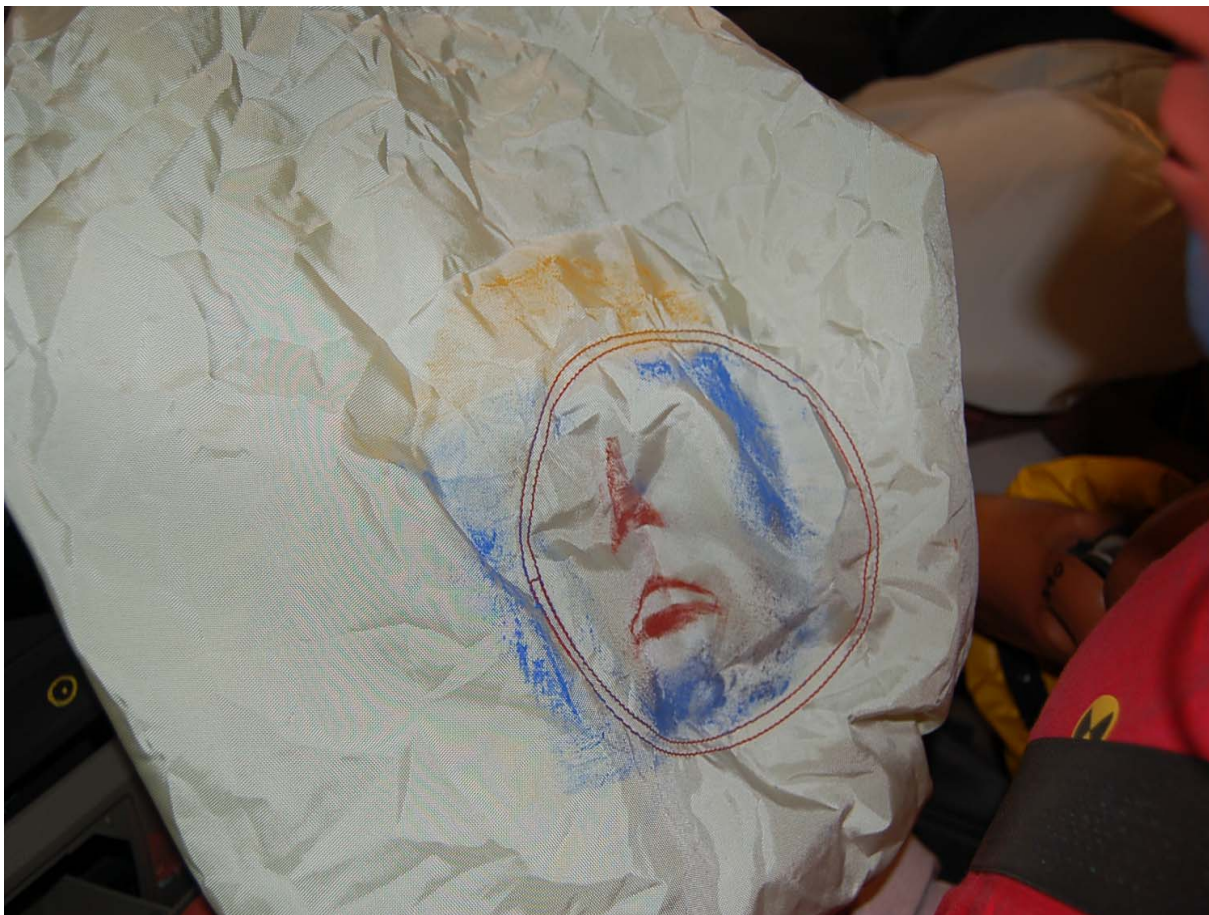
Post-Test Driver Dummy Airbag Contact

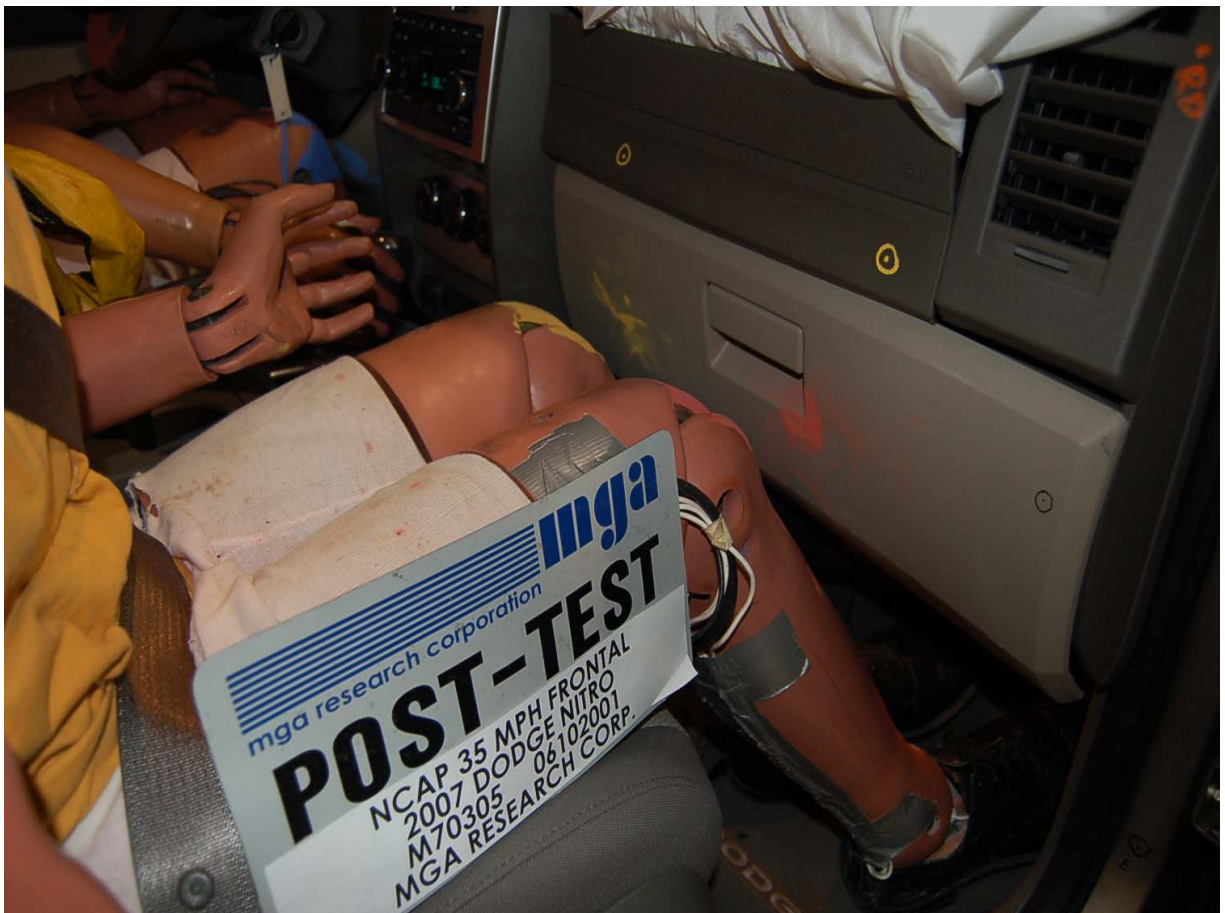
Post-Test Passenger Side Glove Box

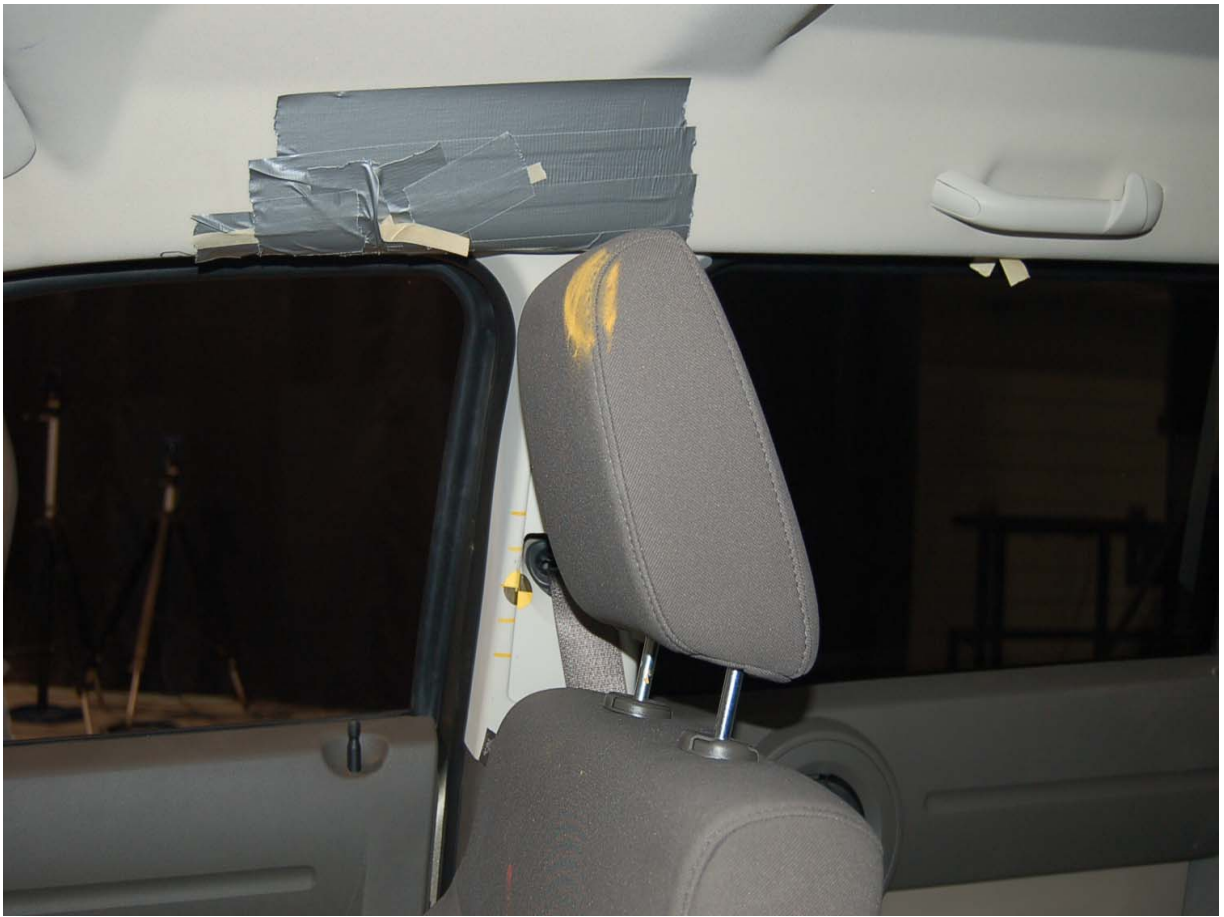
Post-Test Passenger Dummy Head Contact

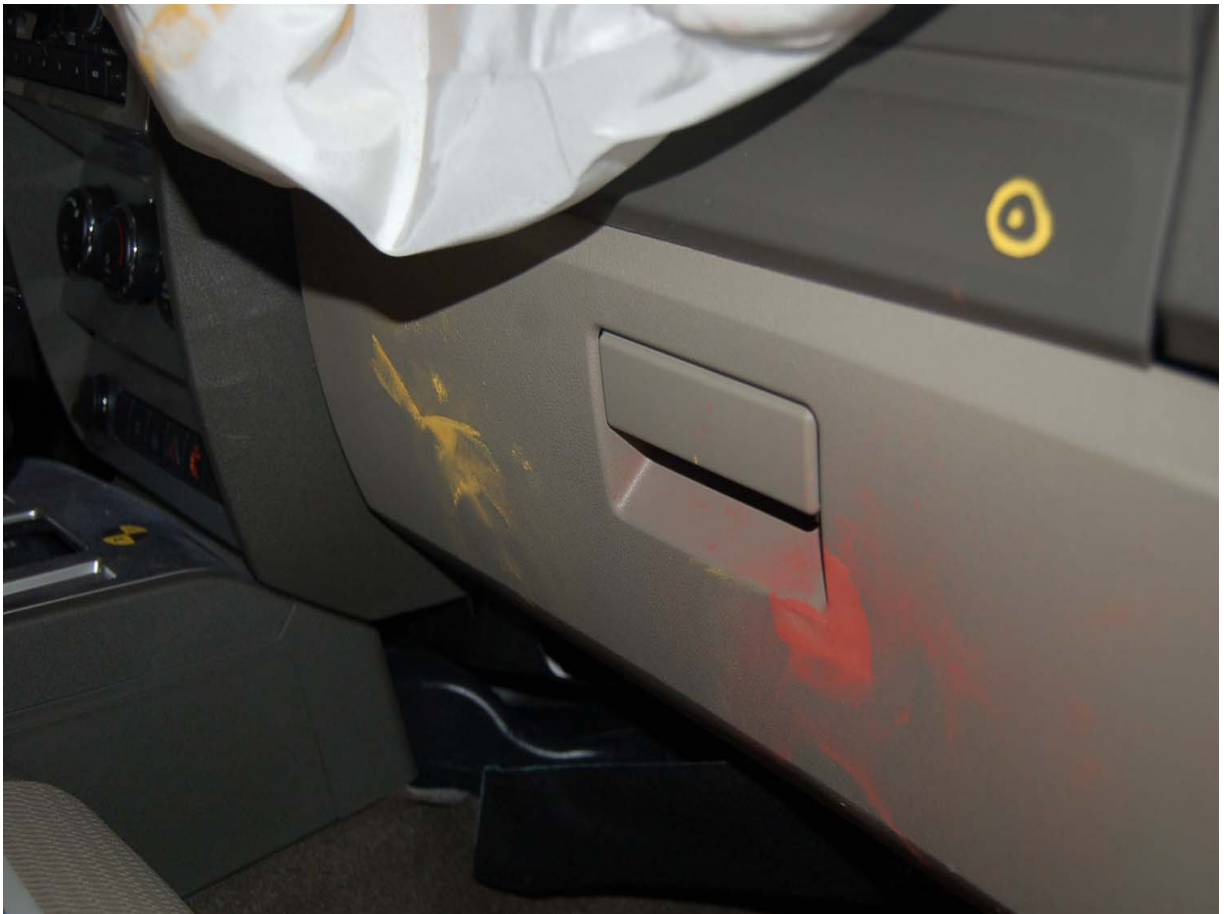
Post-Test Passenger Dummy Knee Contact

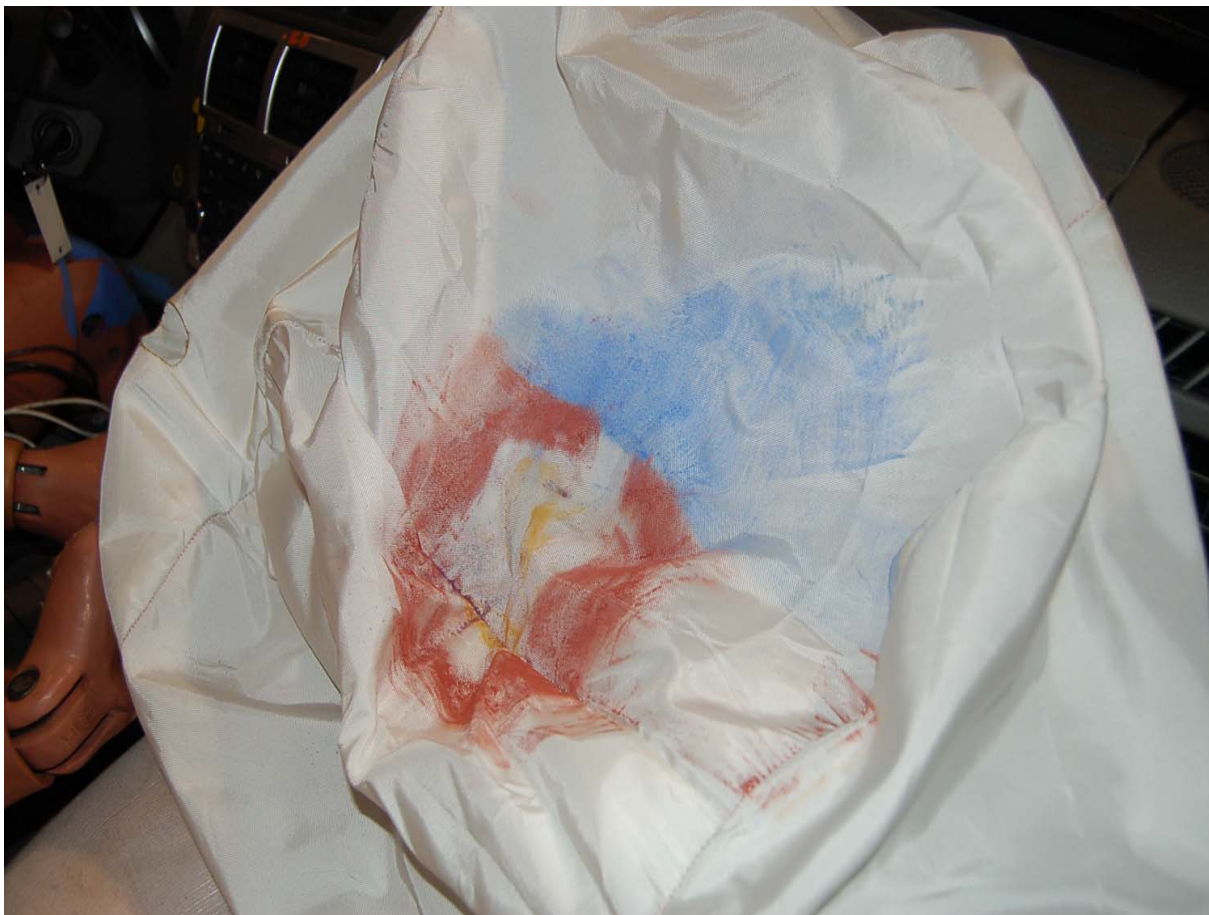
Post-Test Passenger Dummy Airbag Contact

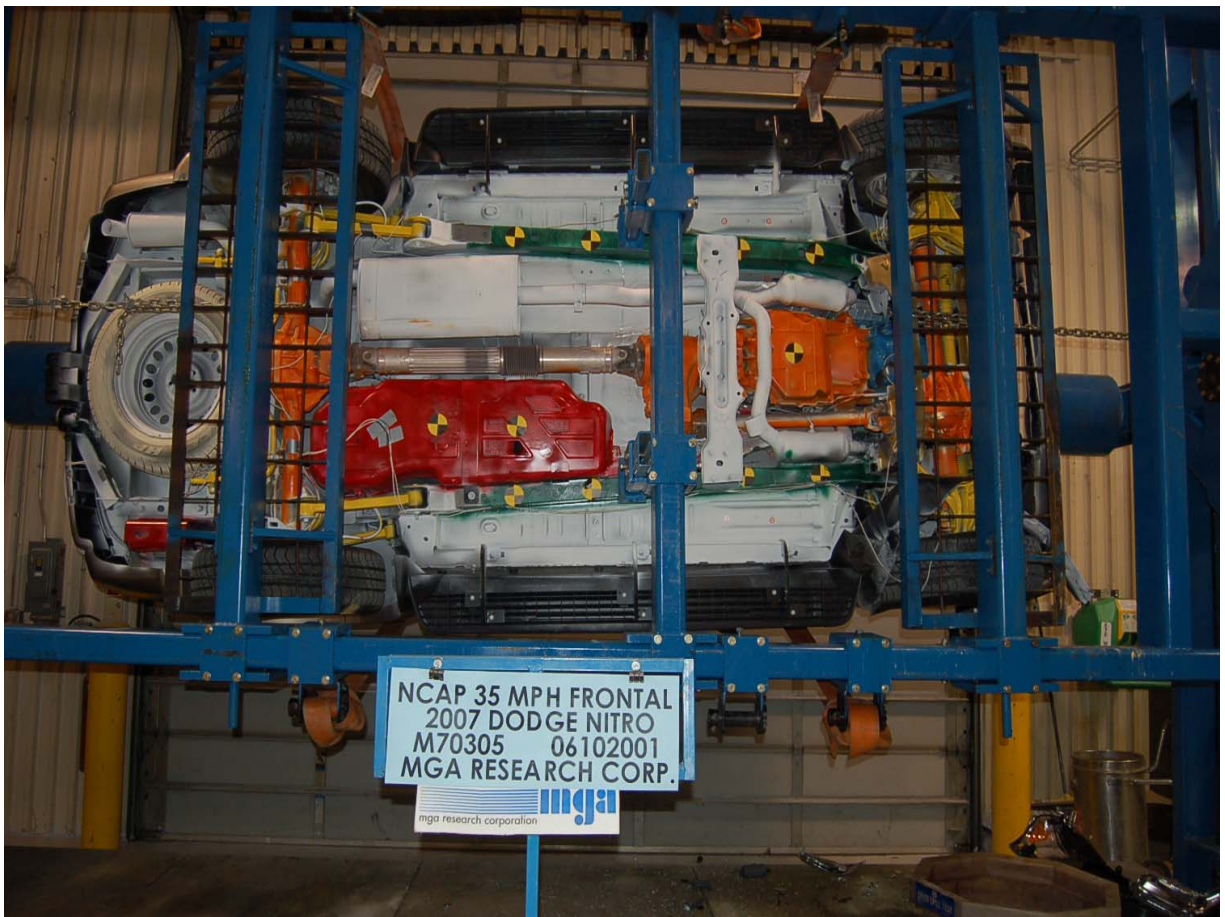
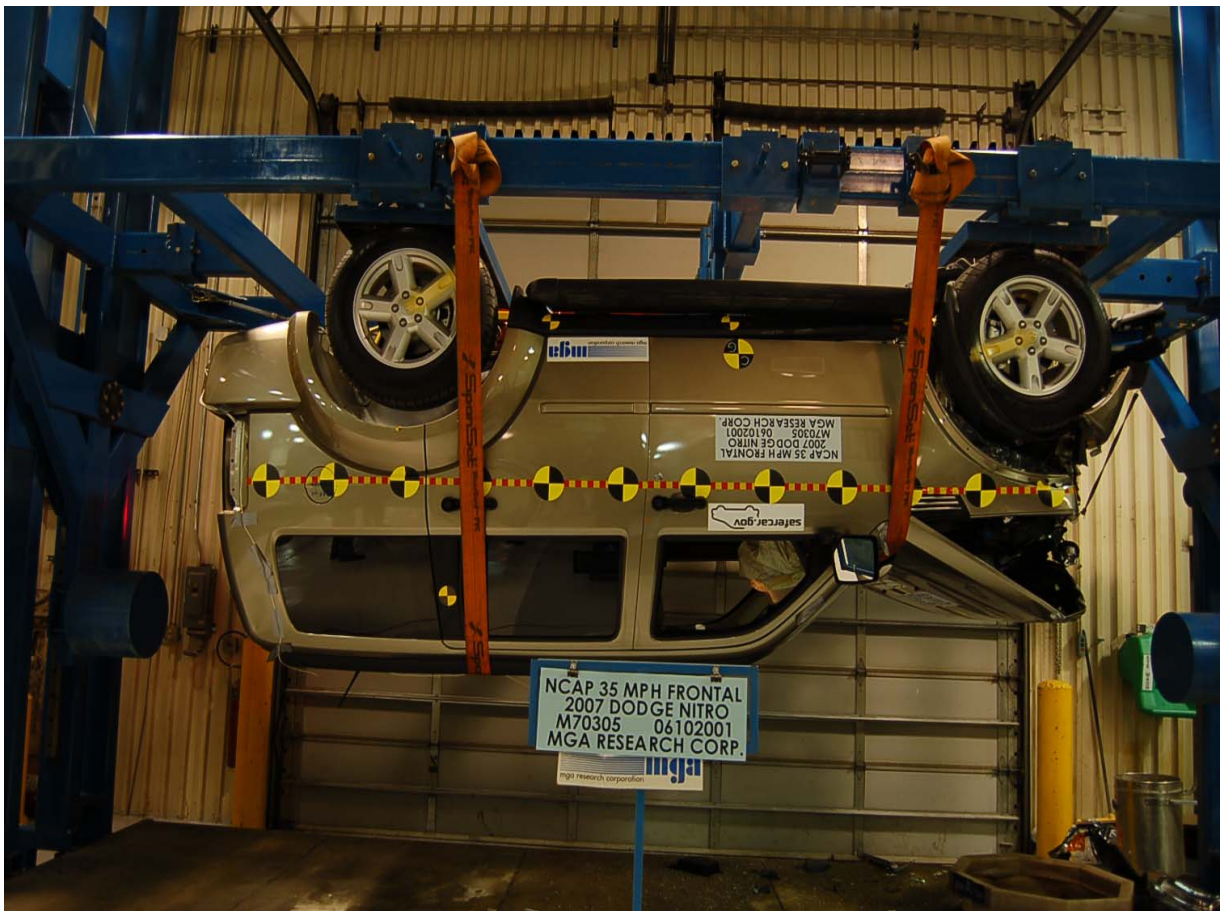
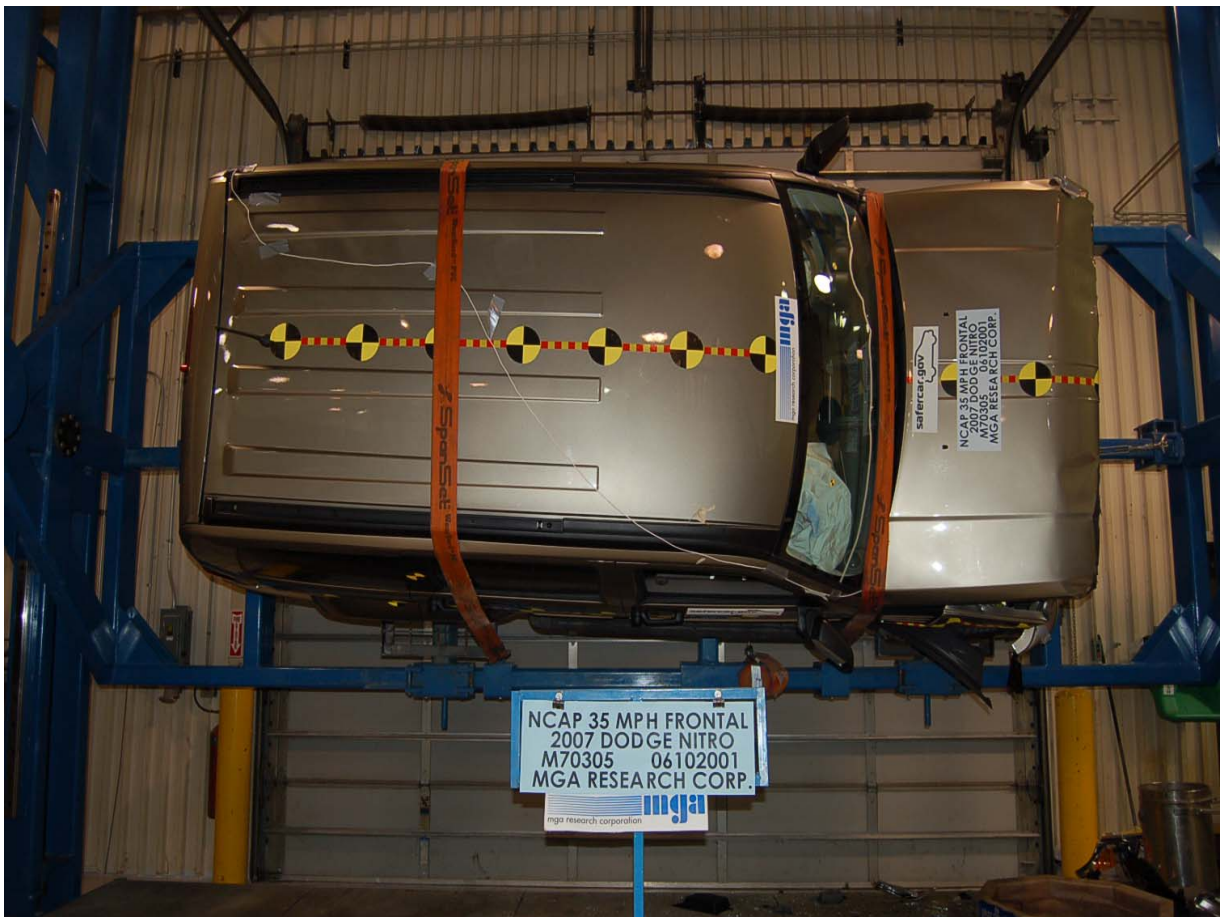
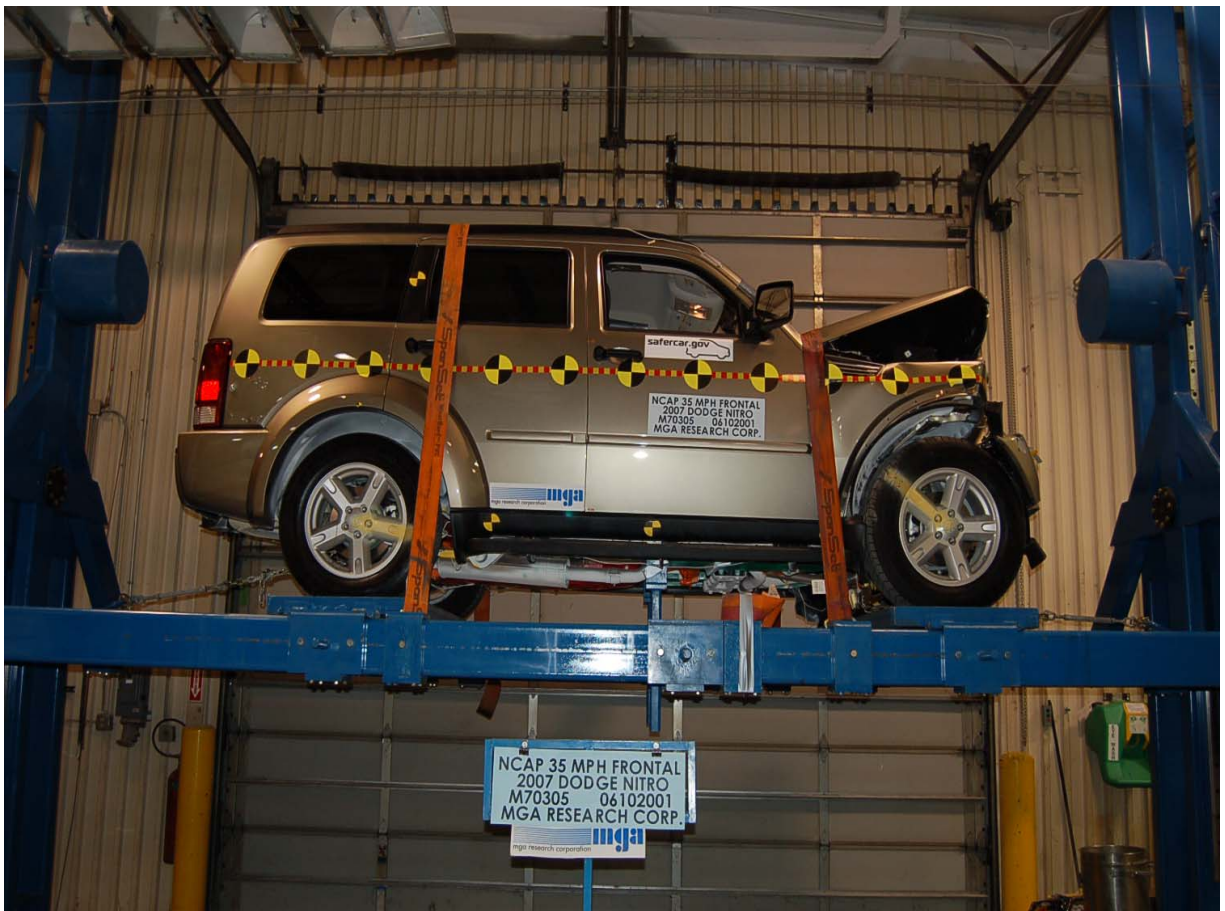
Rollover 90 Degrees

Rollover 180 Degrees

Rollover 270 Degrees

Rollover 360 Degrees

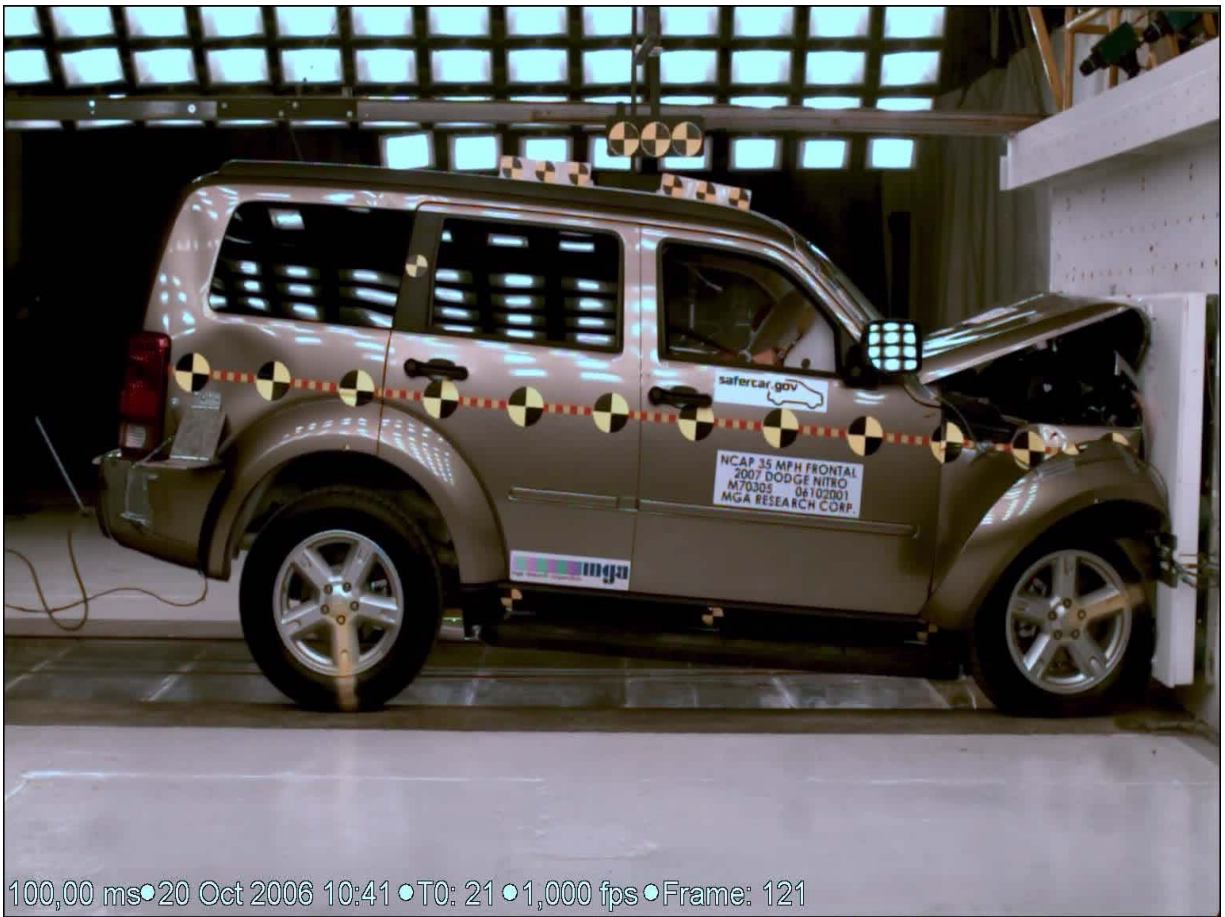
Vehicle Impact

A load cell barrier was impacted by a 2007 Dodge Nitro SLT 4x4 at a velocity of 56.3 kph. The test was performed at MGA Research Corporation on October 20, 2006. Pre-and post-test photographs of the vehicle and dummies can be found in Appendix A.
