**REPORT NUMBER: NCAP-MGA-2007-007**

**NEW CAR ASSESSMENT PROGRAM  
FRONTAL BARRIER IMPACT TEST**

**KIA MOTORS CORPORATION  
2007 KIA SPORTAGE 4X4  
NHTSA NUMBER: M70509**

**PREPARED BY:  
MGA RESEARCH CORPORATION  
5000 WARREN ROAD  
BURLINGTON, WI 53105**

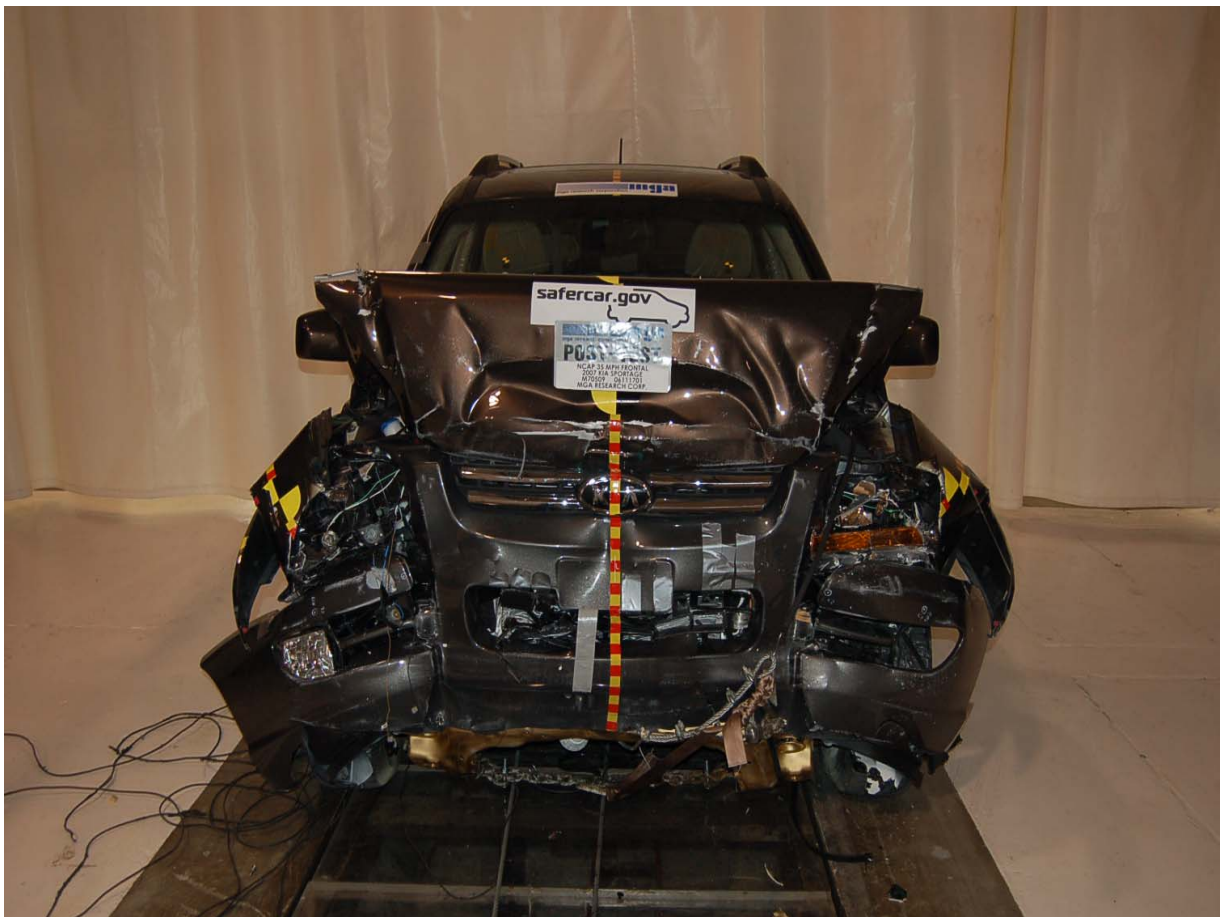
Post-Test Front View

The maximum static crush of the vehicle was 533 mm and both the driver and passenger side doors remained closed and latched during the impact event and were operable after the impact.

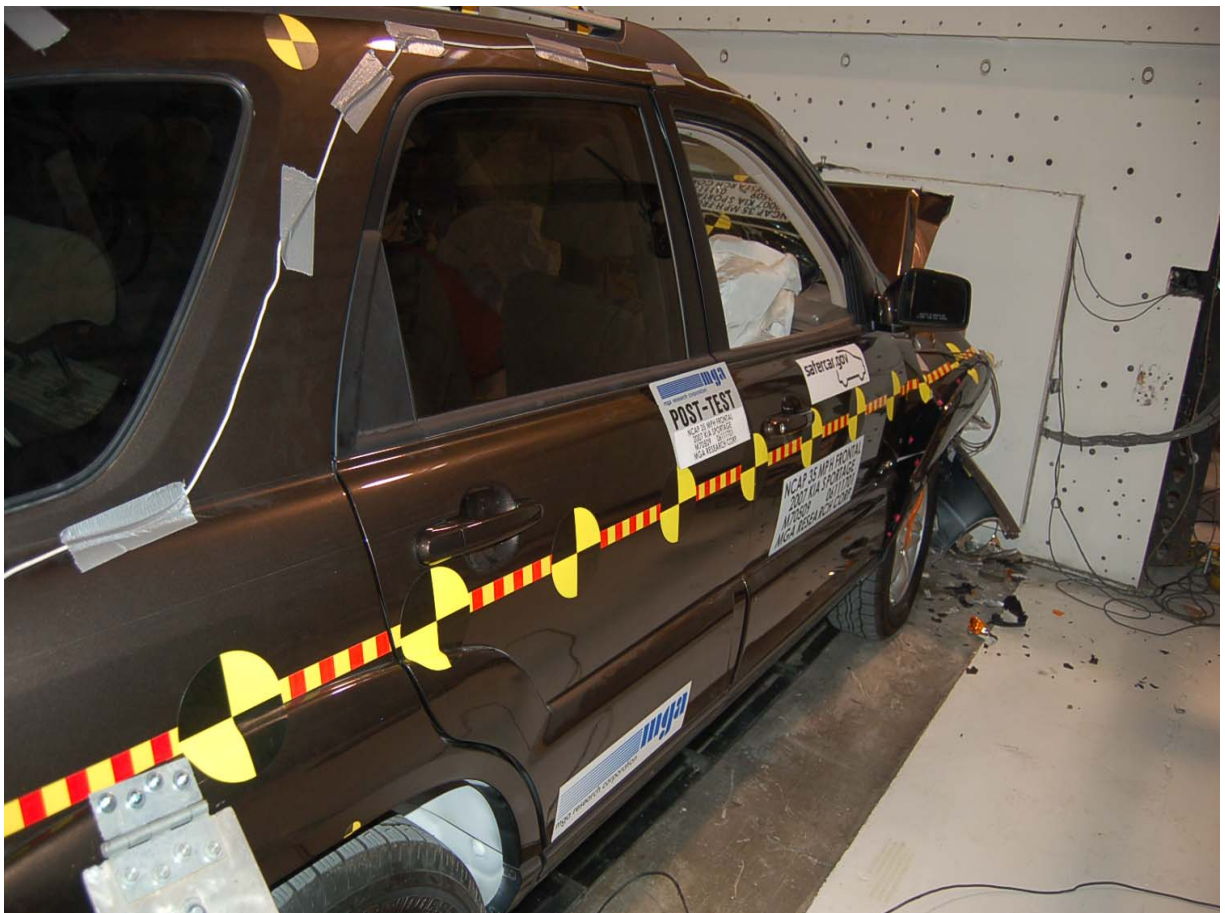
Post-Test Right Side ¾ View of Doors After Impact

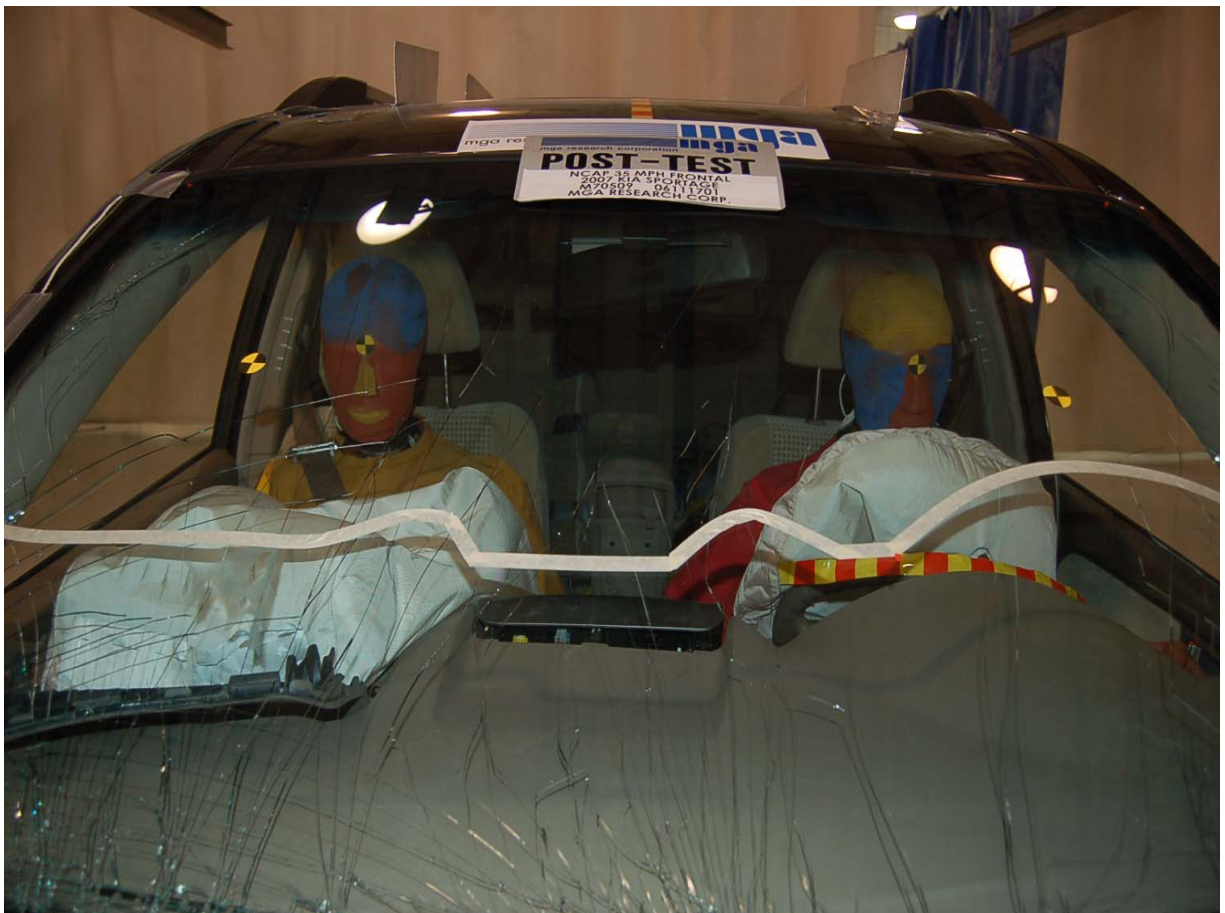
Post-Test Windshield View

There was 100 percent windshield retention and no intrusion into the protected zone of the windshield during the event. There was no Stoddard Solvent leakage after the event or during any phase of the static rollover.

| Description | Driver | Passenger |
|---|---|---|
| Glazing Damage | The windshield was cracked. | |

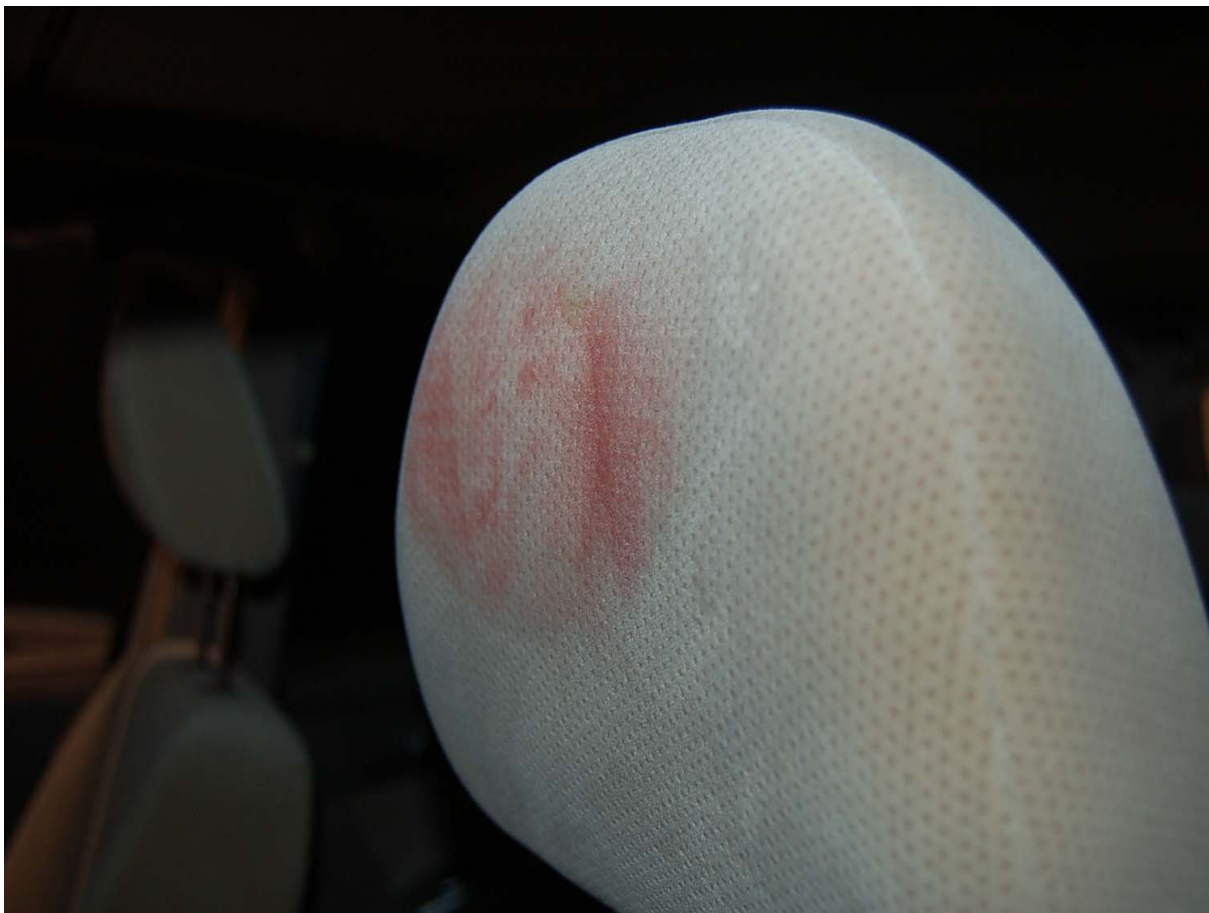
Post-Test Driver Dummy Head Contact (headrest)

The driver's head and chest contacted the airbag. The driver's head also contacted the headrest. The driver's knees contacted the bolster. The passenger's head and chest contacted the airbag. The passenger's head also contacted the headrest. The passenger's knees contacted the glove box.

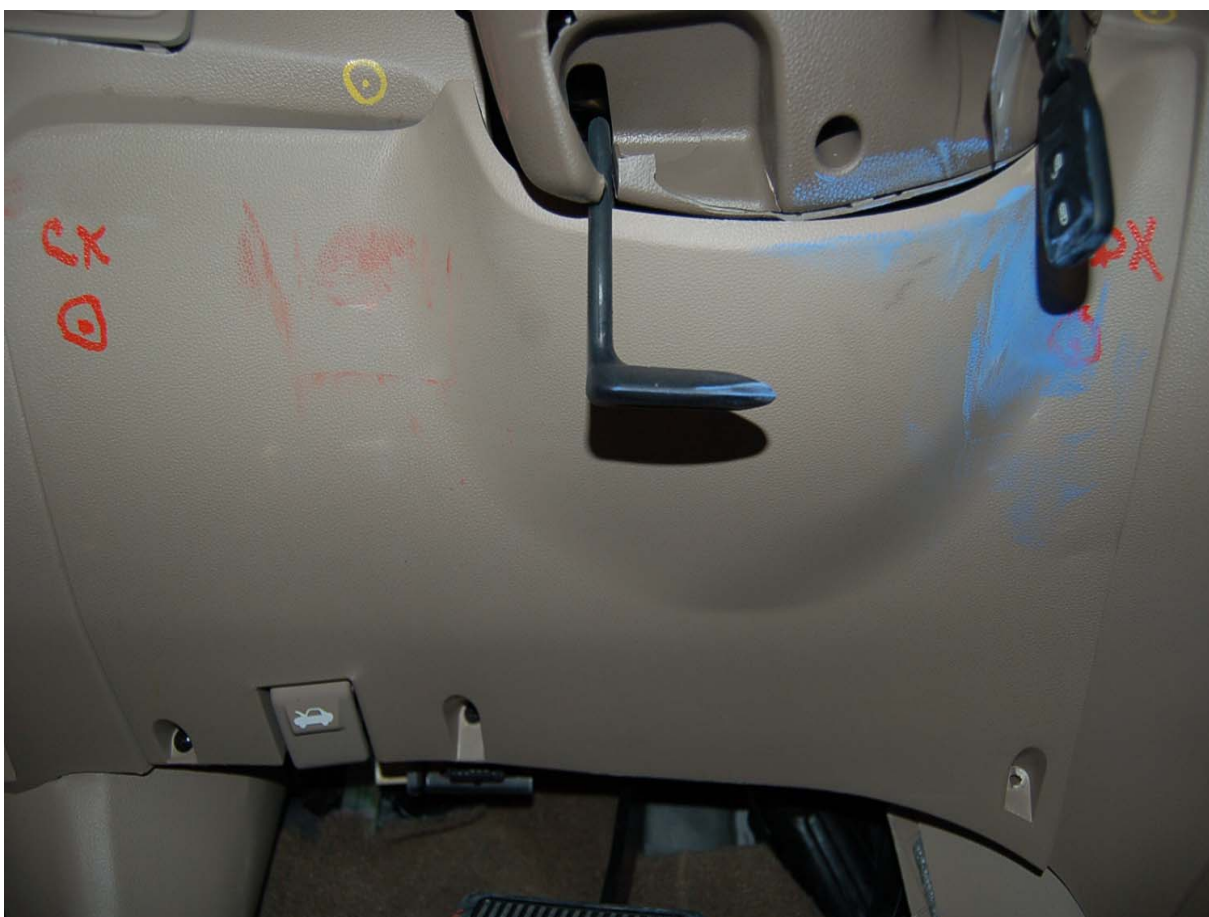
Post-Test Driver Dummy Knee Contact

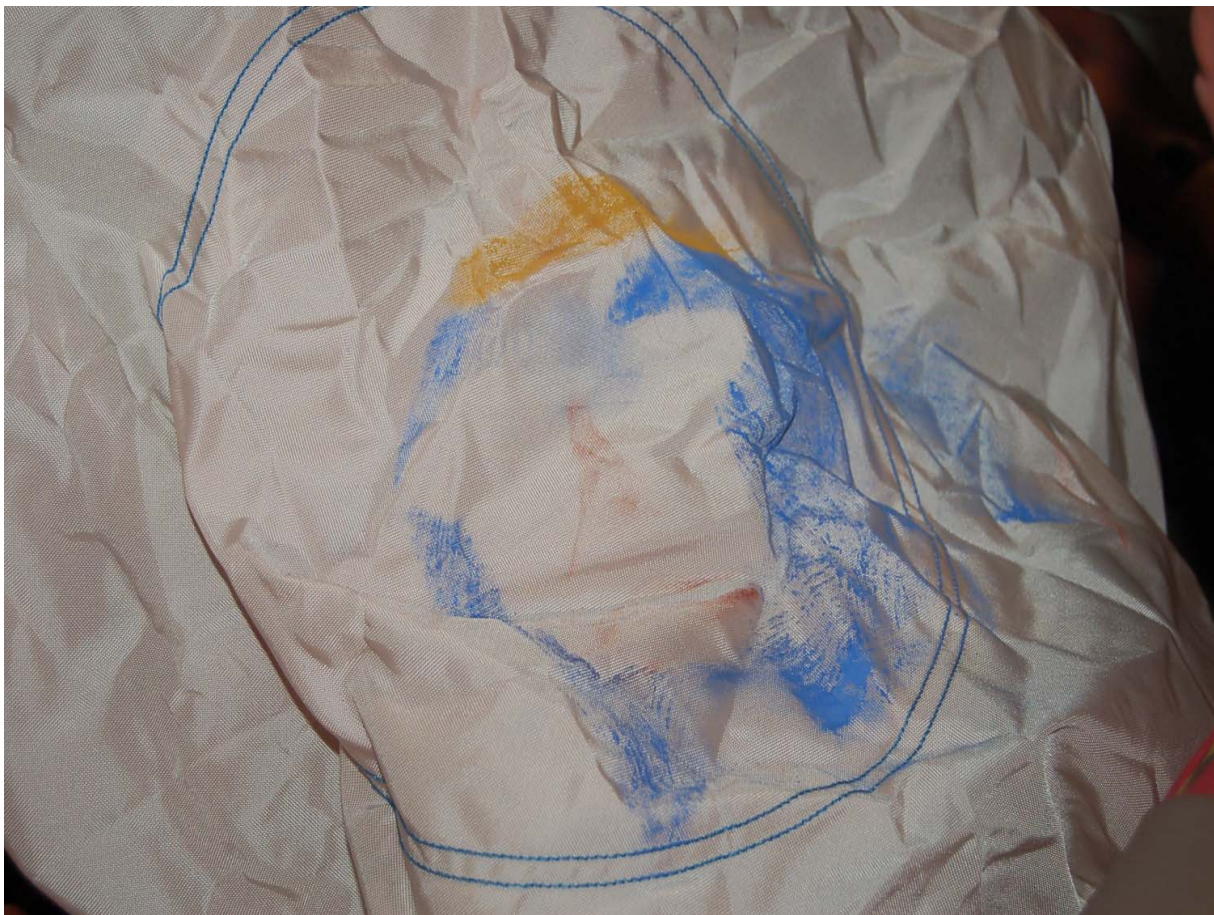
Post-Test Driver Dummy Airbag Contact

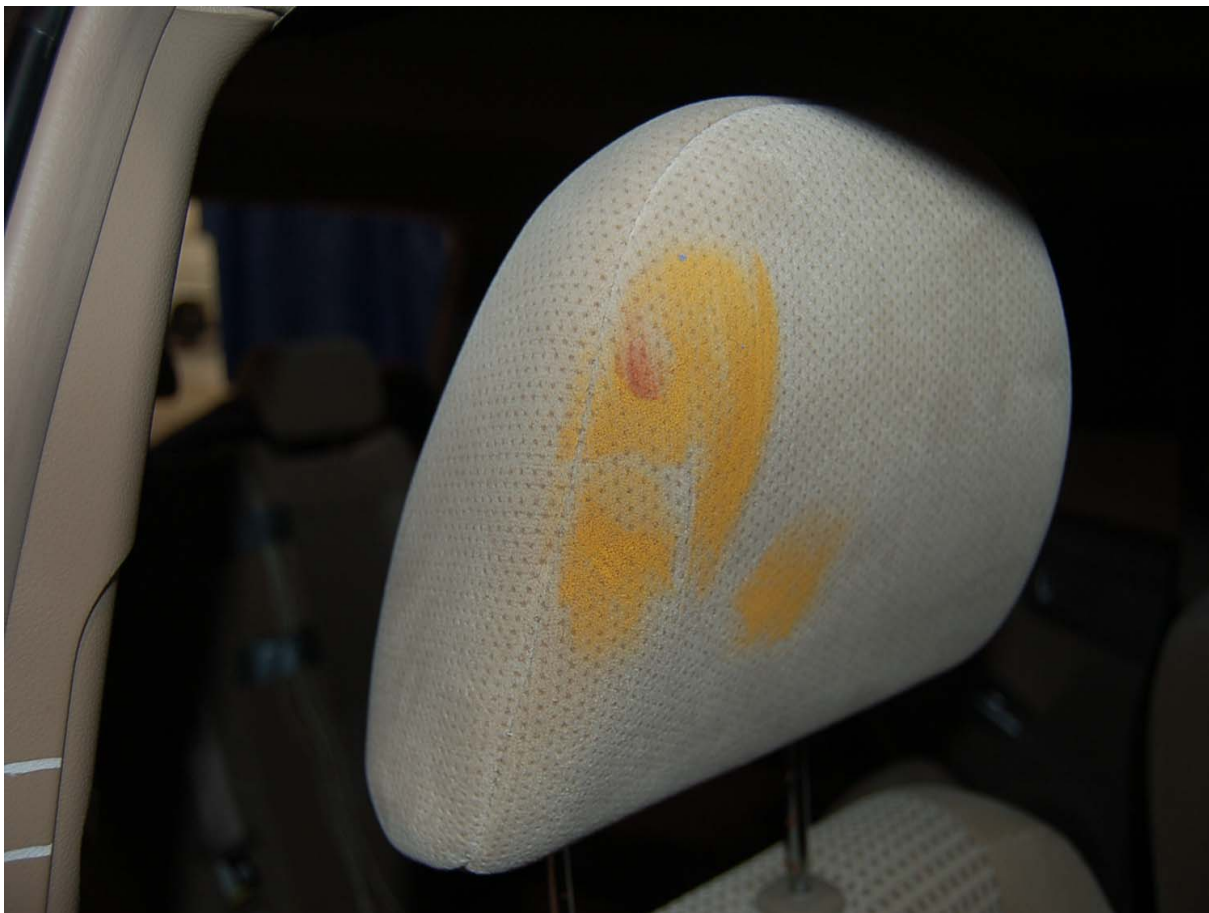
Post-Test Passenger Dummy Head Contact

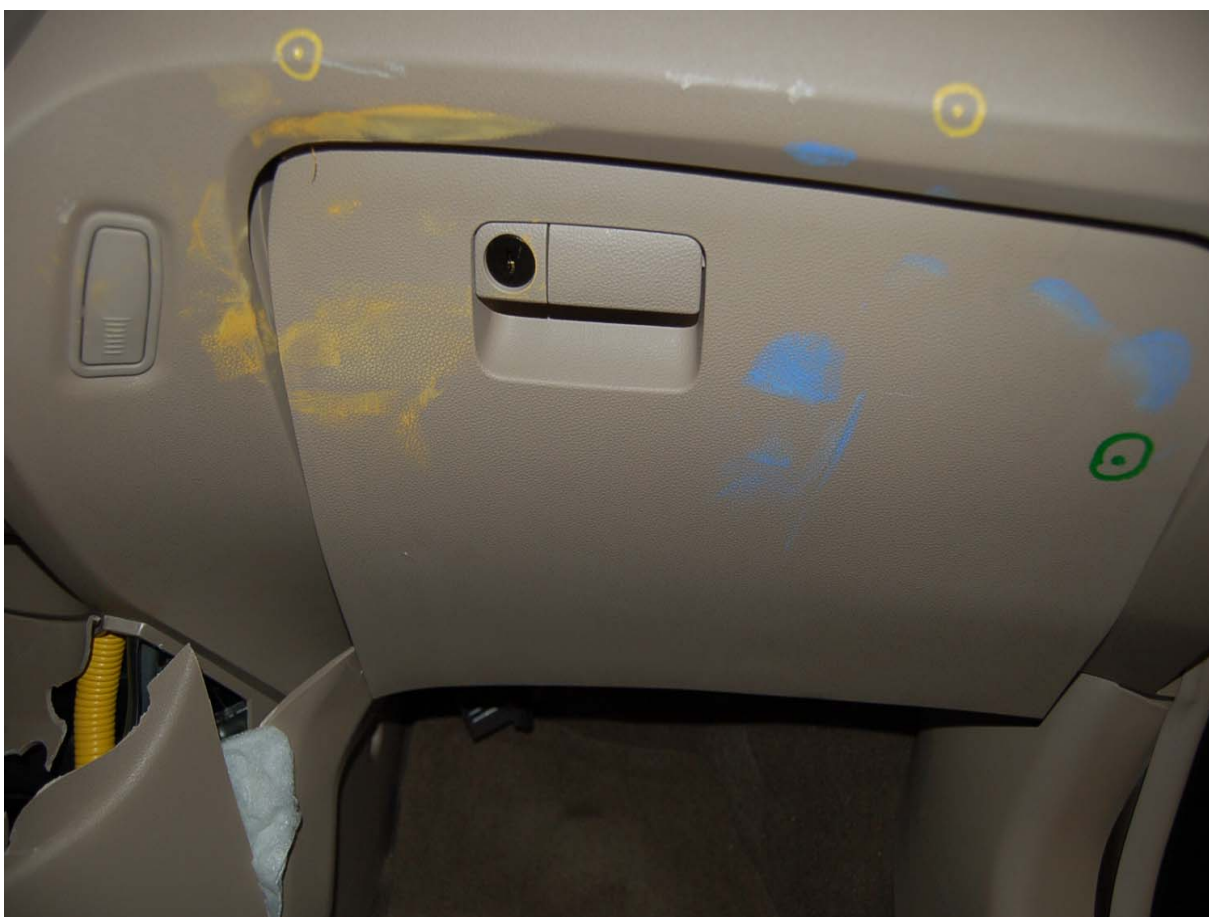
Post-Test Passenger Dummy Knee Contact

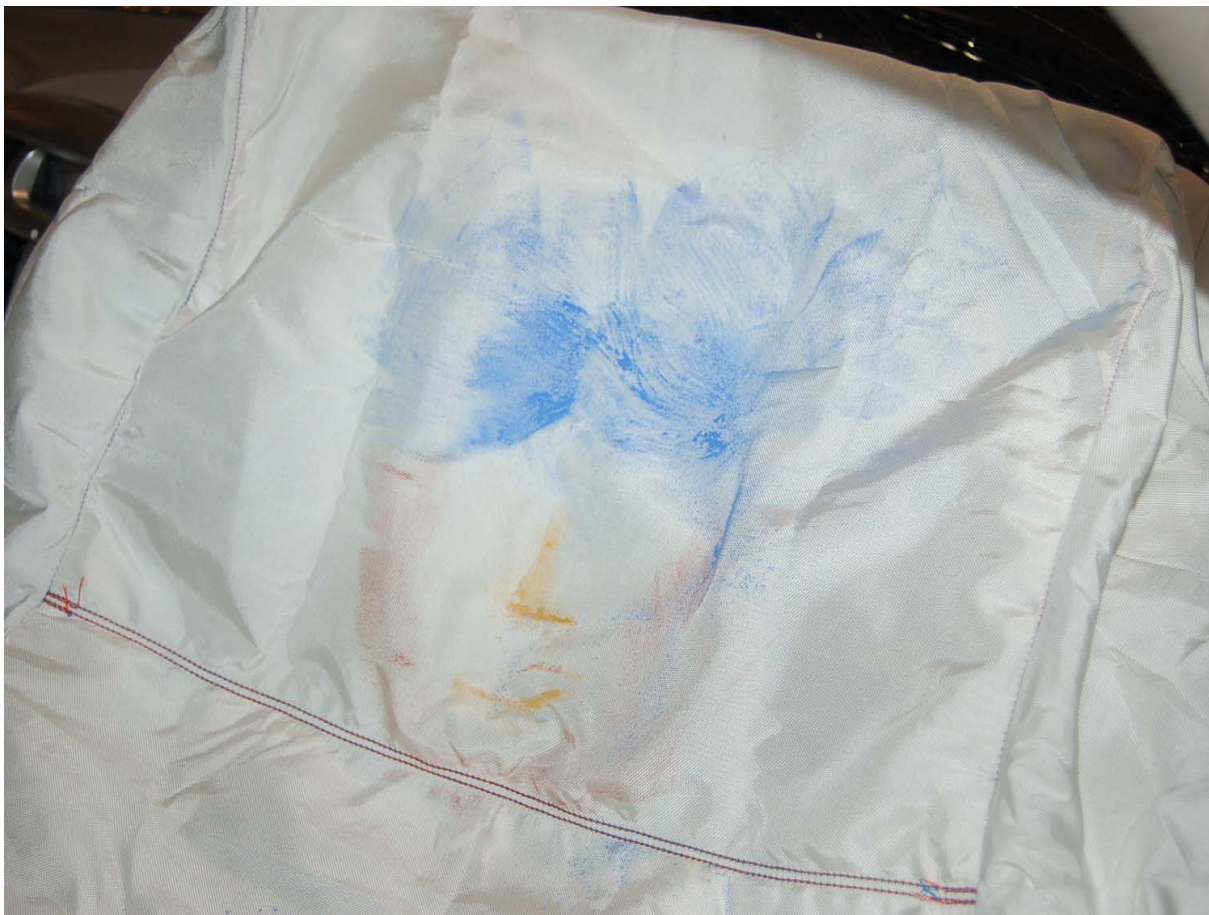
Post-Test Passenger Dummy Airbag Contact
