**REPORT NUMBER: TWG-MGA-2010-006**

**SIDE AIRBAG OUT-OF-POSITION INJURY  
TECHNICAL WORKING GROUP**

**GENERAL MOTORS DE MEXICO, S. DE R.L. DE C.V.  
2010 CADILLAC SRX AWD  
NHTSA NUMBER: MA0120TWG2**

**FINAL REPORT**

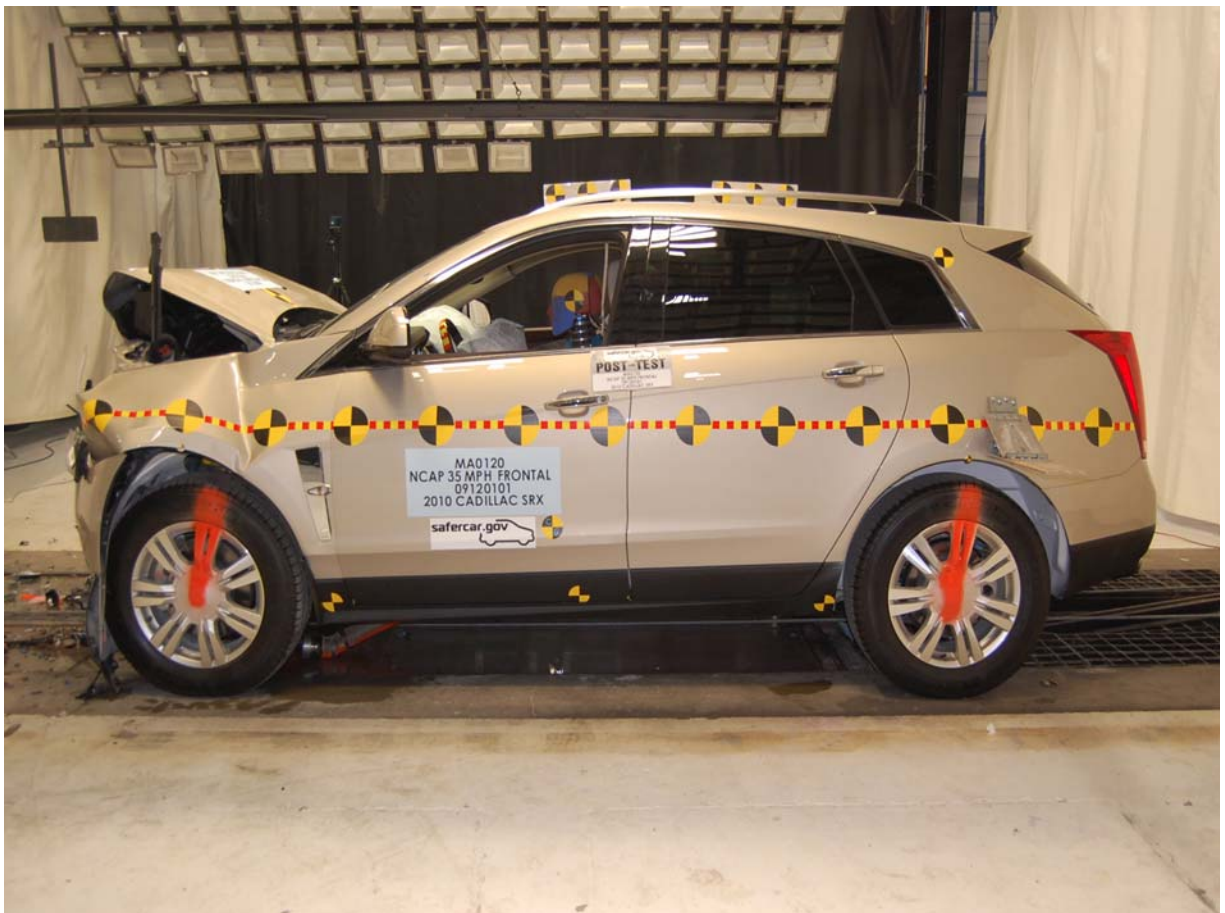
| | <u>Page No.</u> |
|---|---|
| Photo No. 4. Post-Test Vehicle Left Side View | 10 |

Post-Test Vehicle Left Side View

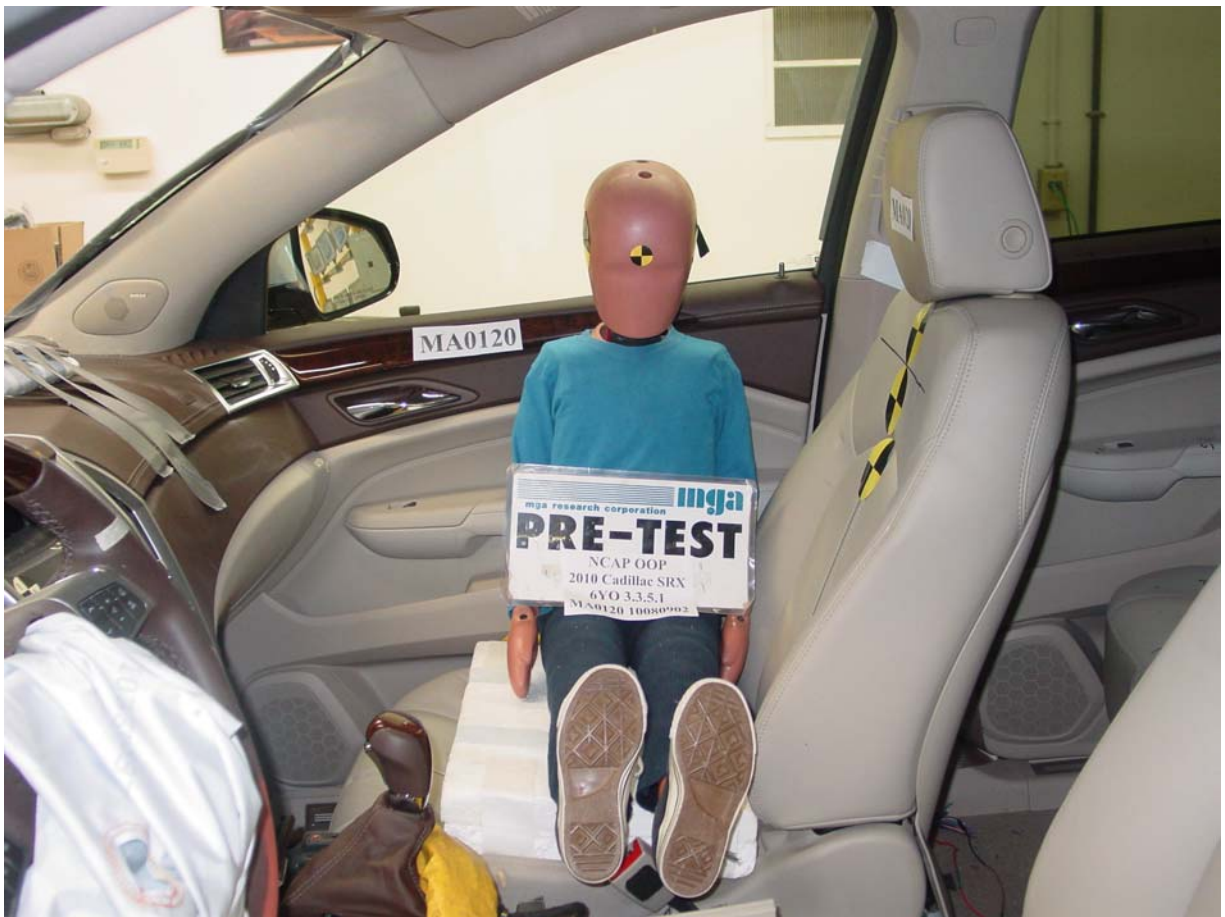
| | <u>Page No.</u> |
|---|---|
| Photo No. 5. Pre-Test 6-Year-Old Child Dummy Left Side View | 11 |

The Hybrid III 6-Year-Old child dummy was placed in the right front passenger seat along the outboard edge of the foam block, facing inboard with its legs extended and arms hanging at its sides. The seat track was positioned forward to minimize the cushion to head interaction. The dummy's pelvis was slid outboard until the dummy's back contacted the door trim panel or armrest and the center of gravity of the head was centered in the deployment trajectory of the airbag. The head remained in its neutral orientation. A vertical plane through the centerline of the dummy's shoulder bolts was parallel to the vehicle centerline. The dummy's arms were bent at the elbow until the fingertips contacted the foam block.

Pre-Test 6-Year-Old Child Dummy Left Side View

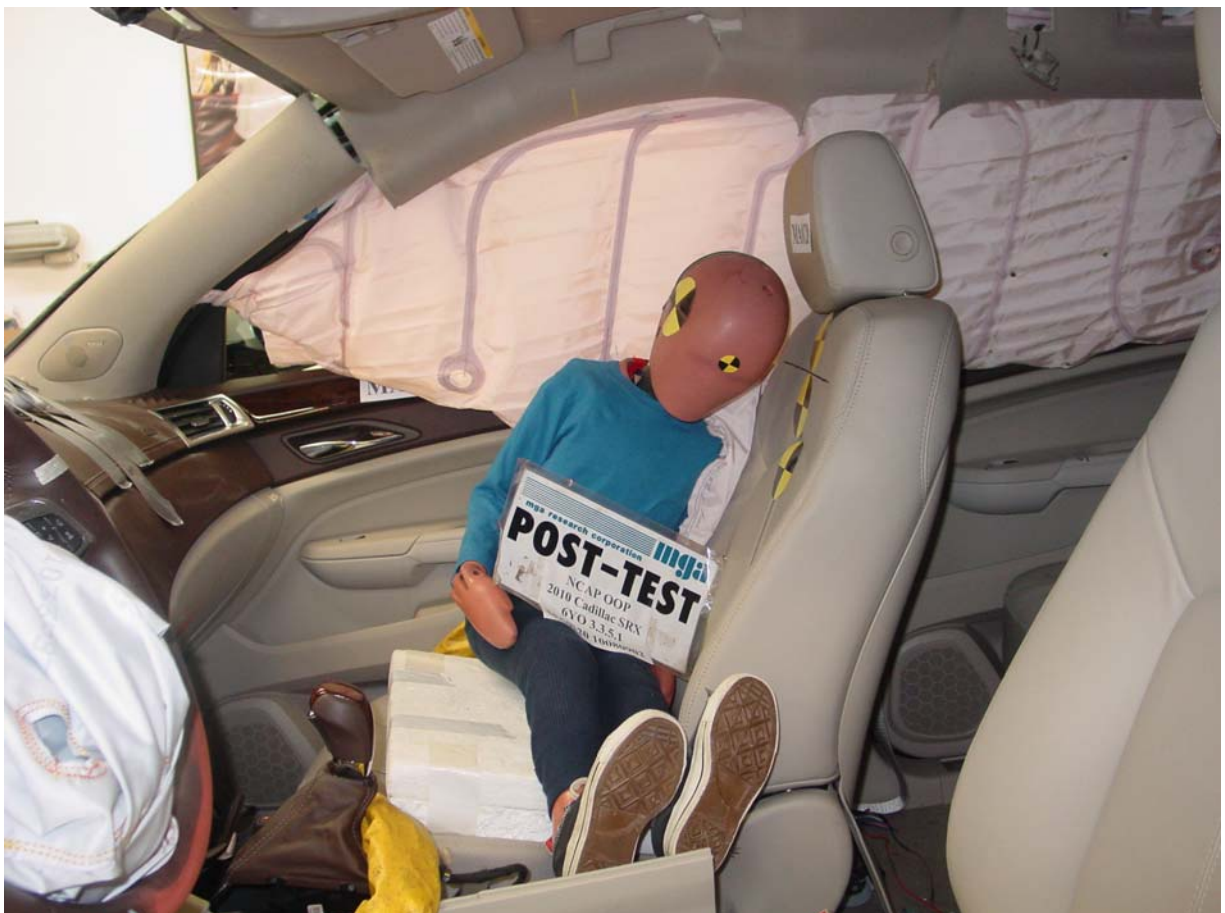
| | <u>Page No.</u> |
|---|---|
| Photo No. 6. Post-Test 6-Year-Old Child Dummy Left Side View | 11 |

- Curtain airbag to back of head
- Torso bag to left shoulder, left torso, and left pelvis

Post-Test 6-Year-Old Child Dummy Left Side View

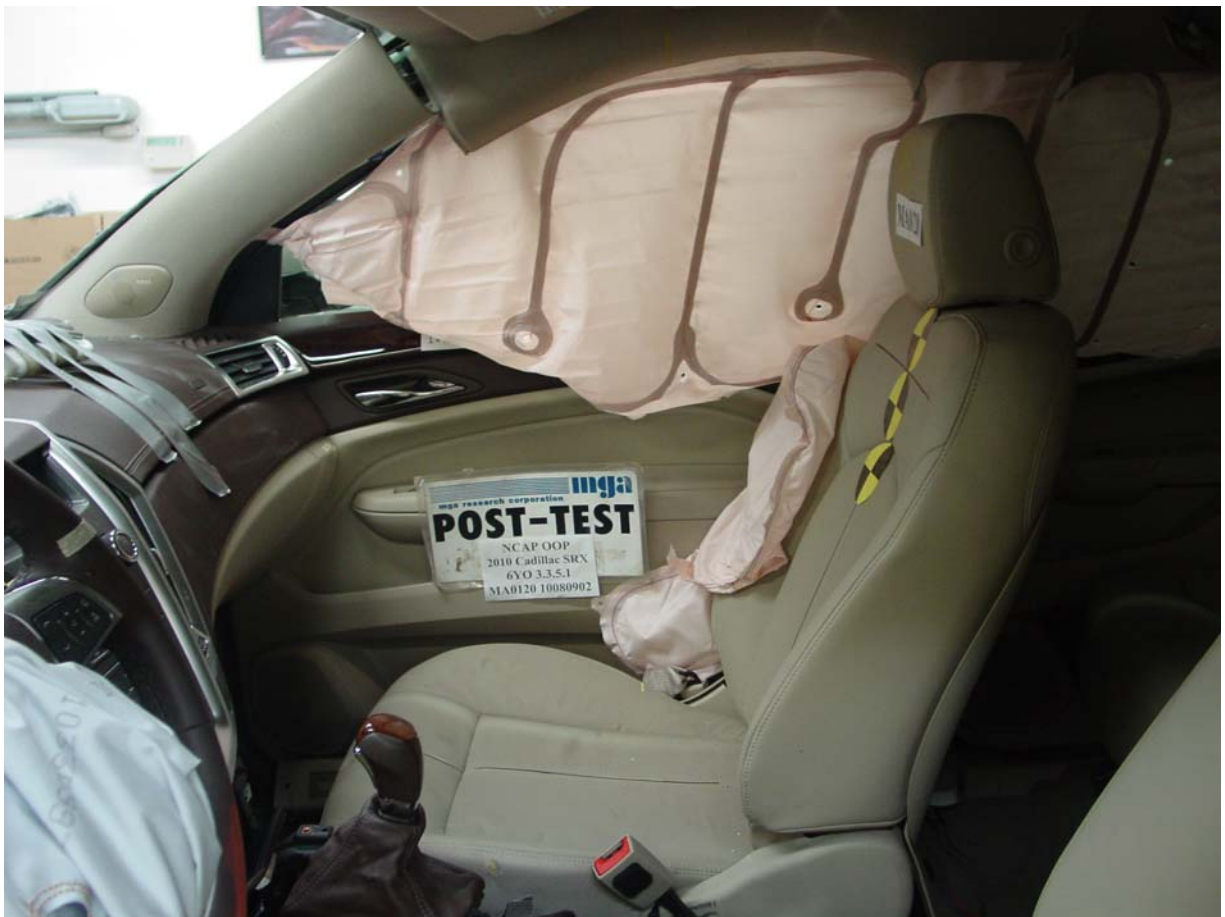
| | <u>Page No.</u> |
|---|---|
| Photo No. 21. Post-Test Curtain and Torso/Pelvis Airbag Left View | 19 |

Post-Test Curtain and Torso/Pelvis Airbag Left View

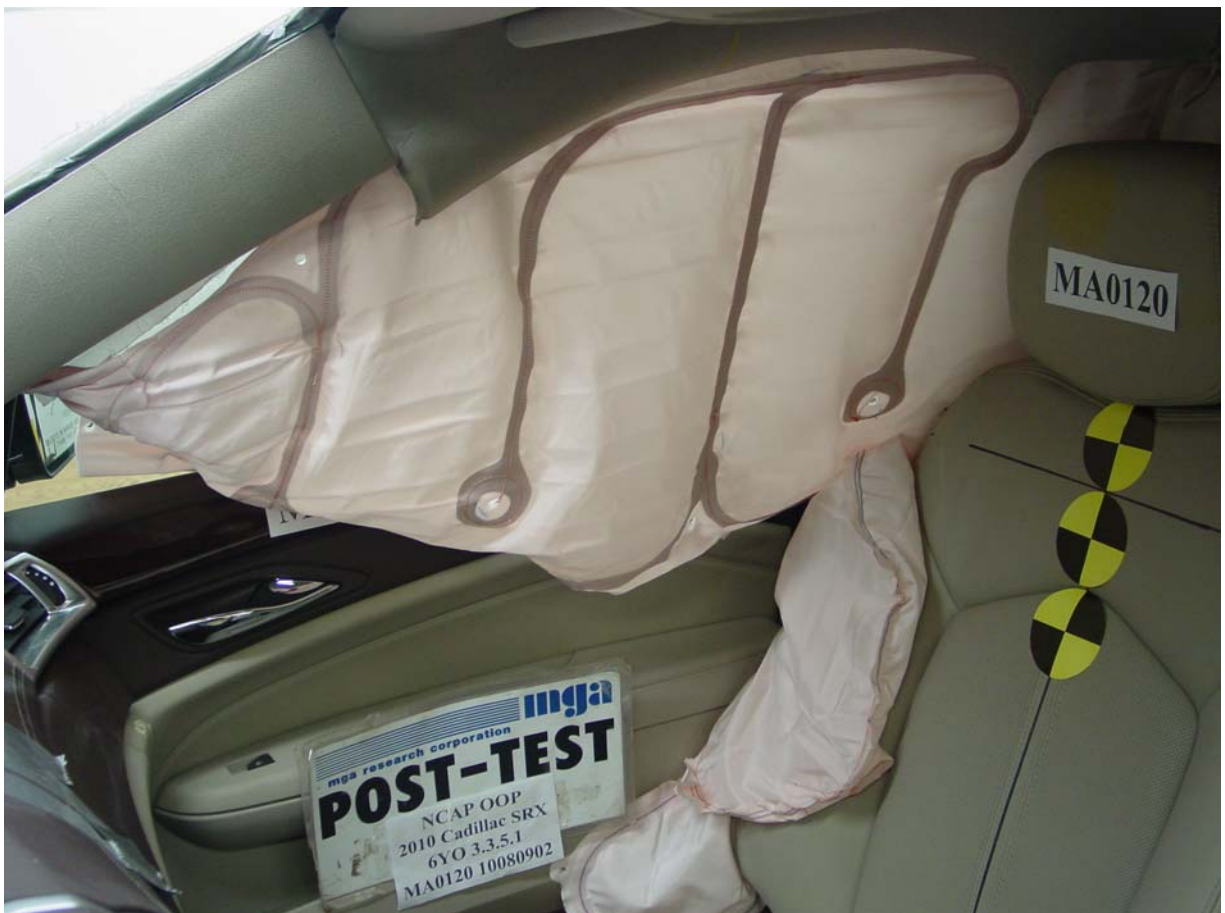
| | <u>Page No.</u> |
|---|---|
| Photo No. 22. Post-Test Curtain and Torso/Pelvis Airbag Left ¾ Front View | 19 |

Post-Test Curtain and Torso/Pelvis Airbag Left 3/4 Front View

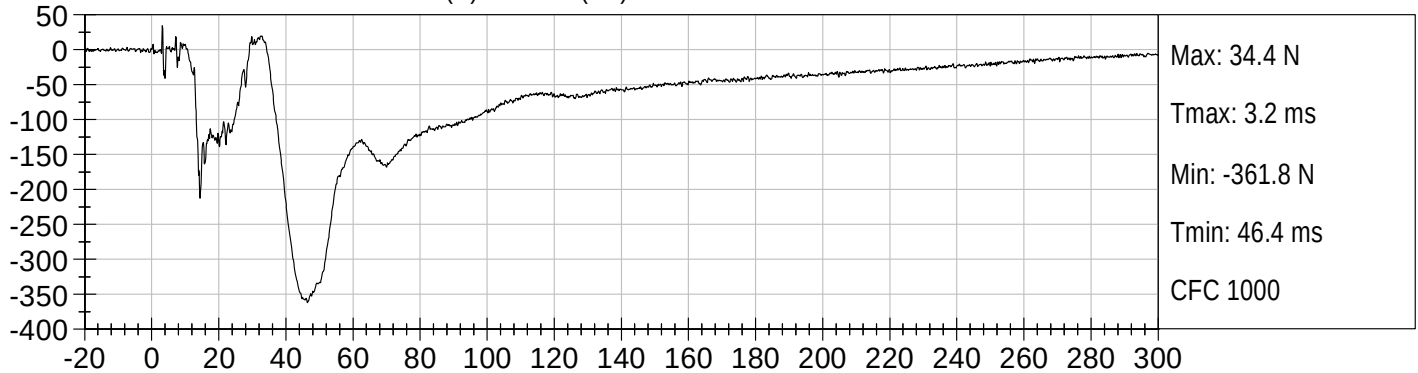
PASSENGER UPPER NECK FX (N) vs TIME (ms)

| DESCRIPTION | UNIT | MAXIMUM VALUE | | | |
|---|---|---|---|---|---|
| Upper Neck Fx | N | 34.4 | 3.2 | -361.8 | 46.4 |

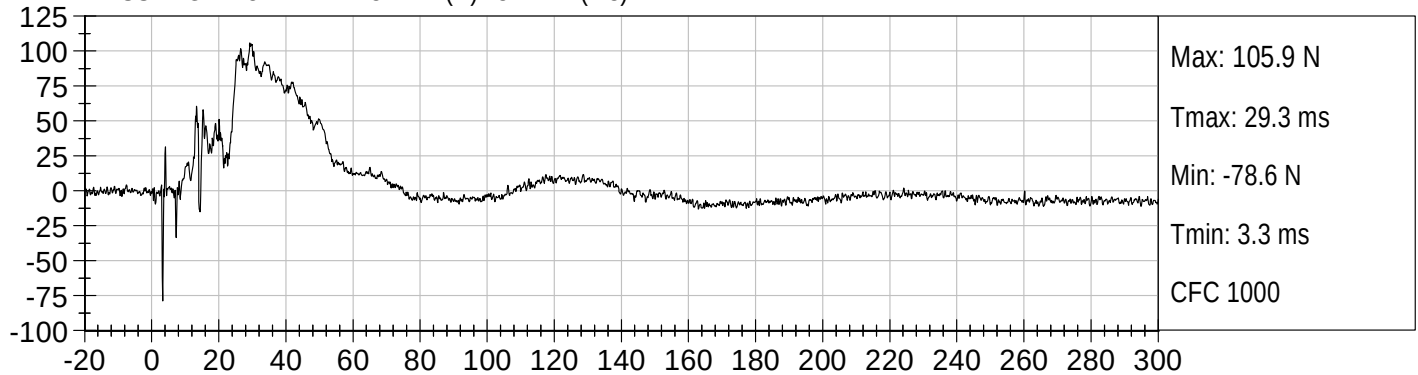
PASSENGER UPPER NECK FY (N) vs TIME (ms)

| DESCRIPTION | UNIT | MAXIMUM VALUE | | | |
|---|---|---|---|---|---|
| Upper Neck Fy | N | 105.9 | 29.3 | -78.6 | 3.3 |

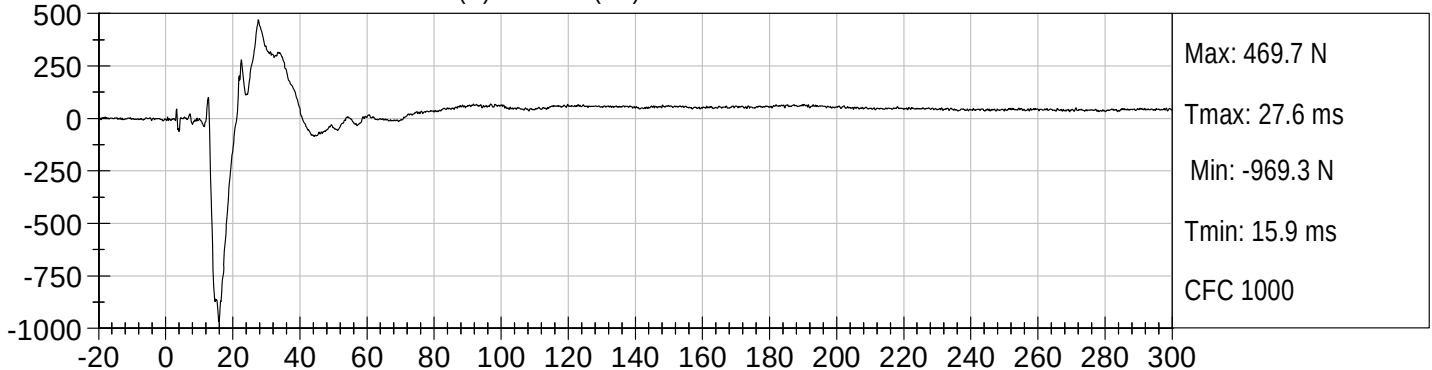
PASSENGER UPPER NECK FZ (N) vs TIME (ms)

| DESCRIPTION | UNIT | MAXIMUM VALUE | | | |
|---|---|---|---|---|---|
| Upper Neck Fz | N | 469.7 | 27.6 | -969.3 | 15.9 |

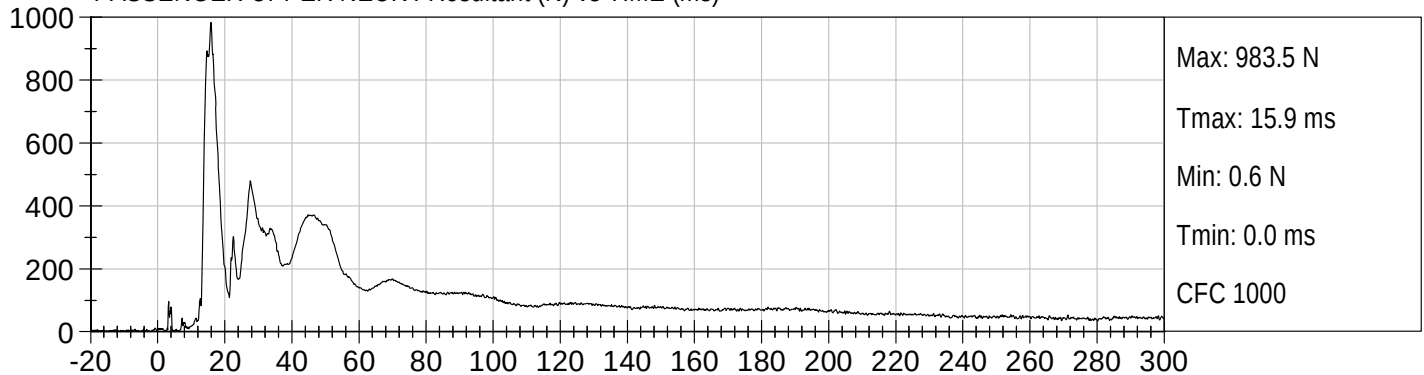
PASSENGER UPPER NECK FResultant (N) vs TIME (ms)

| DESCRIPTION | UNIT | MAXIMUM VALUE | | | |
|---|---|---|---|---|---|
| Upper Neck F Resultant | N | 983.5 | 15.9 | | |

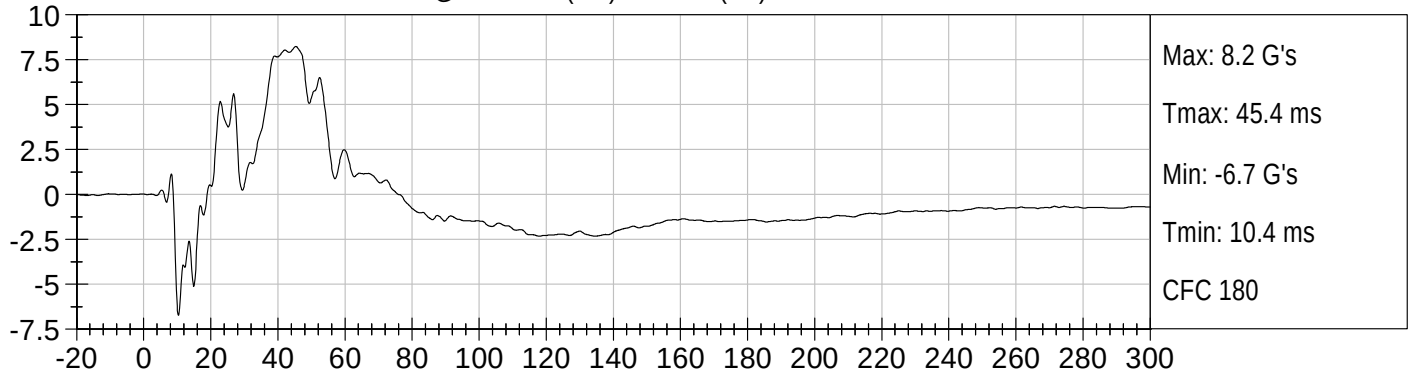
PASSENGER UPPER THORAX @ SPINE X (G's) vs TIME (ms)

| DESCRIPTION | UNIT | MAXIMUM VALUE | | | |
|---|---|---|---|---|---|
| Upper Thorax @ Spine X | G | 8.2 | 45.4 | -6.7 | 10.4 |

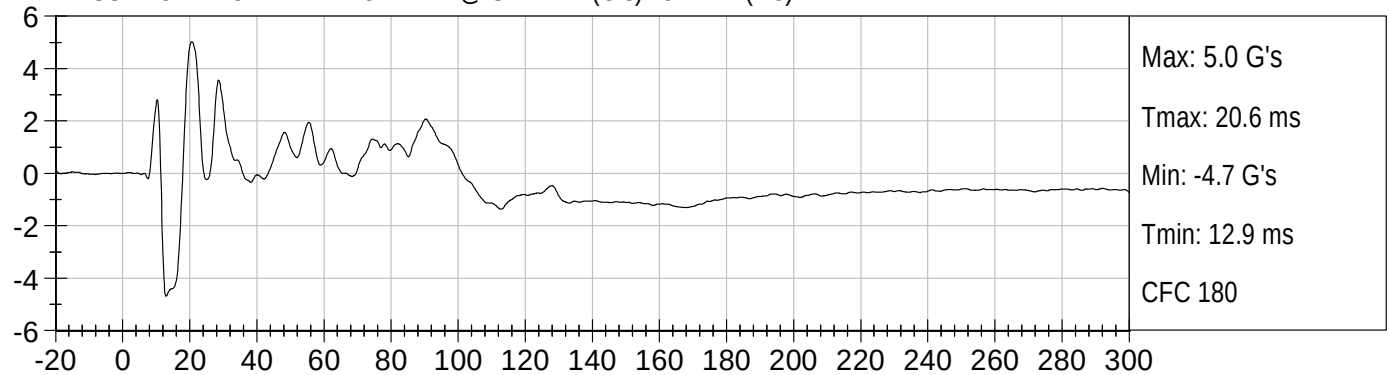
PASSENGER LOWER ABDOMINAL @ SPINE X (G's) vs TIME (ms)

| DESCRIPTION | UNIT | MAXIMUM VALUE | | | |
|---|---|---|---|---|---|
| Lower Abdominal @ Spine X | G | 5.0 | 20.6 | -4.7 | 12.9 |

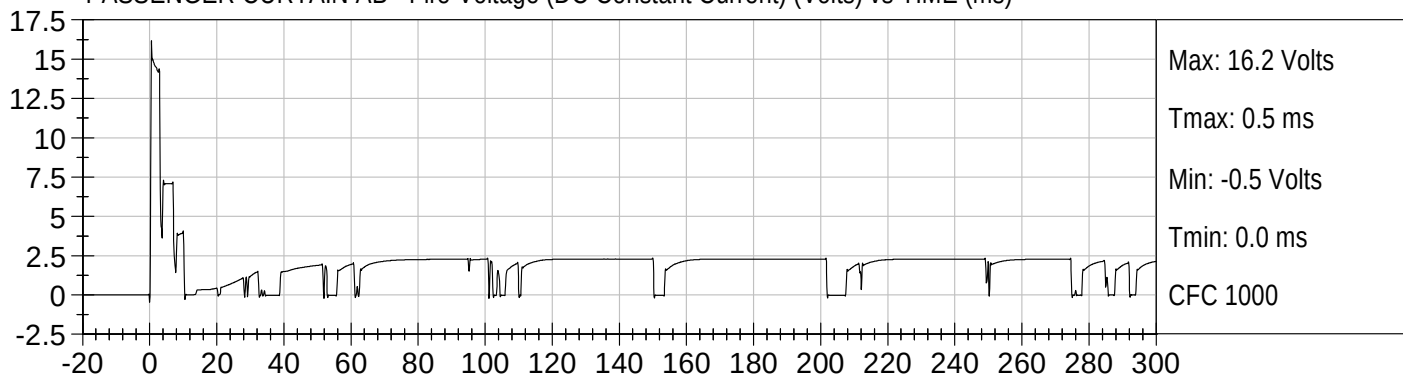
PASSENGER CURTAIN AB - Fire Voltage (DC Constant Current) (Volts) vs TIME (ms)

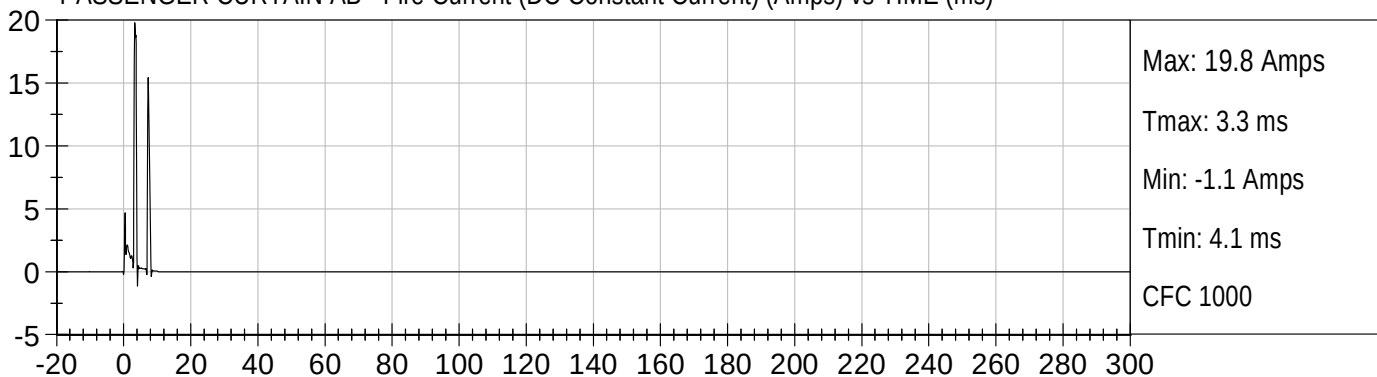
PASSENGER CURTAIN AB - Fire Current (DC Constant Current) (Amps) vs TIME (ms)

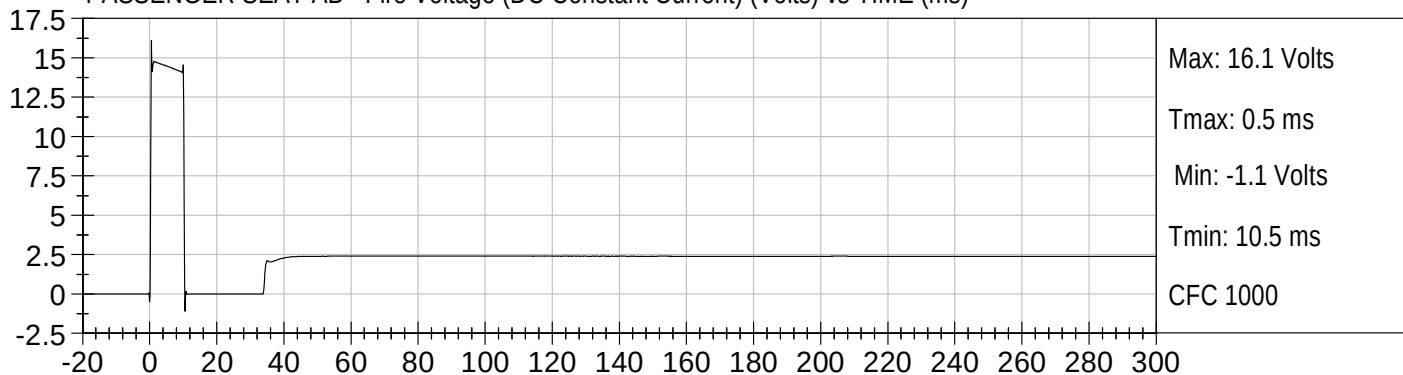
PASSENGER SEAT AB - Fire Voltage (DC Constant Current) (Volts) vs TIME (ms)

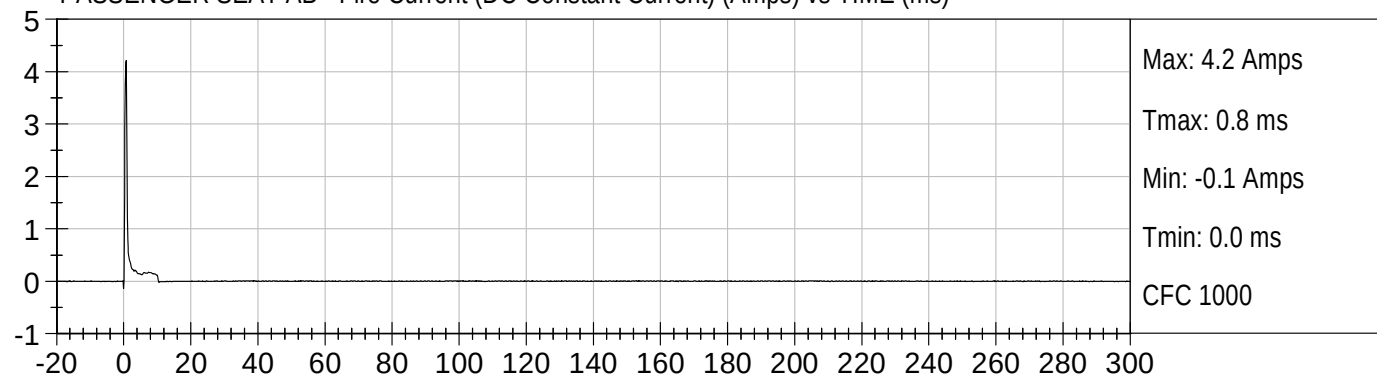
PASSENGER SEAT AB - Fire Current (DC Constant Current) (Amps) vs TIME (ms)
