**REPORT NUMBER: NCAP-KAR-11-045**

**NEW CAR ASSESSMENT PROGRAM (NCAP)  
FRONTAL BARRIER IMPACT TEST**

**TOYOTA MOTOR MANUFACTURING, KENTUCKY, INC.  
2011 TOYOTA VENZA 5-DOOR MPV**

**FINAL REPORT**

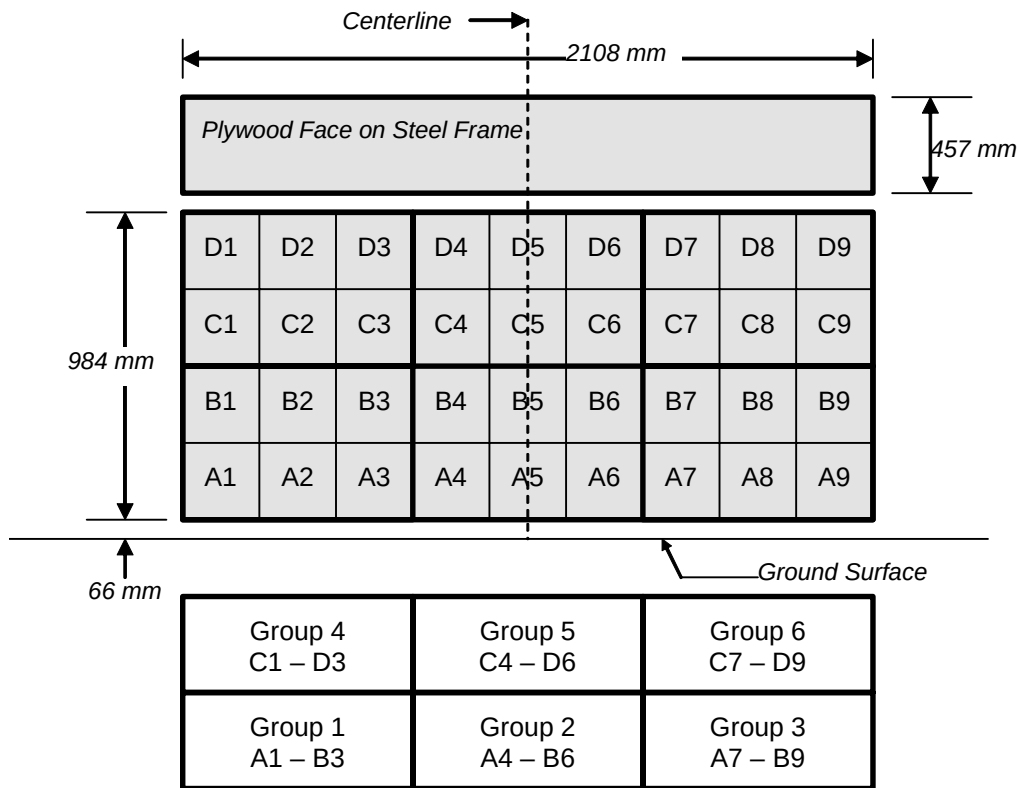
#### 36 Load Cell Rigid Barrier (NHTSA Standard) Load Cell Locations on Fixed Barrier

6 Groups of 6 Load Cells Each

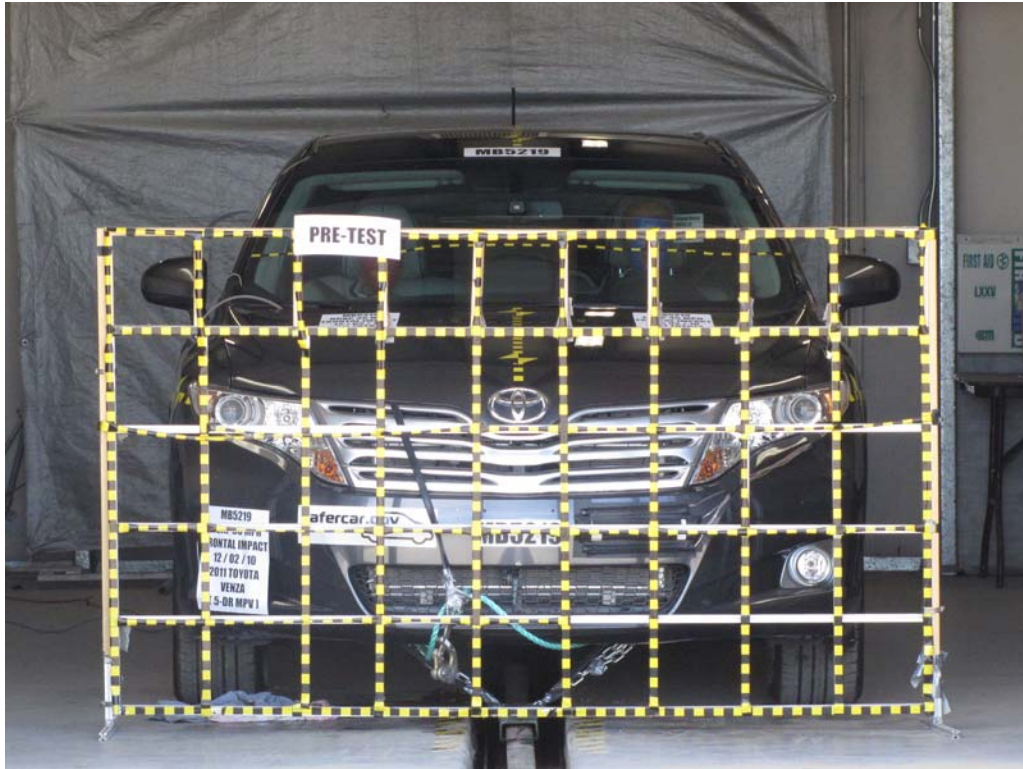
FIGURE 1. Load Cell Location

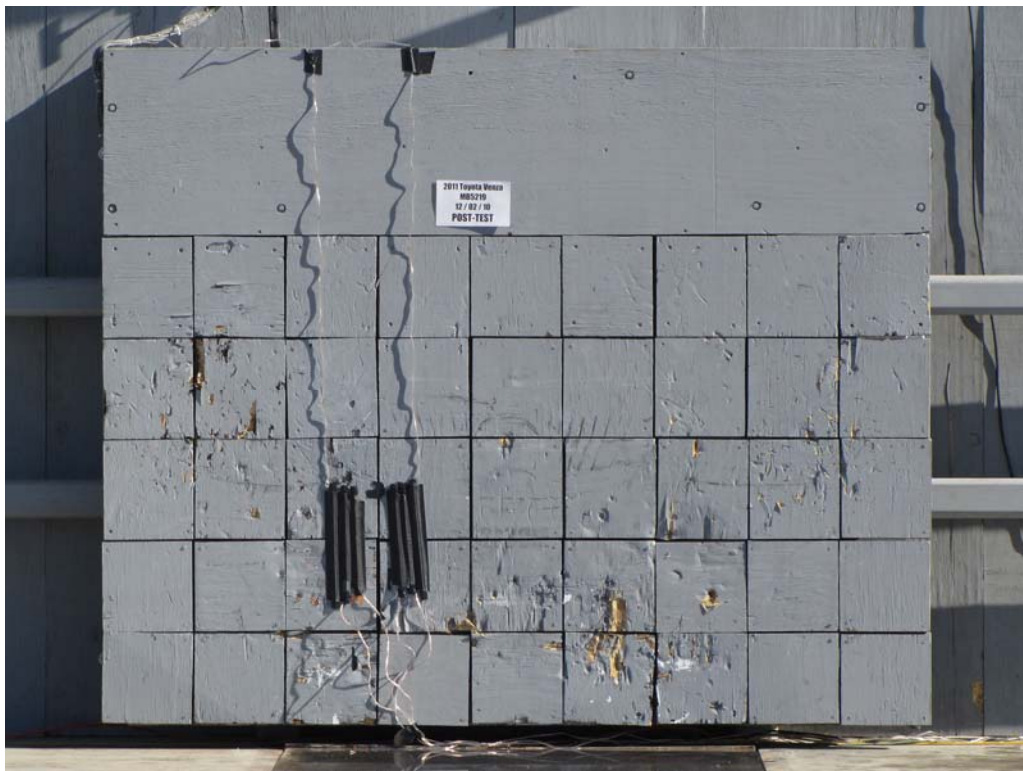
FIGURE 2. Load Cell Wall

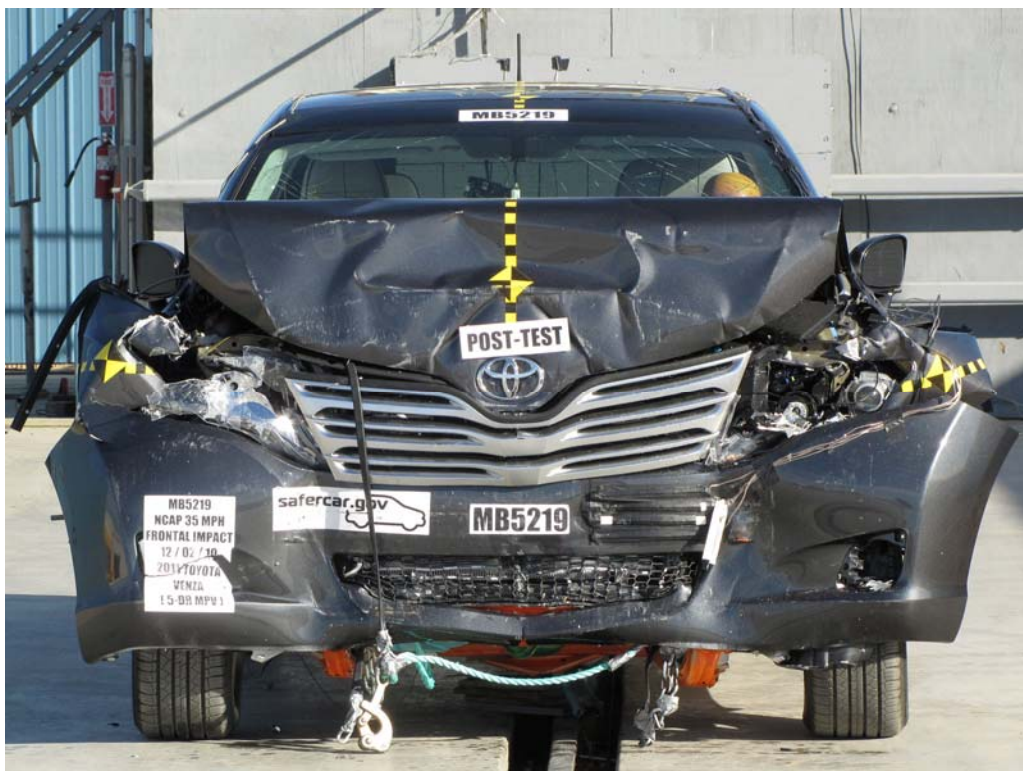
FIGURE 8. Post-Test Front View of Test Vehicle

The maximum static crush of the test vehicle was 573 mm located at the centerline. Both the driver and passenger side doors remained closed during the impact event and were operable after the impact.

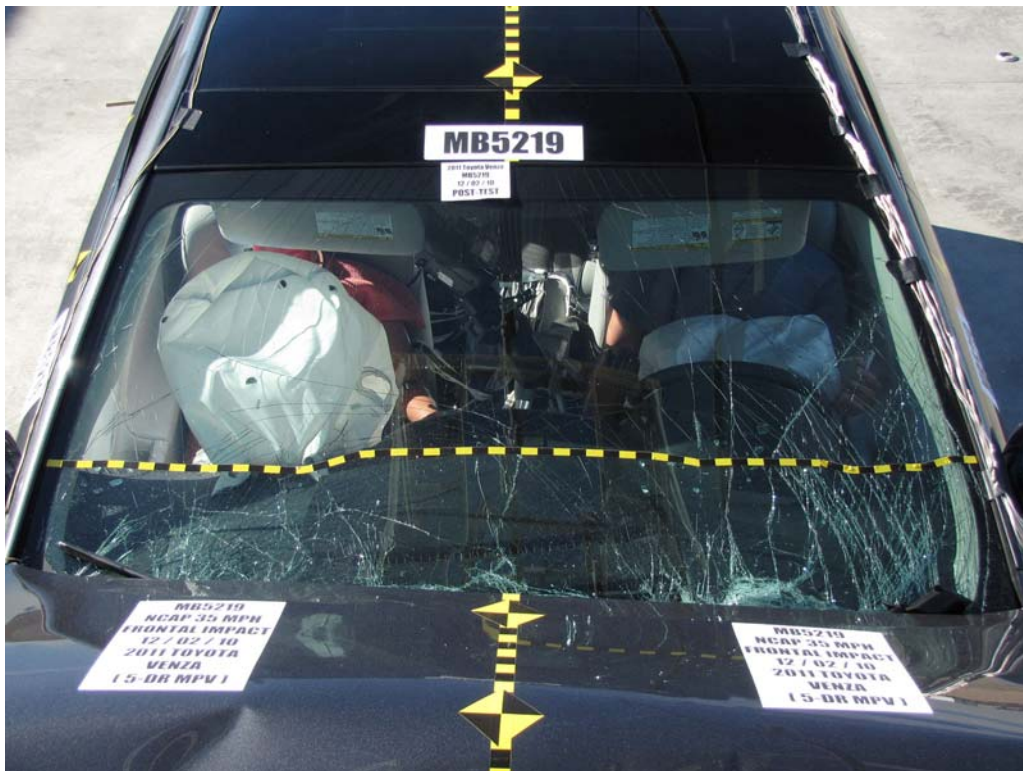
FIGURE 18. Post-Test Windshield View

There was 100% windshield retention and no intrusion into the protected zone of the windshield during the event. There was no Stoddard solvent leakage after the event or during any phase of the static rollover.

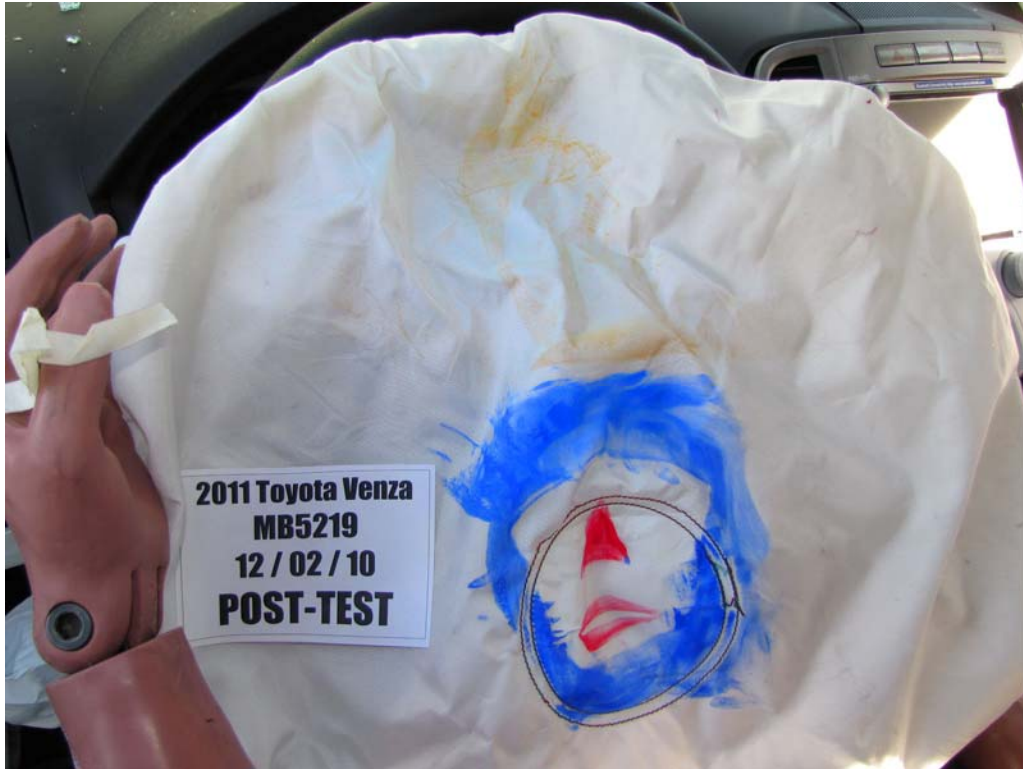
FIGURE 43. Post-Test Driver Dummy Contact With Airbag

The driver's visible contact points were as follows: The driver ATD's head contacted the airbag, head restraint, B-pillar, and side header. The upper torso contacted the airbag. Both the left and right knees contacted the knee airbag.

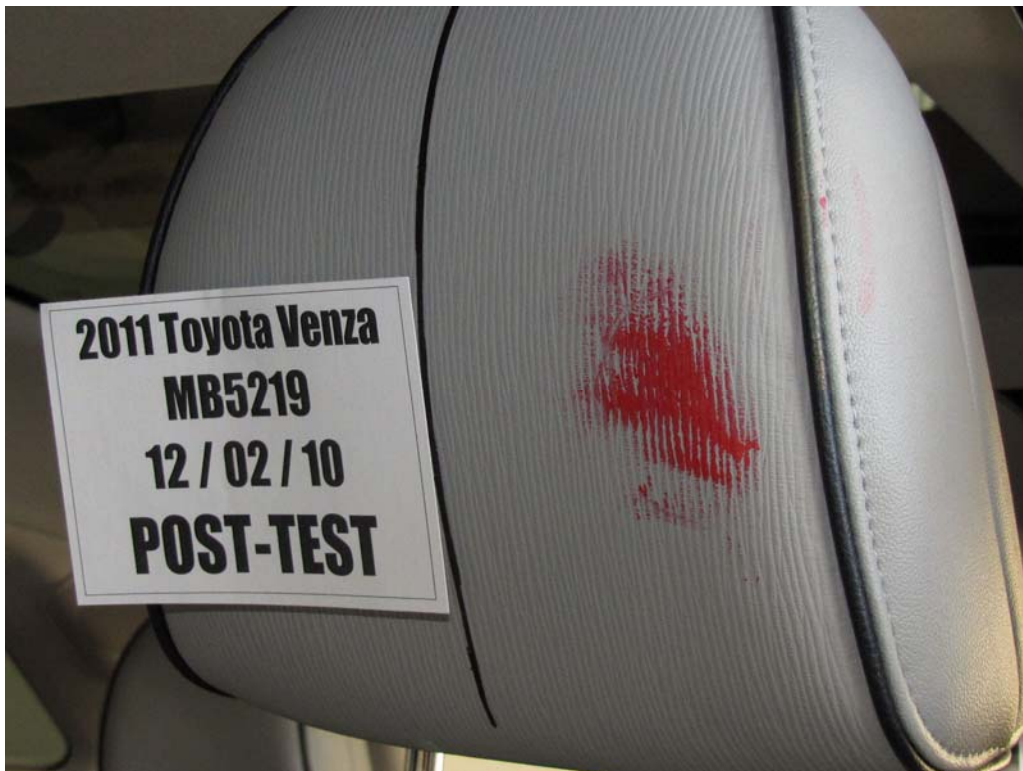
FIGURE 43a. Post-Test Driver Dummy Contact With Head Restraint

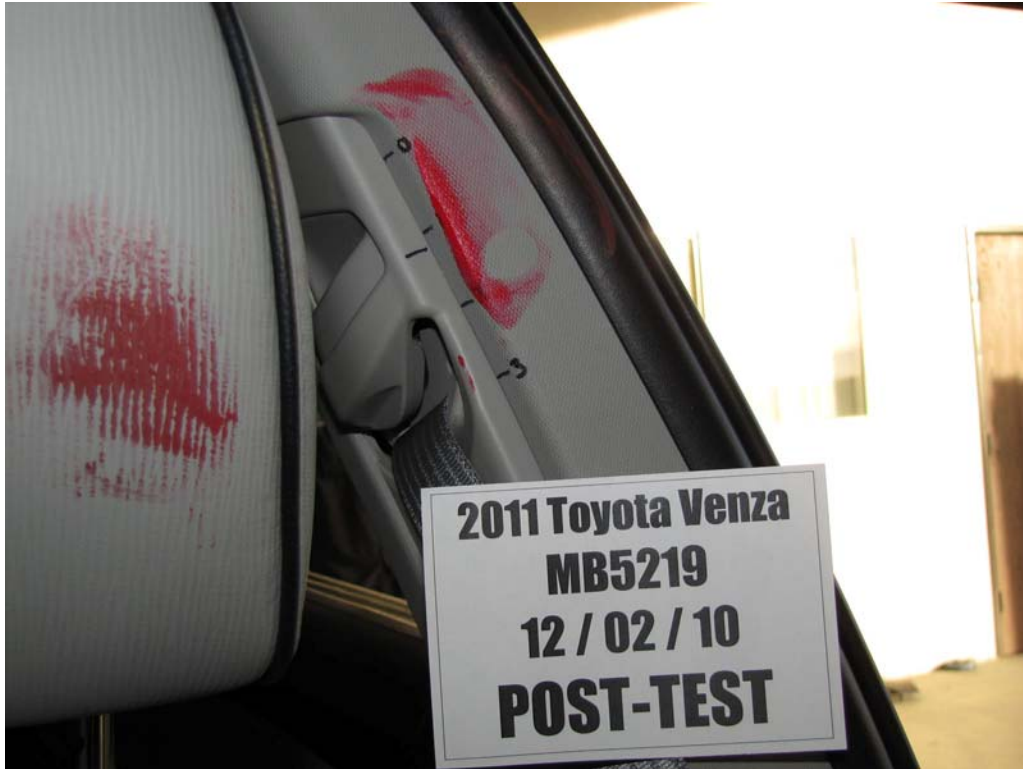
FIGURE 43b. Post-Test Driver Dummy Contact With B-Pillar

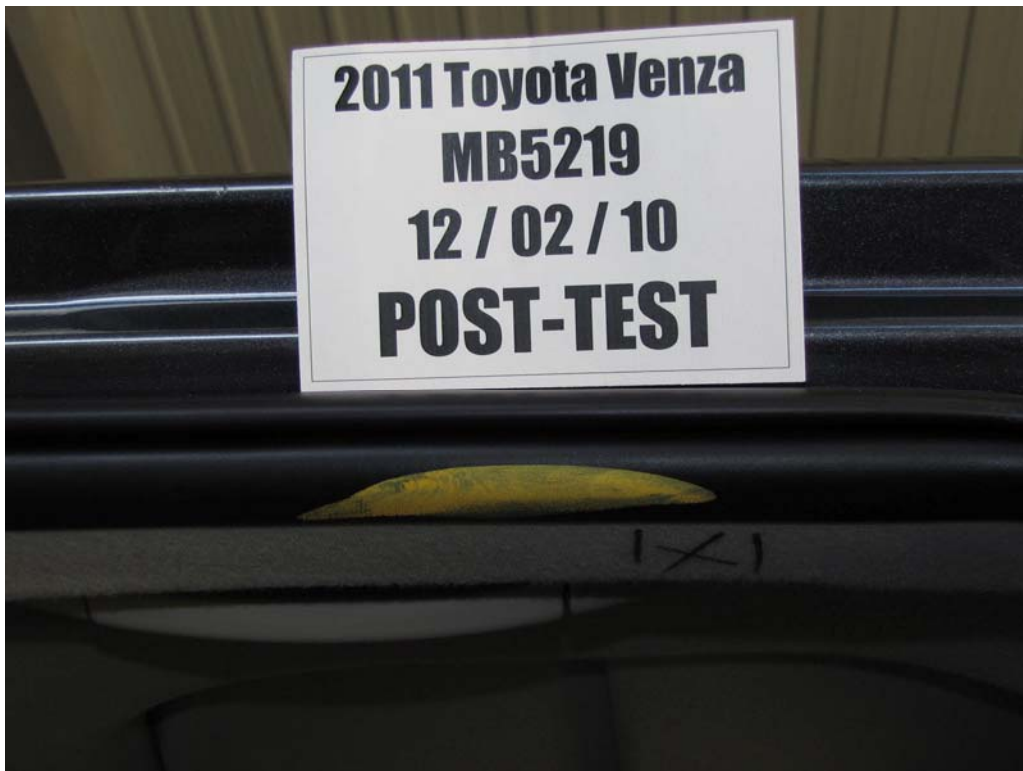
FIGURE 43c. Post-Test Driver Dummy Contact With Side Header

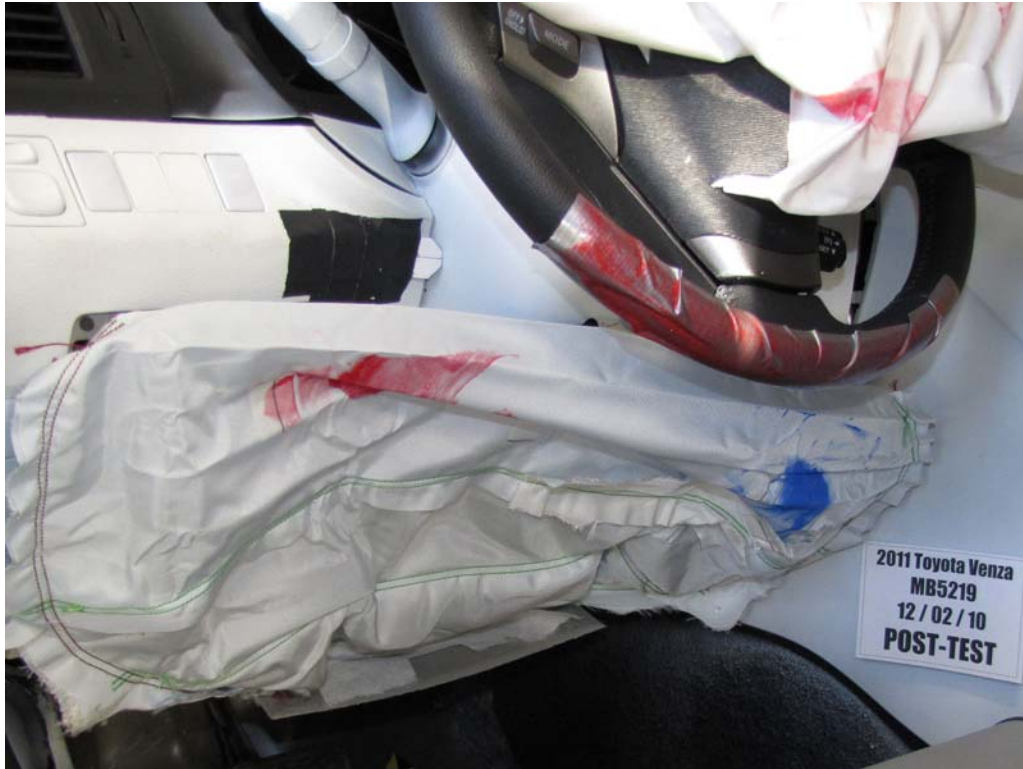
FIGURE 45. Post-Test View of Steering Column Shear Capsule

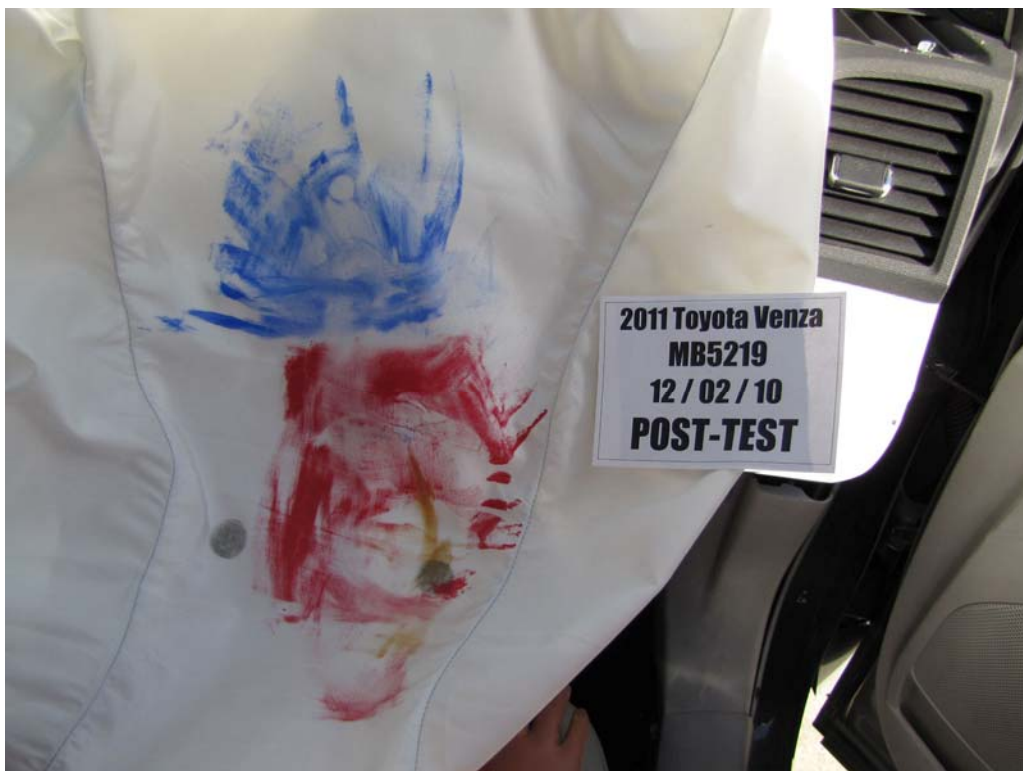
FIGURE 60. Post-Test Passenger Dummy Contact With Airbag

The passenger's visible contact points were as follows: The passenger ATD's head contacted the airbag, sun visor, and head restraint. The upper torso contacted the airbag. Both the left knee and right knee contacted the glovebox.

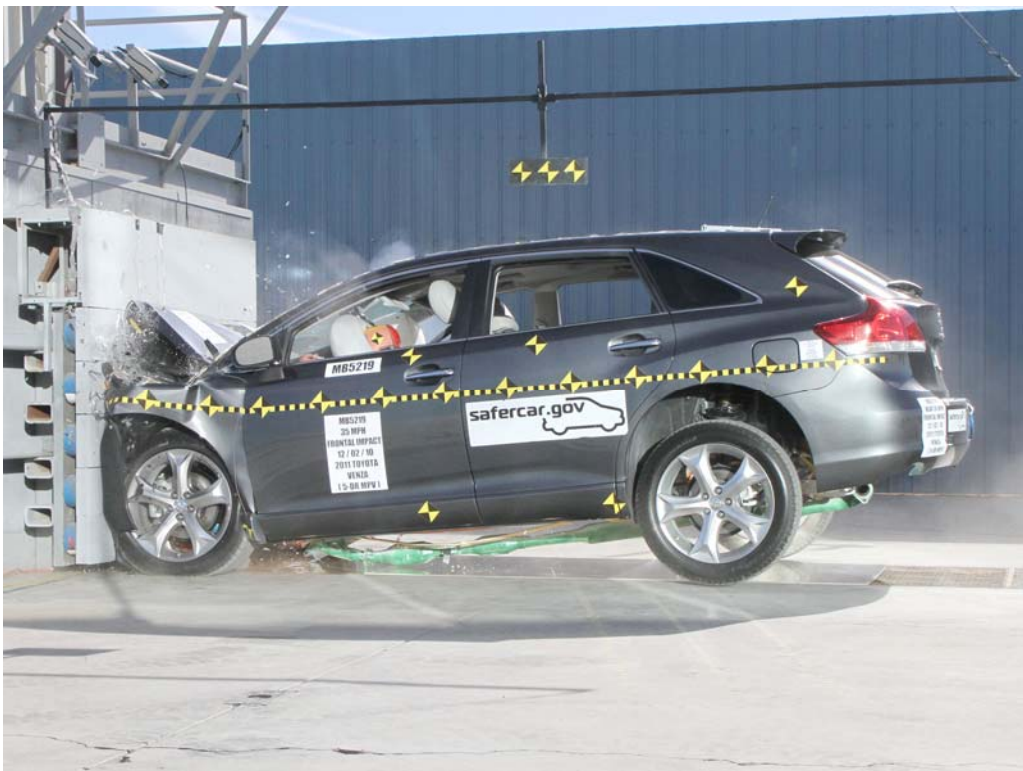
FIGURE 69. 2011 Toyota Venza Frontal Impact Event

A load cell barrier consisting of 36 load cells was impacted by a 2011 Toyota Venza 5-Door MPV at a velocity of 56.21 km/h. The test was performed at KARCO Engineering, LLC. on December 2, 2010. Pre- and post-test photographs of the vehicle and dummies can be found in Appendix A of this report. (Note: the NHTSA Number in the photographs should be MB5129, not MB5219)
