**REPORT NUMBER: SPNCAP-KAR-12-042**

**NEW CAR ASSESSMENT PROGRAM (NCAP)  
SIDE IMPACT POLE TEST**

**NISSAN MOTOR CO., LTD.  
2012 NISSAN VERSA 1.6 SV 4-DOOR SEDAN**

**FINAL REPORT**

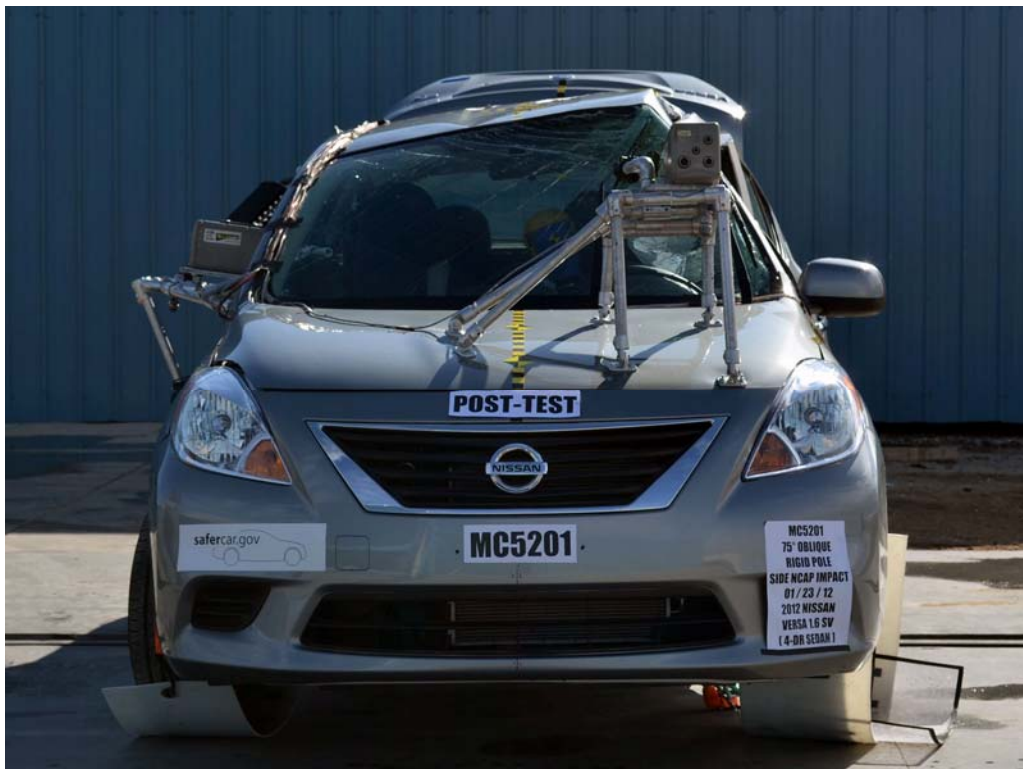
FIGURE 4. Post-Test Frontal View of Test Vehicle

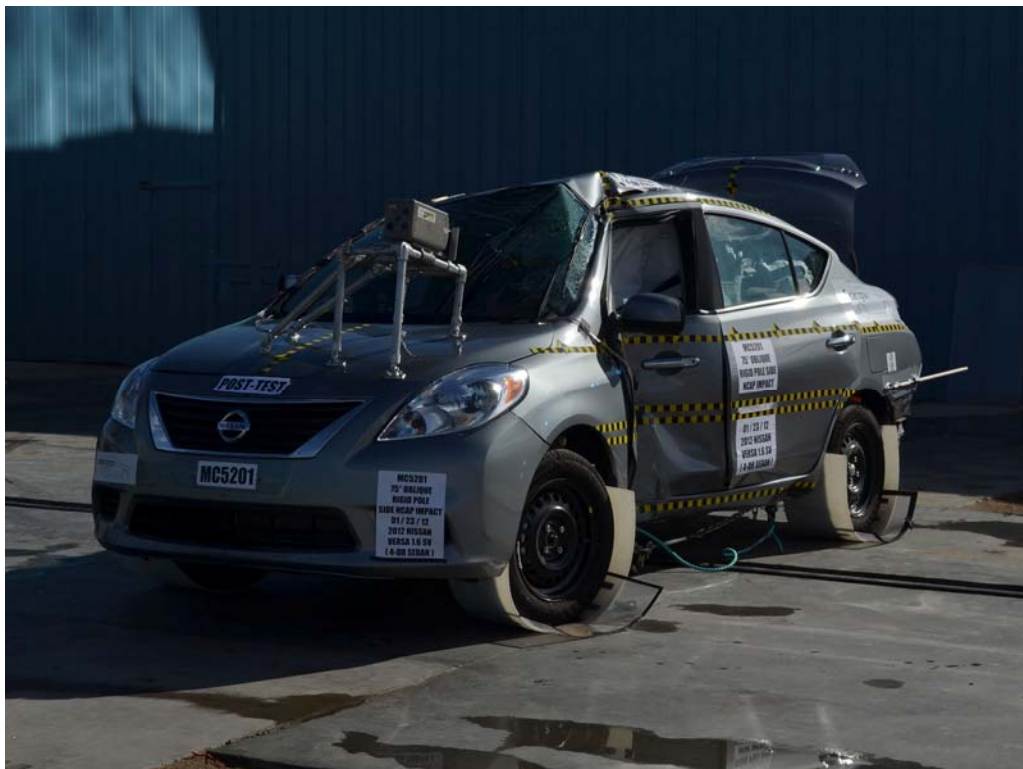
FIGURE 6. Post-Test Left Front Three-Quarter View of Test Vehicle

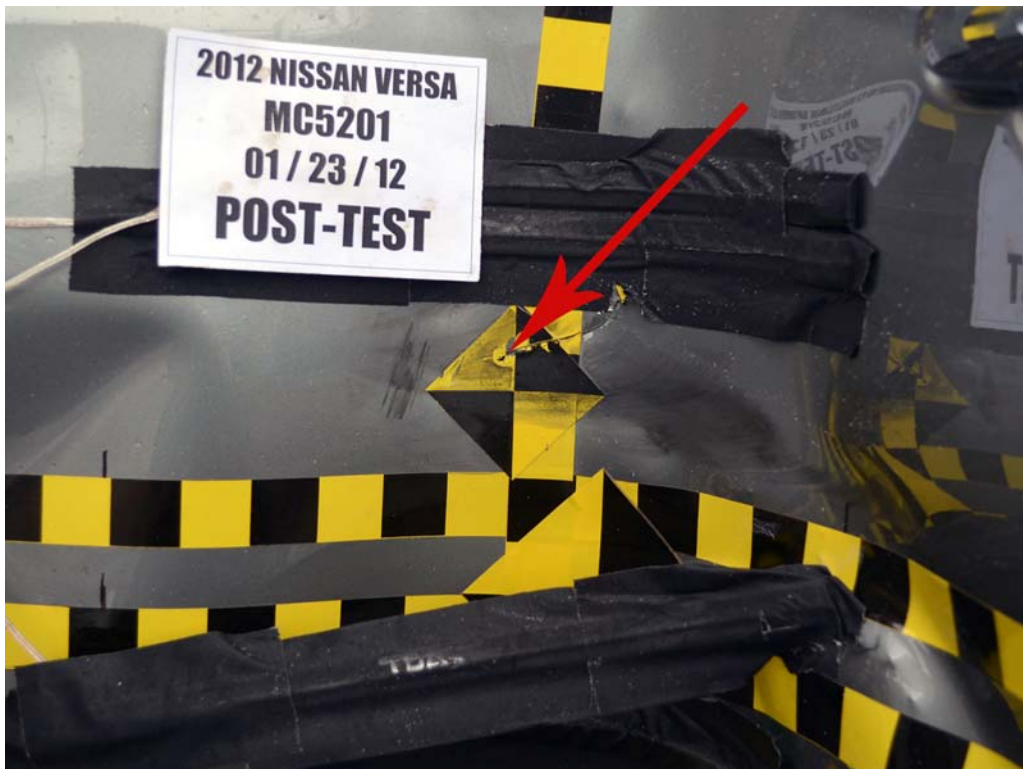
FIGURE 20. Post-Test Close-Up View of Impact Point Target Showing Impact Location

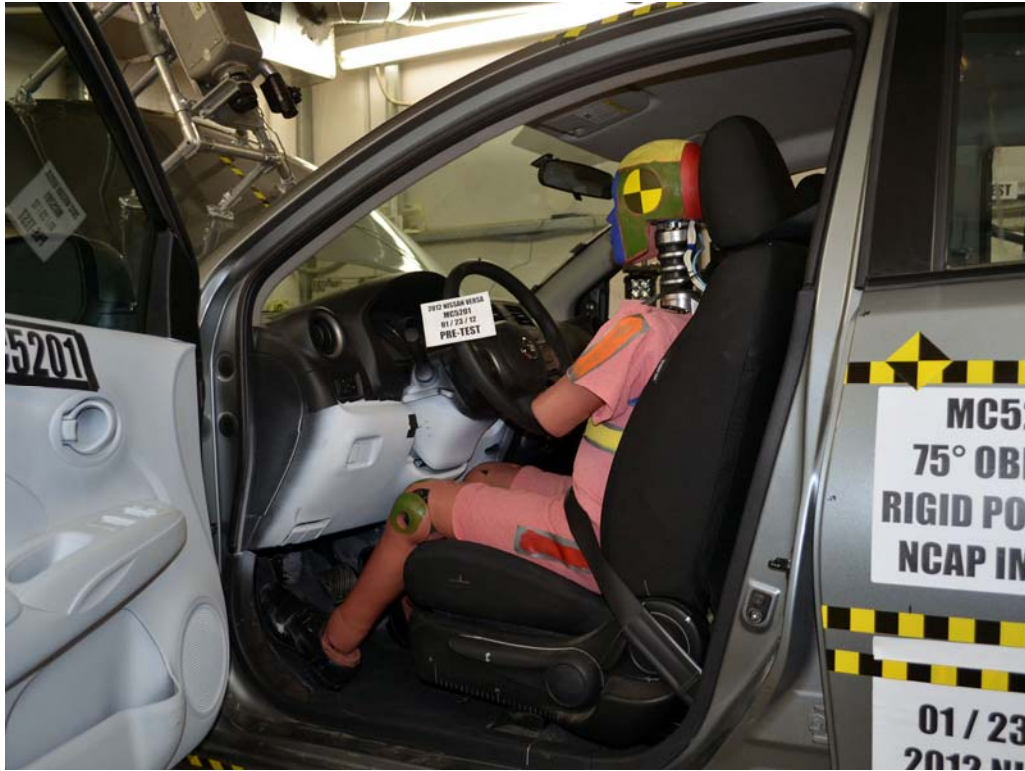
FIGURE 23. Pre-Test Left Side View of Dummy Showing Belt, Chalking, and Contact Switches

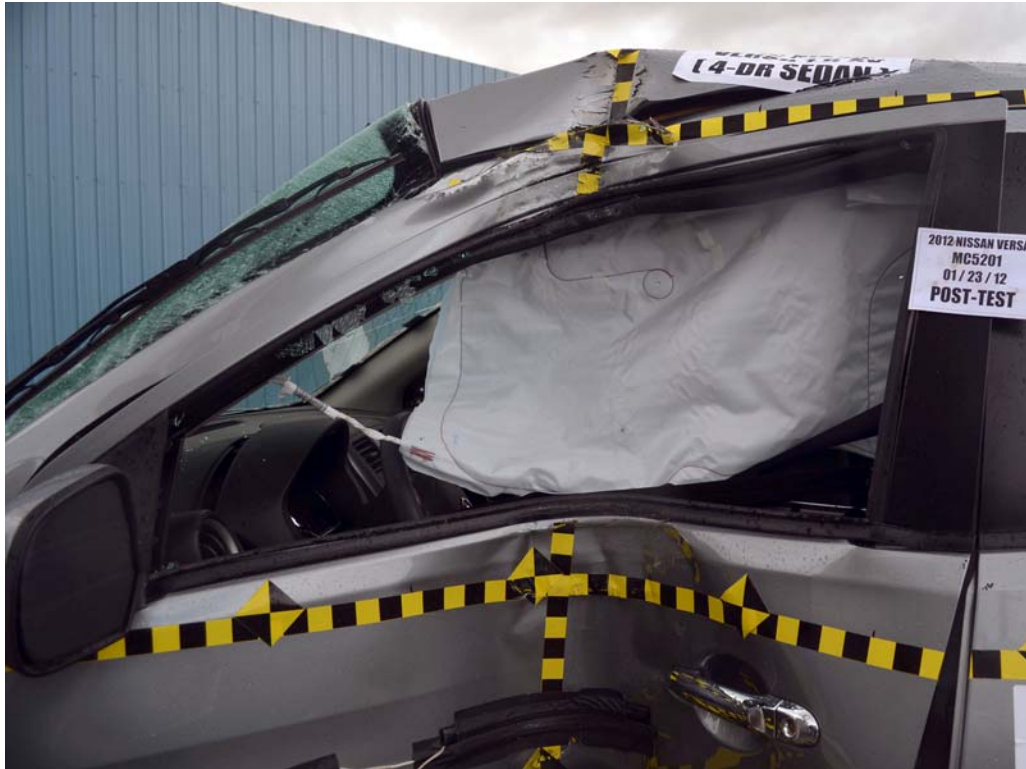
FIGURE 25. Post-Test Left Side View of Dummy Shoulder and Door Top View

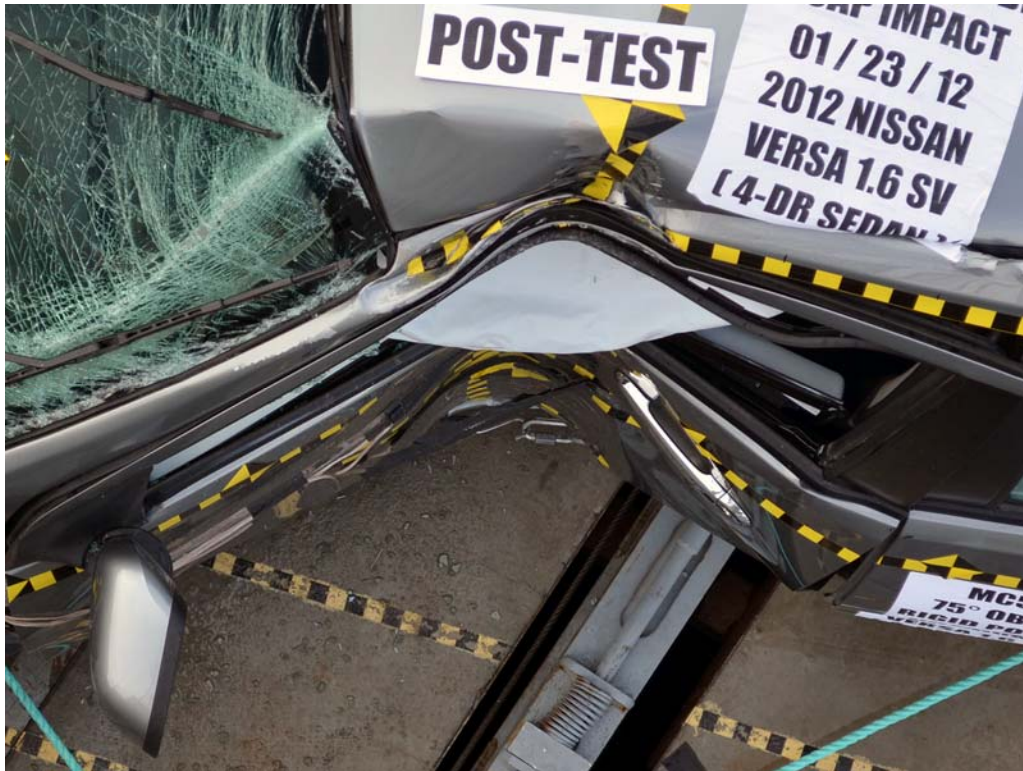
FIGURE 41. Post-Test Driver Dummy and Door Clearance

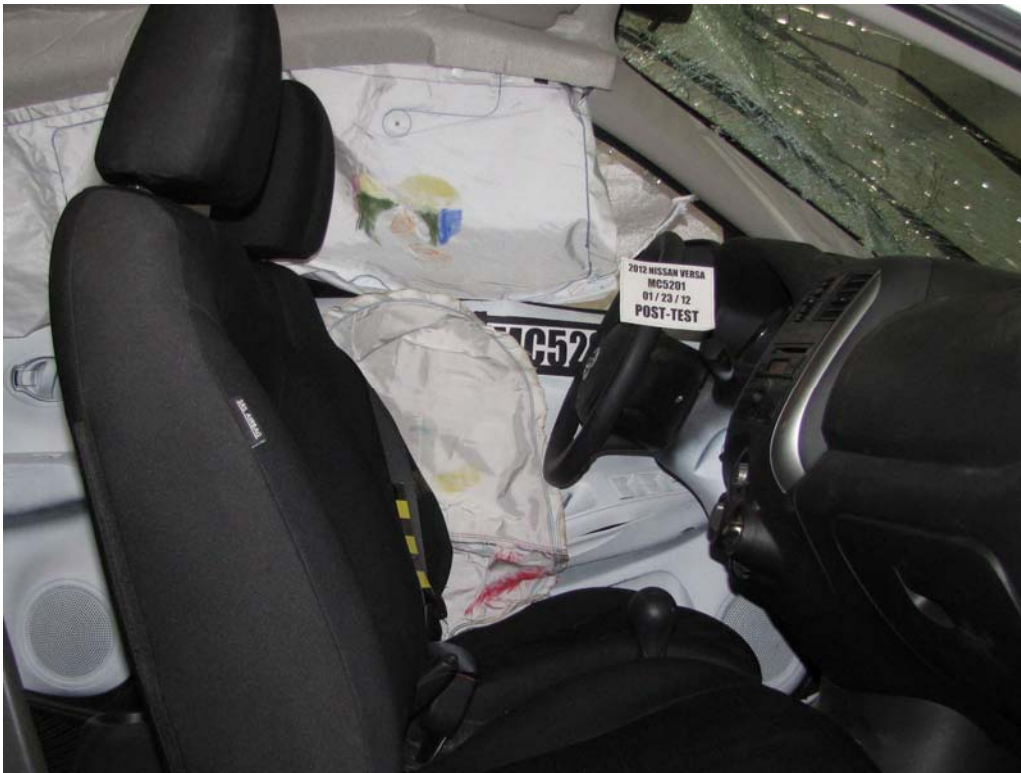
FIGURE 45. Post-Test Inner Driver Door Panel View  
Showing Dummy Contact Locations

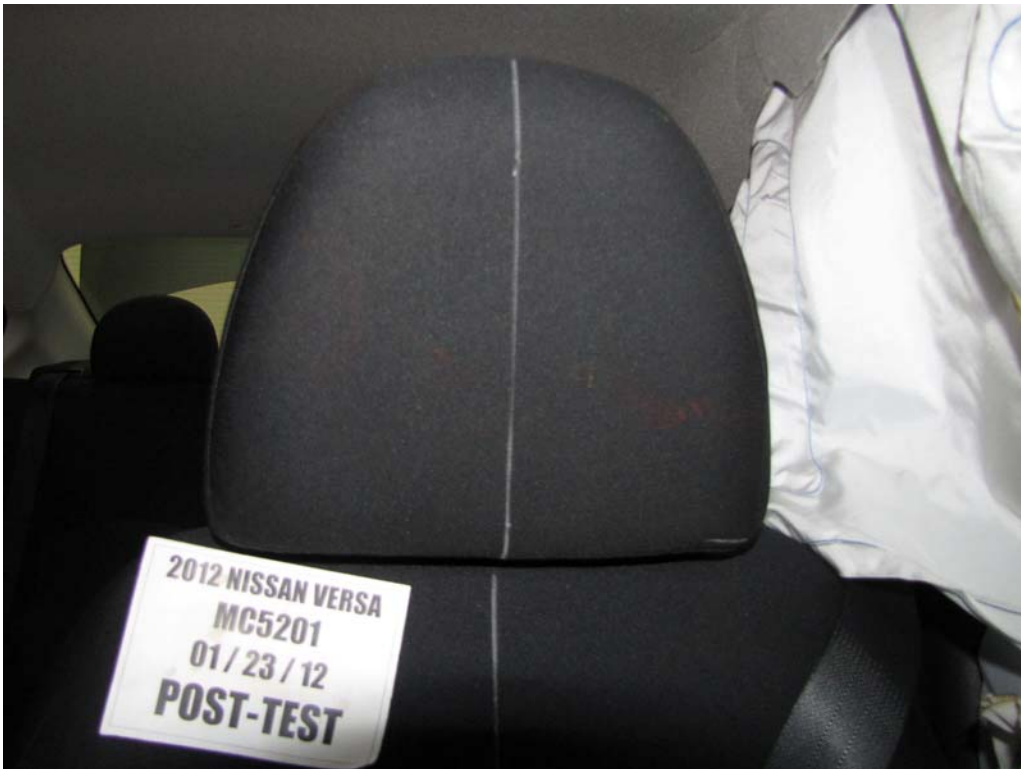
FIGURE 46. Post-Test Dummy Close-Up Head Contact with Vehicle Interior View

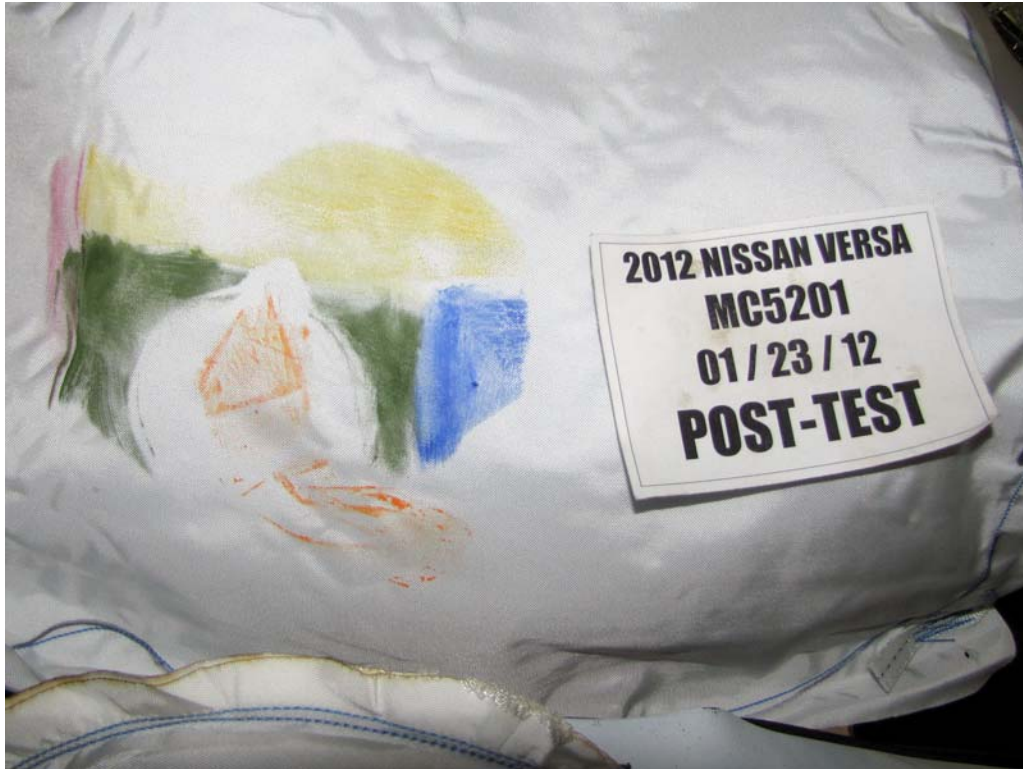
FIGURE 47. Post-Test Dummy Close-Up Head Contact with Side Airbag View

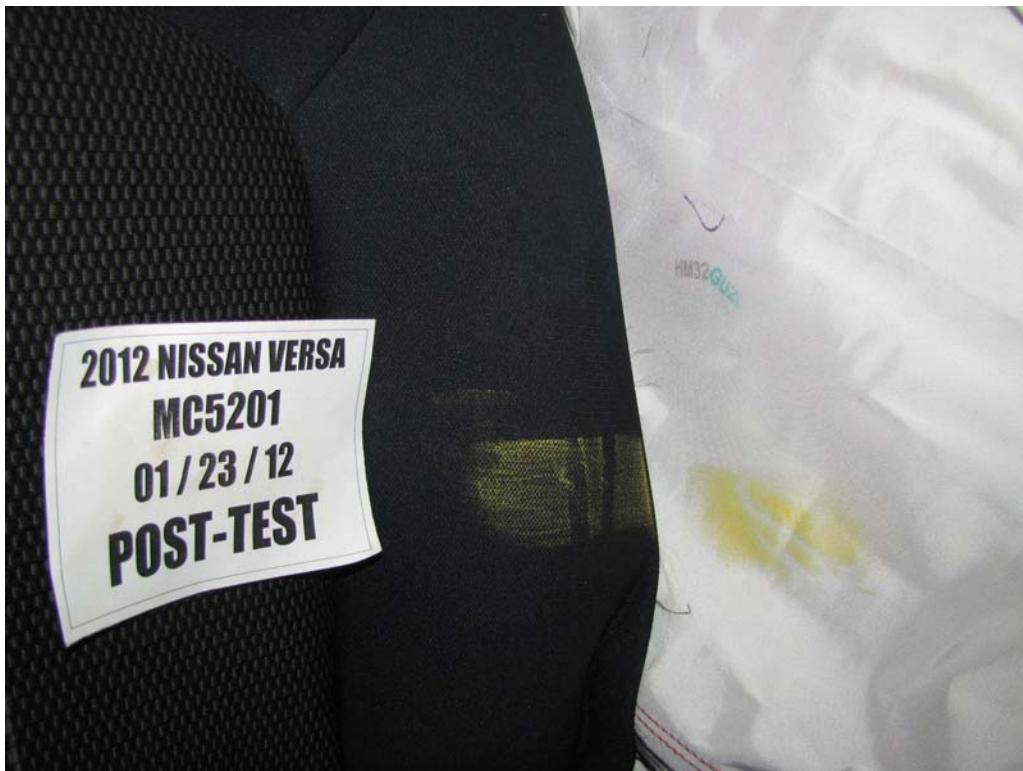
FIGURE 48. Post-Test Dummy Close-Up Torso Contact with Vehicle Interior View

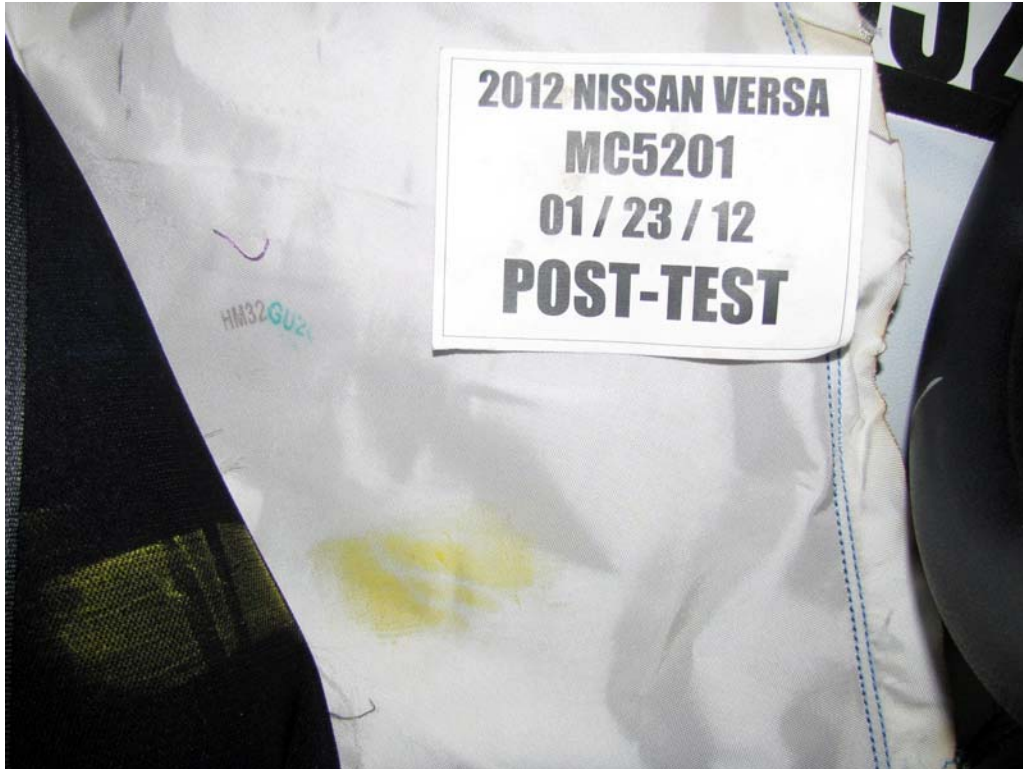
FIGURE 49. Post-Test Dummy Close-Up Torso Contact with Side Airbag View

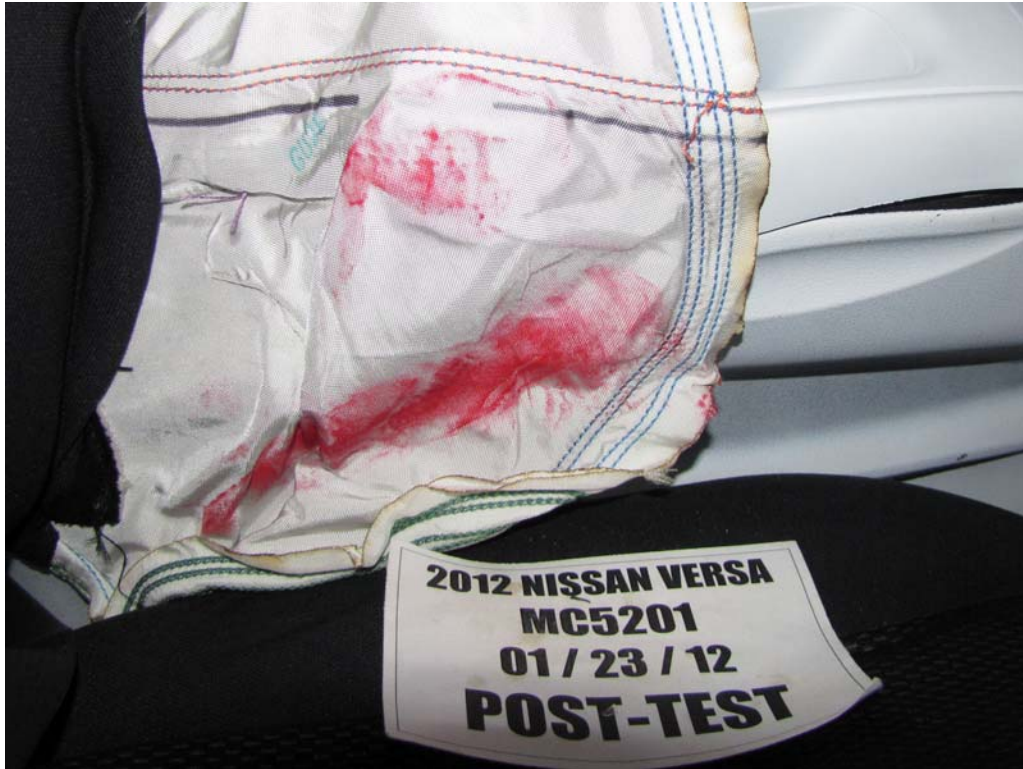
FIGURE 51. Post-Test Dummy Close-Up Pelvis Contact with Side Airbag View

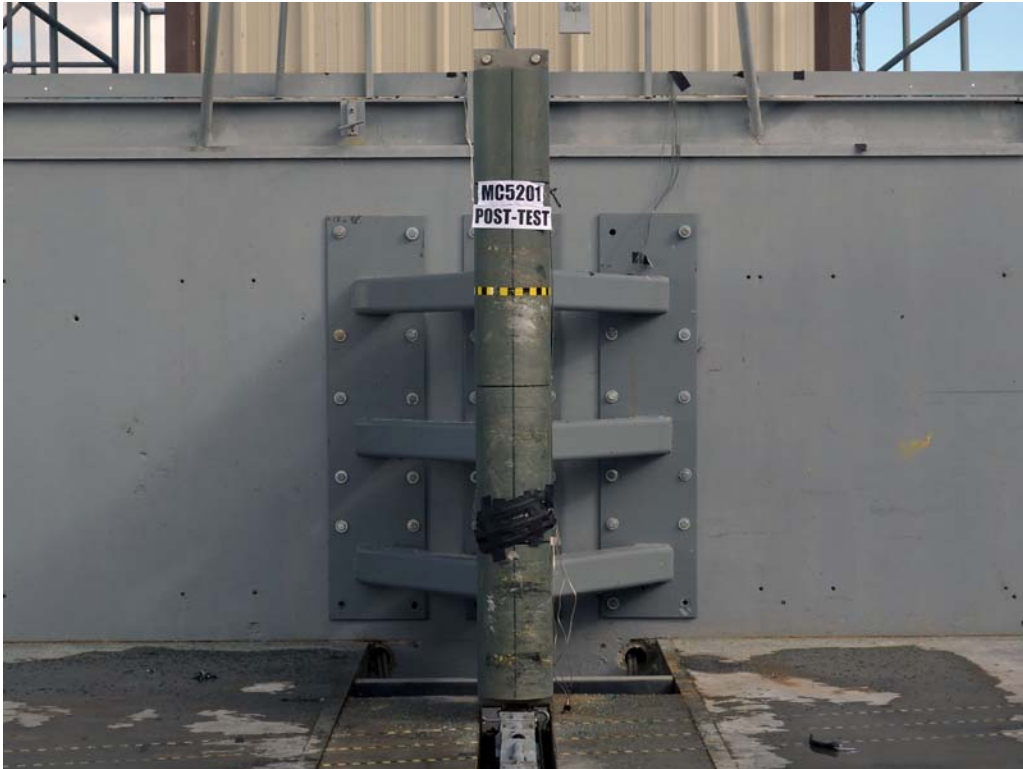
FIGURE 57. Post-Test Pole Barrier Front View

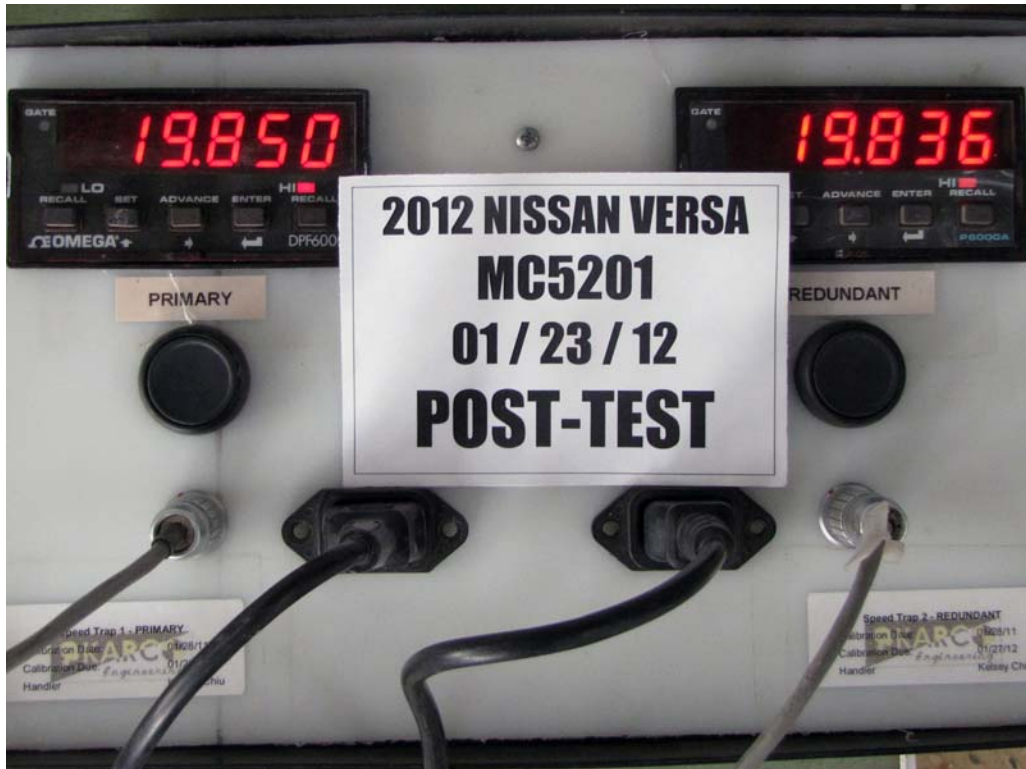
FIGURE 61. Post-Test Primary and Redundant Speed Trap Read-Out

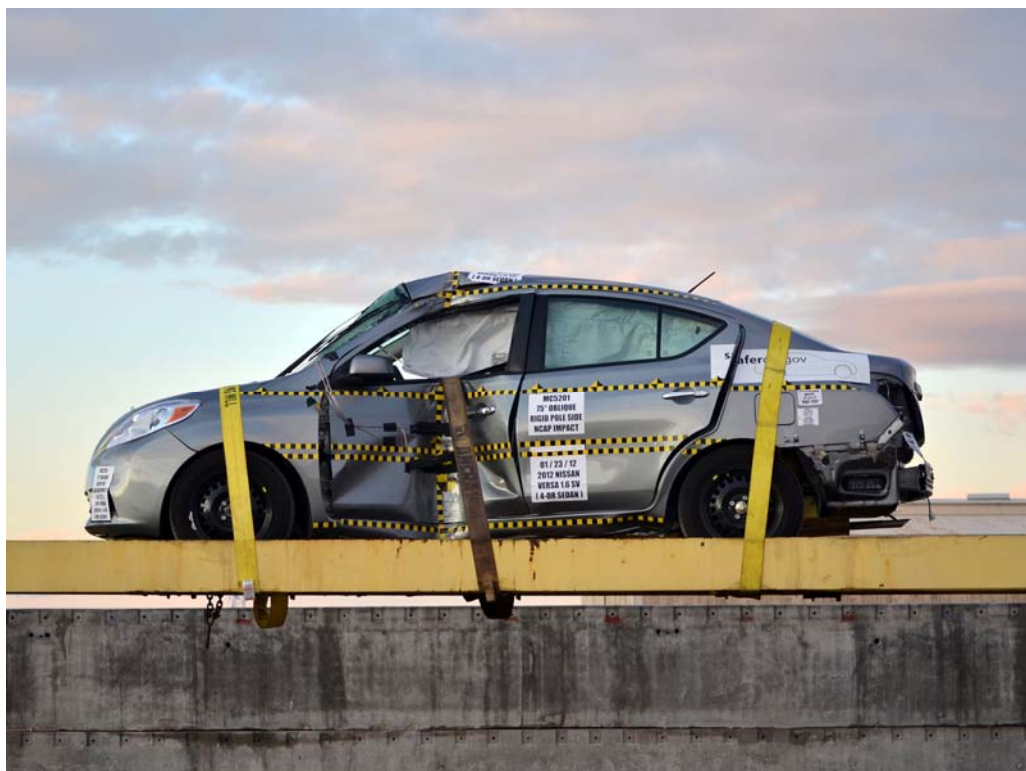
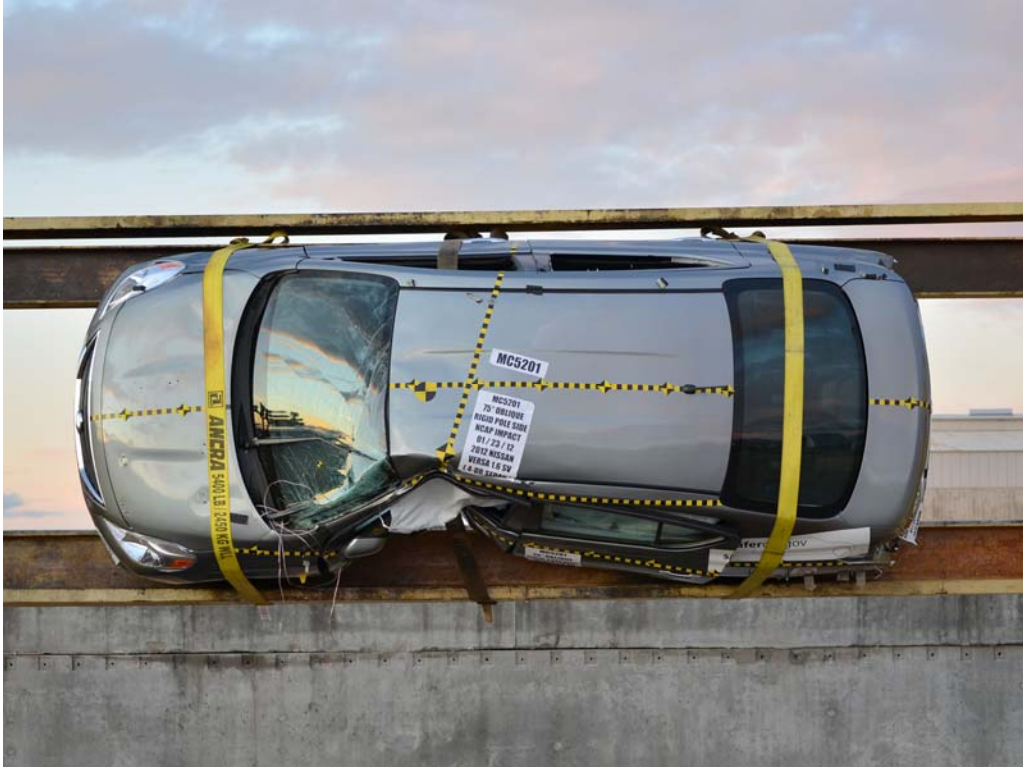
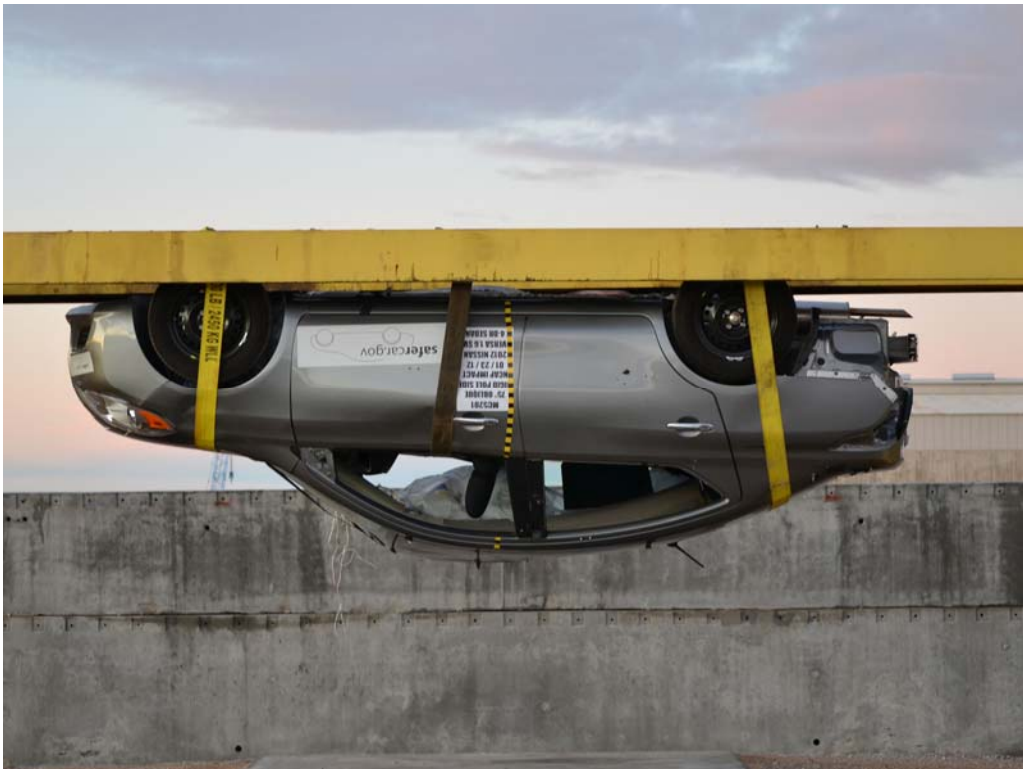
FIGURE 62. FMVSS No. 301-305 Rollover 0 Degrees

FIGURE 63. FMVSS No. 301-305 Rollover 90 Degrees

FIGURE 64. FMVSS No. 301-305 Rollover 180 Degrees

FIGURE 65. FMVSS No. 301-305 Rollover 270 Degrees

FIGURE 66. FMVSS No. 301-305 Rollover 360 Degrees

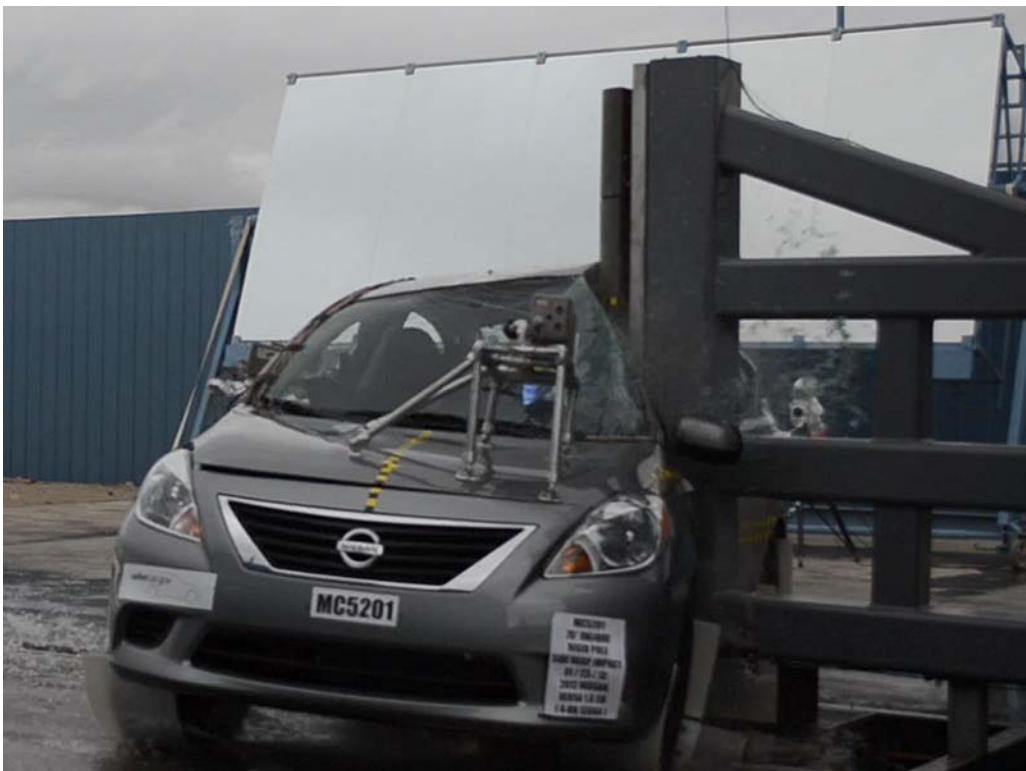
FIGURE 67. Impact Event

A rigid pole side impact test was conducted on a 2012 Nissan Versa 1.6 SV 4-door sedan. The subject vehicle was towed into the rigid pole at an angle of 74.5° and a velocity of 32.0 km/h. The test was conducted by KARCO Engineering, LLC. in Adelanto, California on January 23, 2012. Pre- and post-test photographs of the test vehicle and side impact dummy (SID-IIs) are included in Appendix A of this report.
