**Vehicle Research and Test Center  
Oblique Side Pole Impact  
WorldSID  
2010 Acura MDX  
TRC Inc. Test Number 110630**

**Prepared By:  
Transportation Research Center Inc.  
10820 State Route 347  
P. O. Box B-67  
East Liberty, OH 43319**

**Final Report  
June 2011 - January 2012**

**TRC TEST NUMBER: 110630**

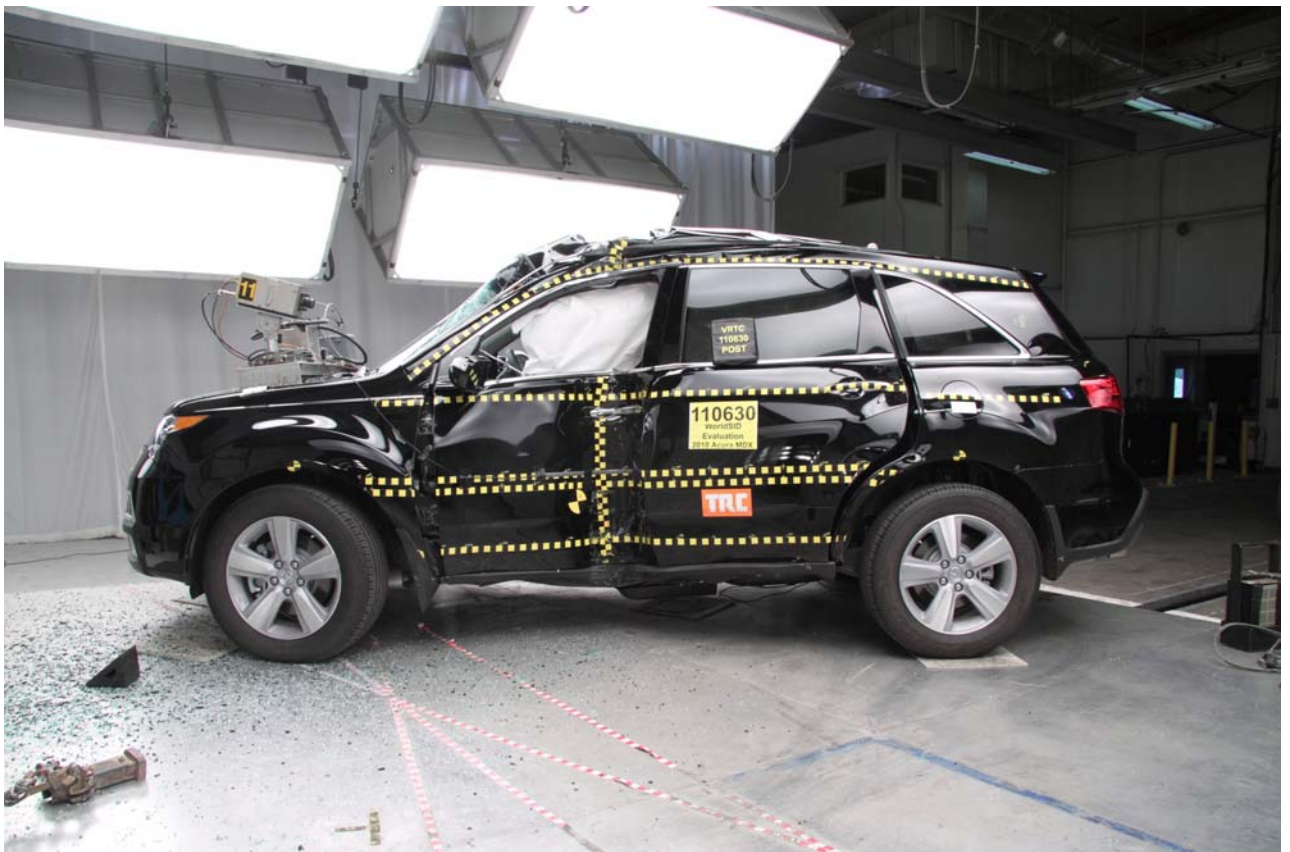
**Figure A-8 Post-Test Left Side View**

| Critical Areas of Performance | Observations and Conclusions |
|---|---|
| Window Damage | Driver's side window shattered |

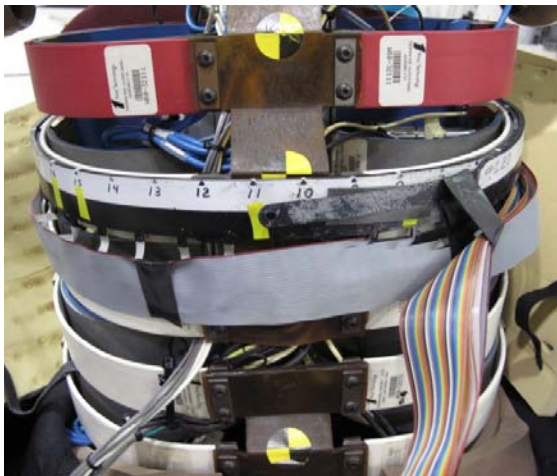
**Figure 1. Front of dummy showing chest band location**

One 40-channel chest band was installed directly on the rib denoted in the table using double-sided foam tape to ensure that the band followed the rib's motion (Figures 1 and 2). The band was used in this test to determine the shape of the rib contour throughout the crash event. Pertinent information regarding the location of the band on the dummy (Table 1) may be used for processing the chest band data in RBandPC or CrashStar software. In addition to the chest band, an aluminum block with 3 linear accelerometers and 3 angular rate sensors (Figure 3) was installed at the top of the front of the spine box beneath the sternum bib in order to track the motion of the spine box in 3D. FARO data locating three points on the chest band prior to the dummy being in pre-test seated ready position are included in Table 1. However, FARO data locating the block with the accelerometers and angular rate sensors is not available. Table 1 and Figure 4 show results from processing the chest band data using CrashStar. Due to the shape of the rib contour resulting from the soft, flexible sternum combined with the loading during the crash event, maximum deflection (determined using forced angle method by Pintar et al., 2009) occurred at the sternum. In order to determine the maximum deflection in the region of loading, maximum deflection was limited to those gages to the left of the sternum-spine line (Table 1, Figure 4). Information related to the chest band or motion block used in this test may be directed to [heather.rhule@dot.gov](mailto:heather.rhule@dot.gov).

| Distance from sternum | -12.7 mm (see Figure 1) | | |

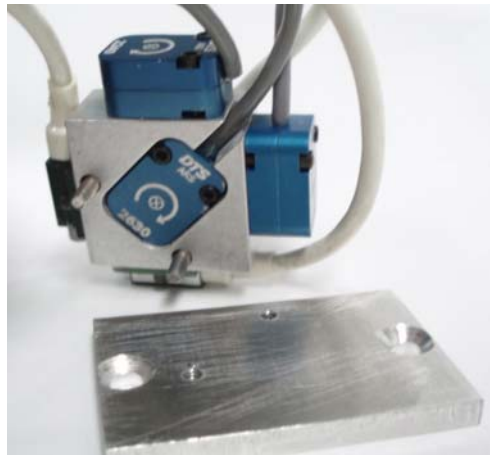
**Figure 3. Aluminum block with 3 linear accelerometers and 3 angular rate sensors installed. Block was mounted to plate shown and secured to dummy front spine box at the top**
