**REPORT NUMBER TR-P32011-04-NC**

**SIDE AIRBAG OCCUPANT RISK PROGRAM  
OCCUPANT OUT-OF-POSITION TESTS**

**HONDA OF AMERICA MFG, INC.  
2012 ACURA TL SH-AWD  
4-DOOR SEDAN**

**NHTSA NUMBER: MC5313TWG2**

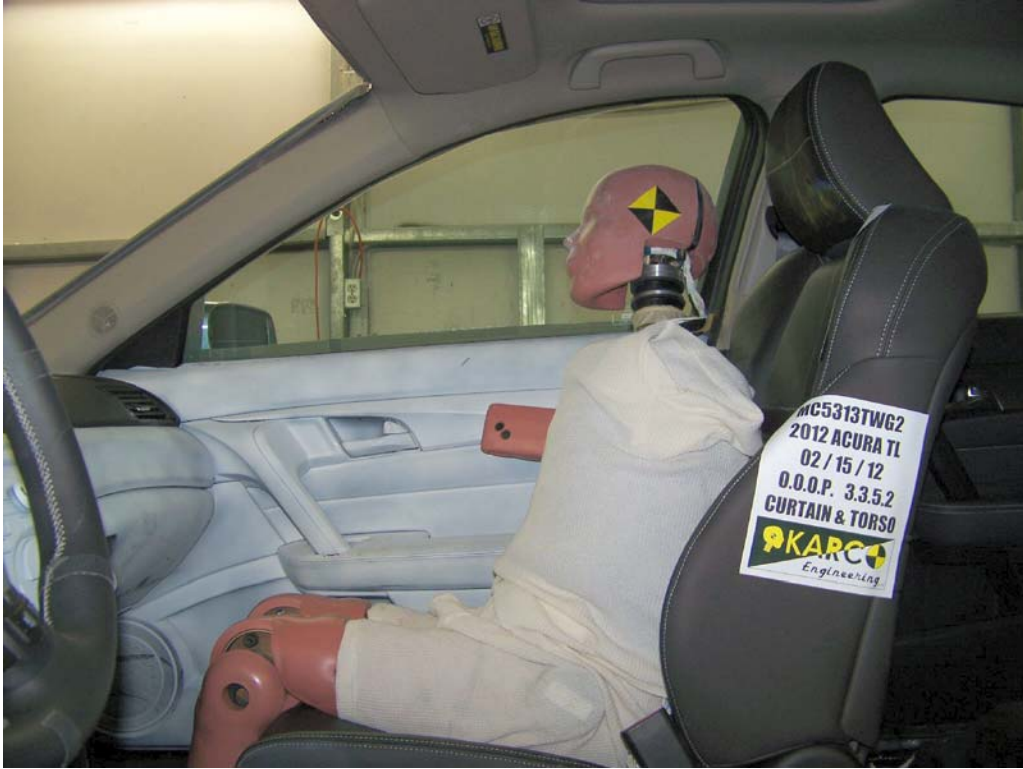
FIGURE 7. Pre-Test Dummy Position, Left Side View

Orientation of the SID IIs 5<sup>th</sup> percentile adult female dummy was in the forward facing position leaning against the front passenger door. The dummy's head centerline was aligned with the deploying trajectory of the curtain airbag. This orientation complies with section 3.3.5.2 of the Technical Working Group (TWG) recommendation in the Recommended Procedures for Evaluating Occupant Injury Risk from Deploying Side Airbags.

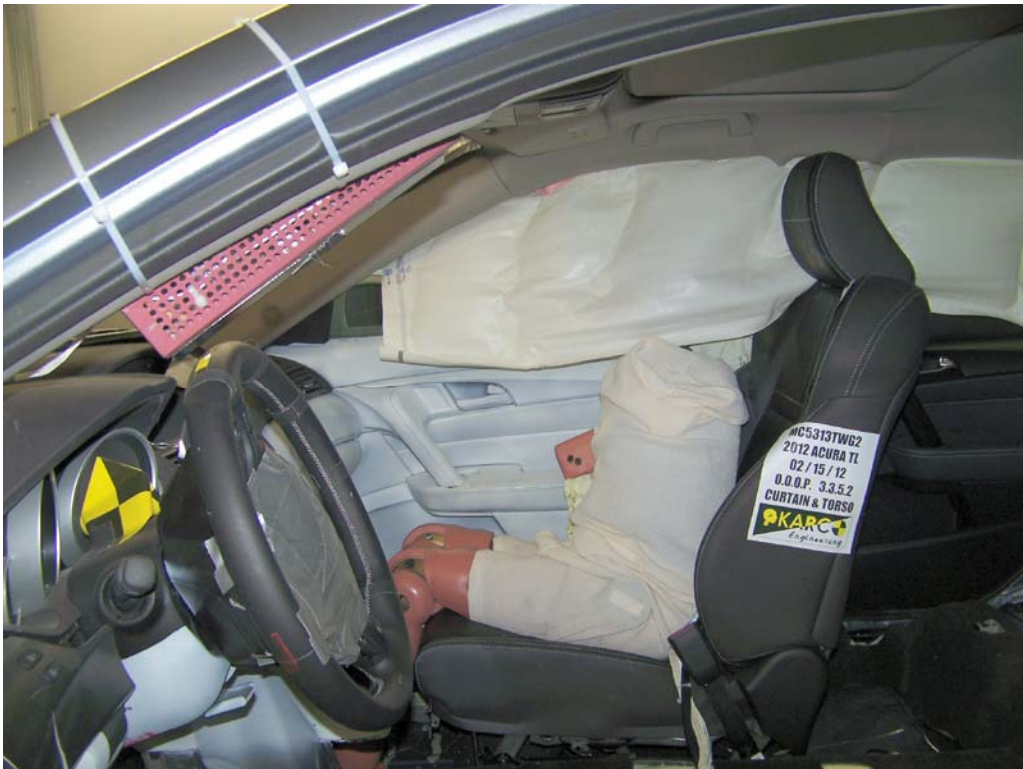
FIGURE 8. Post-Test Dummy Position, Left Side View

The SID IIs 5<sup>th</sup> percentile adult female dummy's visible contact points were as follows: The curtain airbag contacted the ATD's head and the torso airbag contacted the ATD's back.

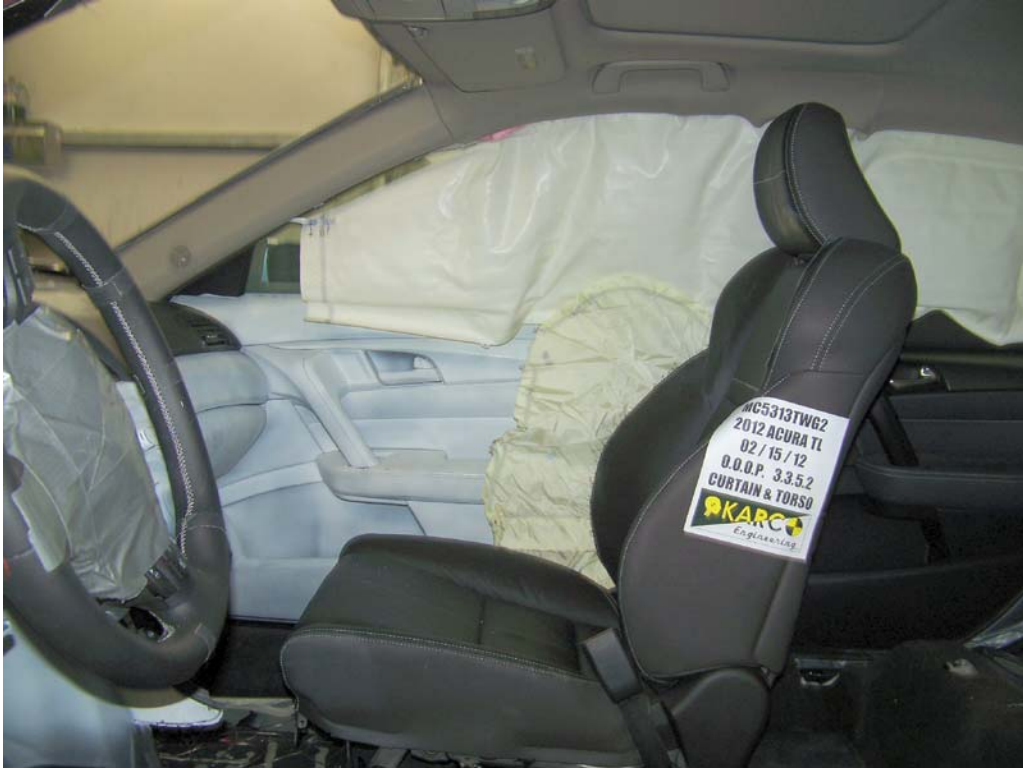
FIGURE 13. Post-Test Airbags, Left Side View

The front passenger side door remained closed during the deployment and was operable after the deployment.
