**REPORT NUMBER TR-P32011-09-NC**

**SIDE AIRBAG OCCUPANT RISK PROGRAM  
OCCUPANT OUT-OF-POSITION TESTS**

**TOYOTA MOTOR CORPORATION  
2012 SCION IQ  
3-DOOR HATCHBACK**

**NHTSA NUMBER: MC5119TWG2**

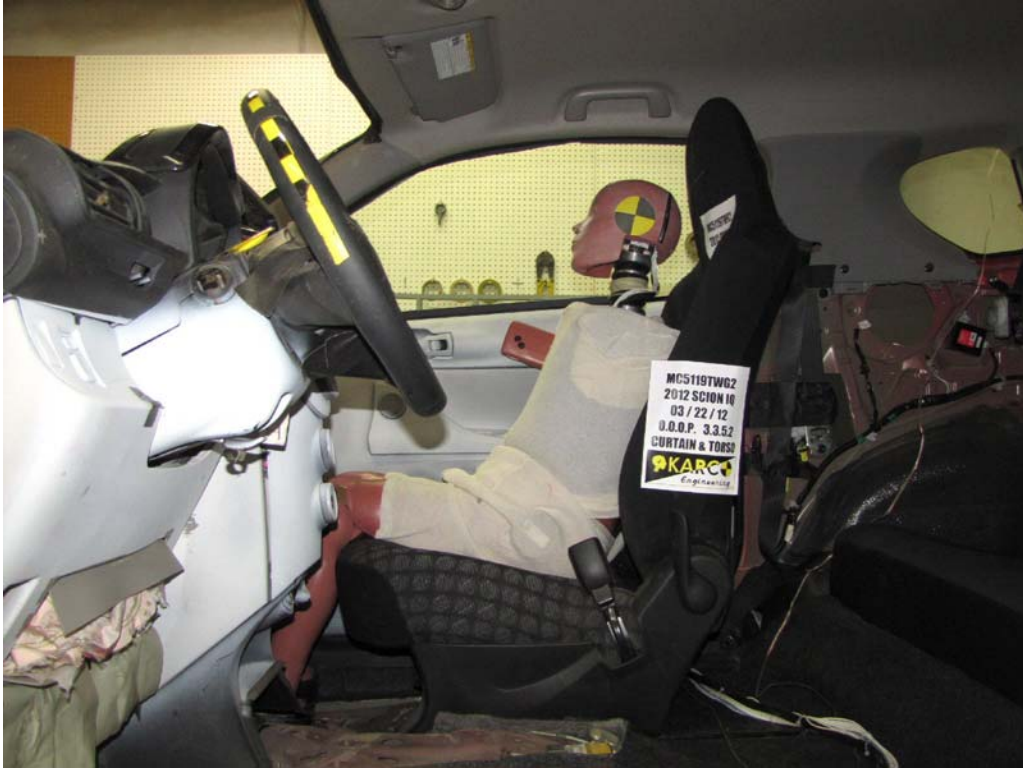
FIGURE 7. Pre-Test Dummy Position, Left Side View

Orientation of the SID IIs 5<sup>th</sup> percentile adult female dummy was in the forward facing position leaning against the front passenger door. The dummy's head centerline was aligned with the deploying trajectory of the curtain airbag. This orientation complies with section 3.3.5.2 of the Technical Working Group (TWG) recommendation in the Recommended Procedures for Evaluating Occupant Injury Risk from Deploying Side Airbags.

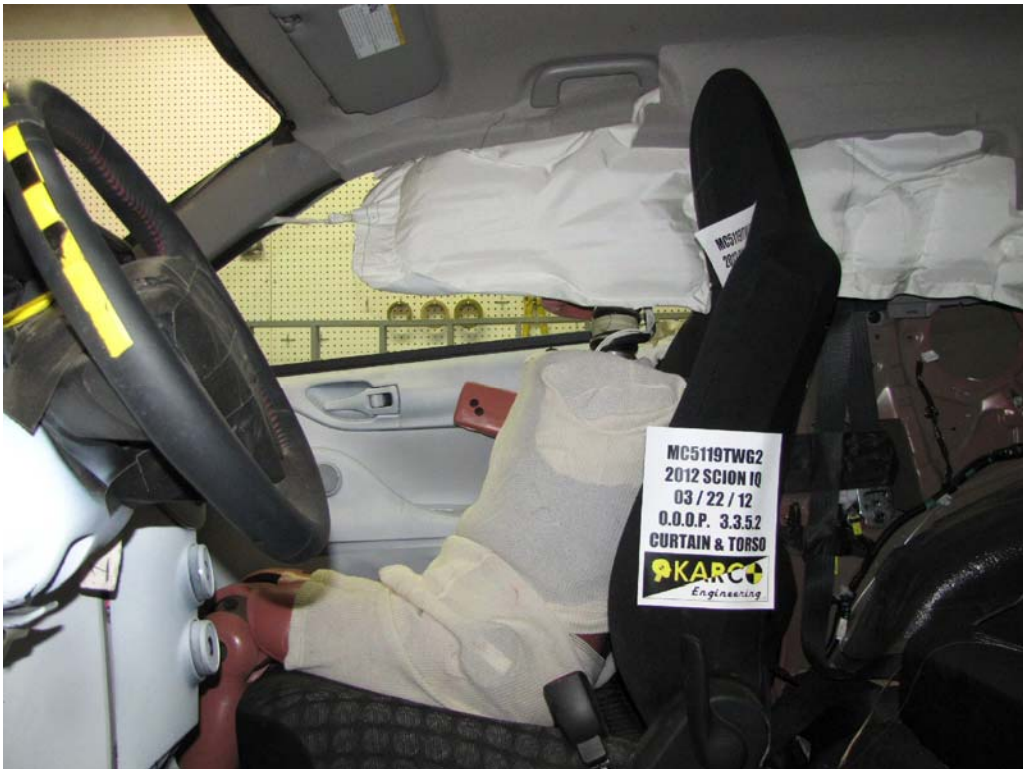
FIGURE 8. Post-Test Dummy Position, Left Side View

The SID IIs 5<sup>th</sup> percentile adult female dummy's visible contact points were as follows: The curtain airbag contacted the ATD's head and the torso airbag contacted the ATD's back.
