**REPORT NUMBER TR-P33007-05-NC**

**SIDE AIRBAG OCCUPANT RISK PROGRAM  
OCCUPANT OUT-OF-POSITION TESTS**

**VOLKSWAGEN DE MEXICO S.A. DE C.V.  
2013 VOLKSWAGEN BEETLE  
2-DOOR COUPE**

**NHTSA NUMBER: MD5801TWG2**

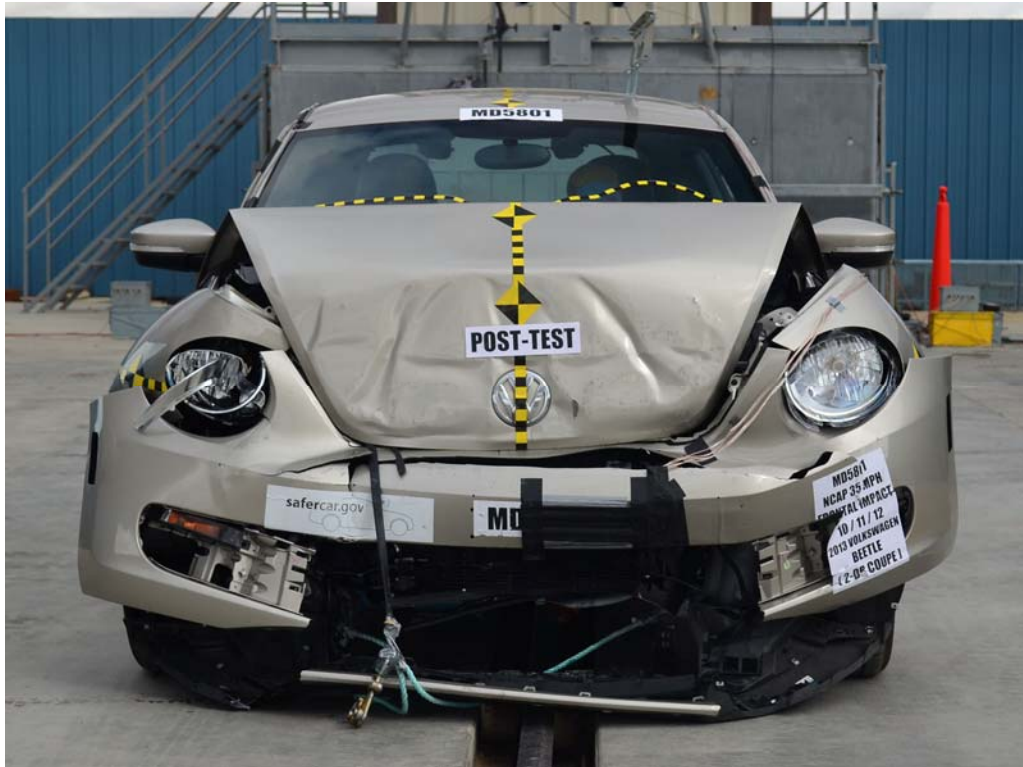
FIGURE 3. Post-Test Front View of NCAP Frontal Impact Test

\* Vehicle underwent New Car Assessment Program Frontal Impact Testing on October 12, 2012

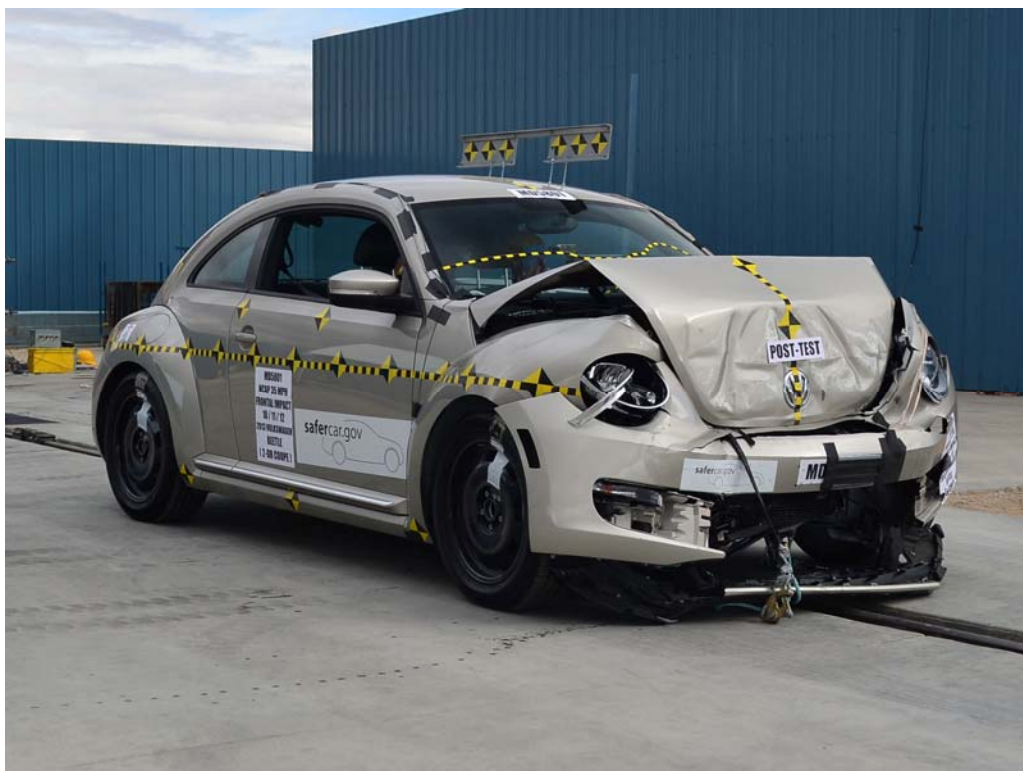
FIGURE 4. Post-Test Right Front 3/4 View of NCAP Frontal Impact Test

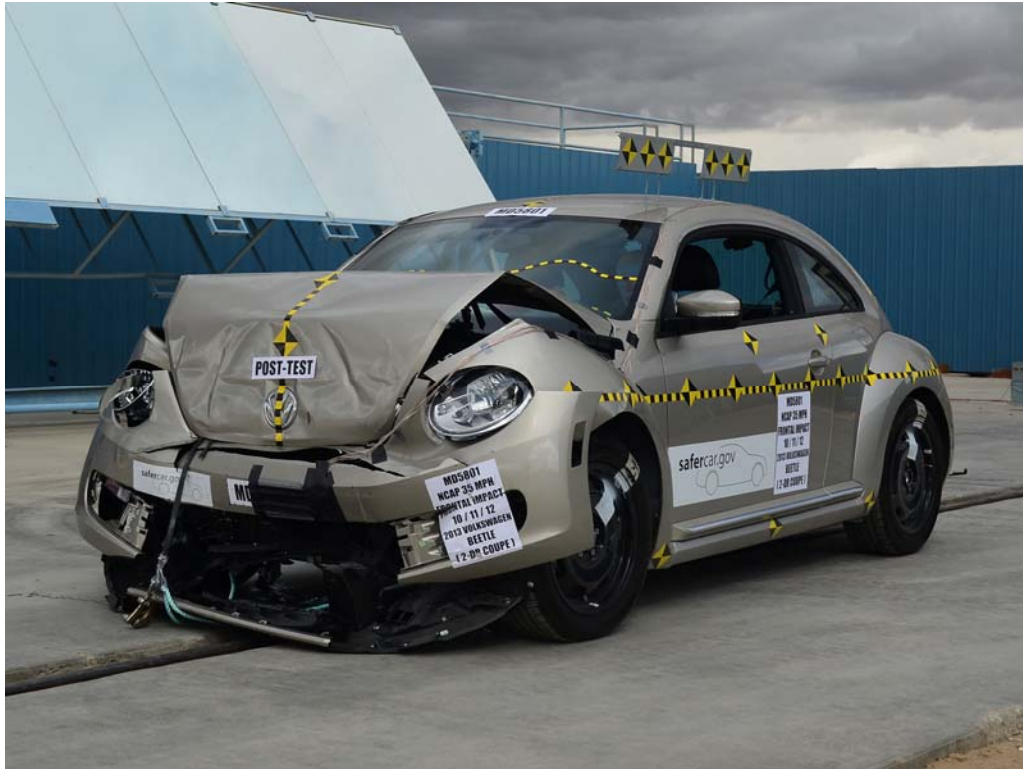
FIGURE 5. Post-Test Left Front  $\frac{3}{4}$  View of NCAP Frontal Impact Test

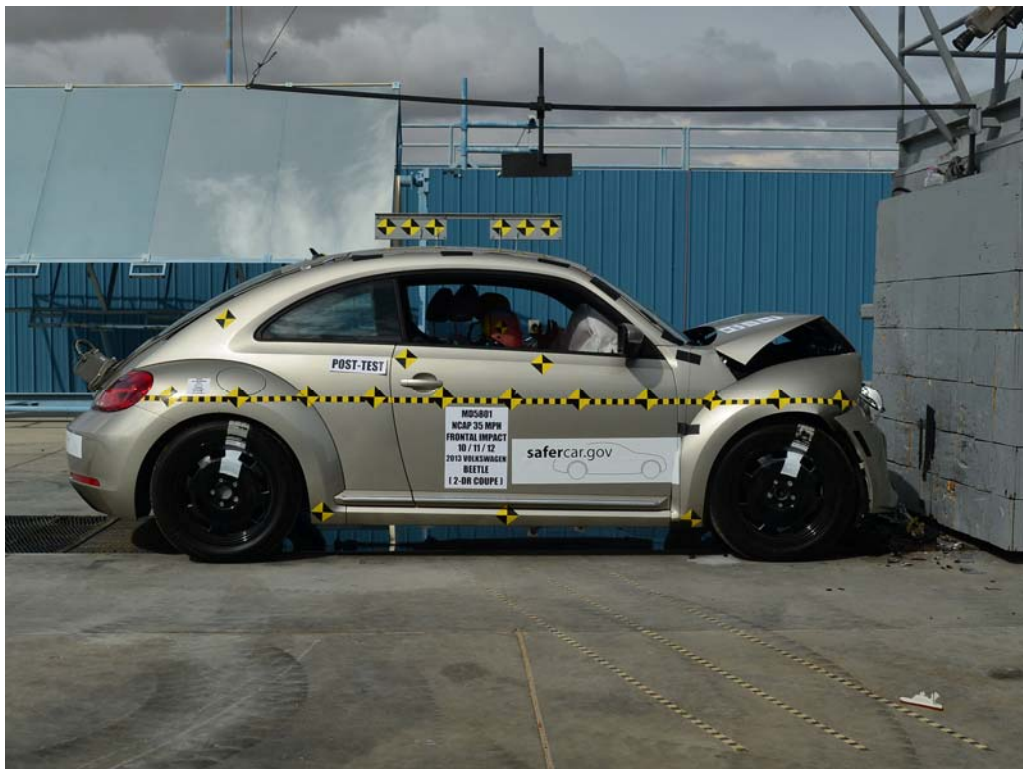
FIGURE 6. Post-Test Right Side View of NCAP Frontal Impact Test

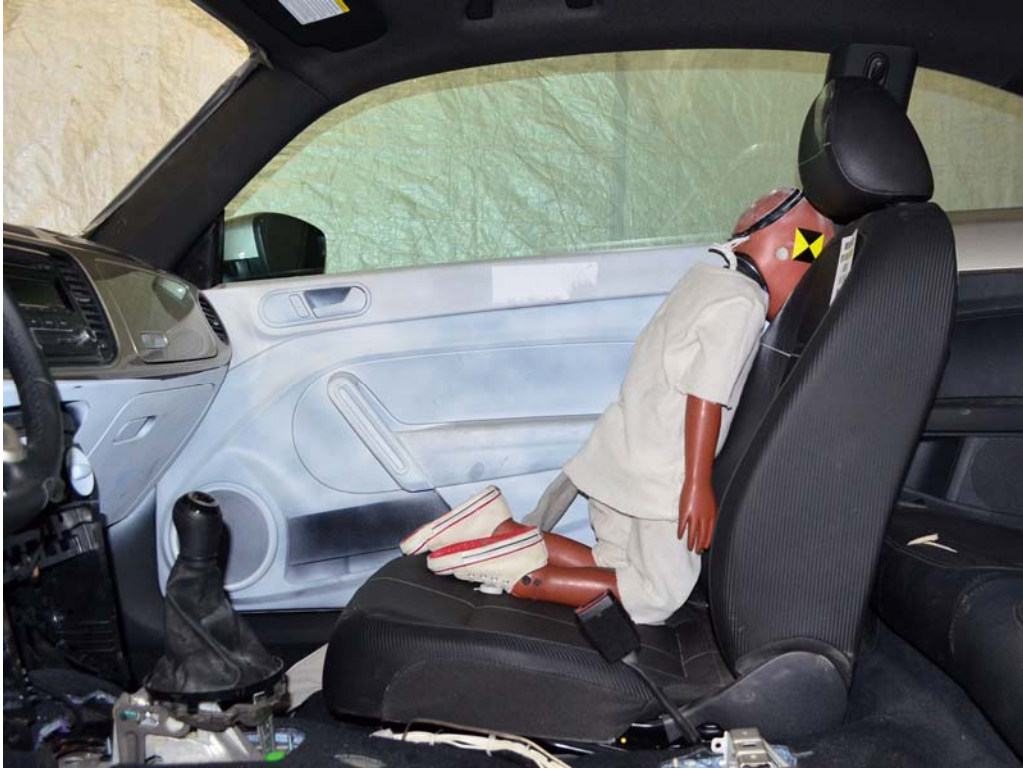
FIGURE 7. Pre-Test Dummy Position, Left Side View

Orientation of the 3 year old dummy was in the rearward facing position leaning against the seat. The dummy's upper sternum was aligned with the deploying trajectory of the airbag. This orientation complies with section 3.3.3.2 of the Technical Working Group (TWG) recommendation in the Recommended Procedures for Evaluating Occupant Injury Risk from Deploying Side Airbags.

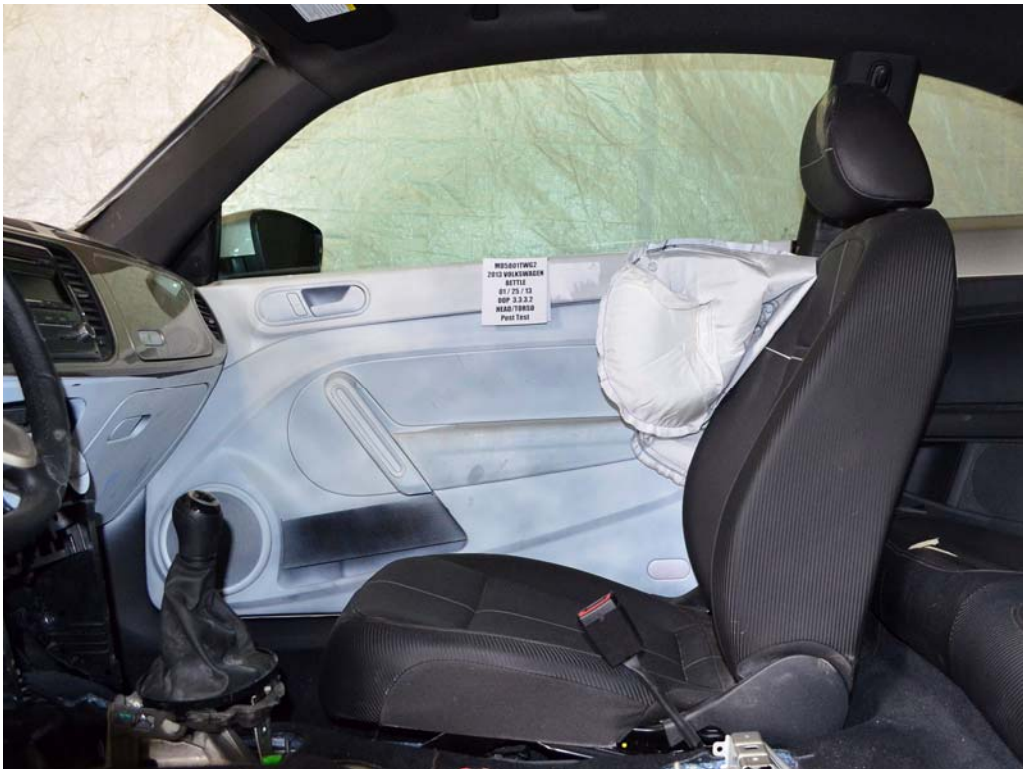
FIGURE 8. Post-Test Dummy Position, Left Side View

The 3 year old dummy's visible contact points were as follows: The head/torso airbag contacted the ATD's head, abdomen, pelvis and legs.

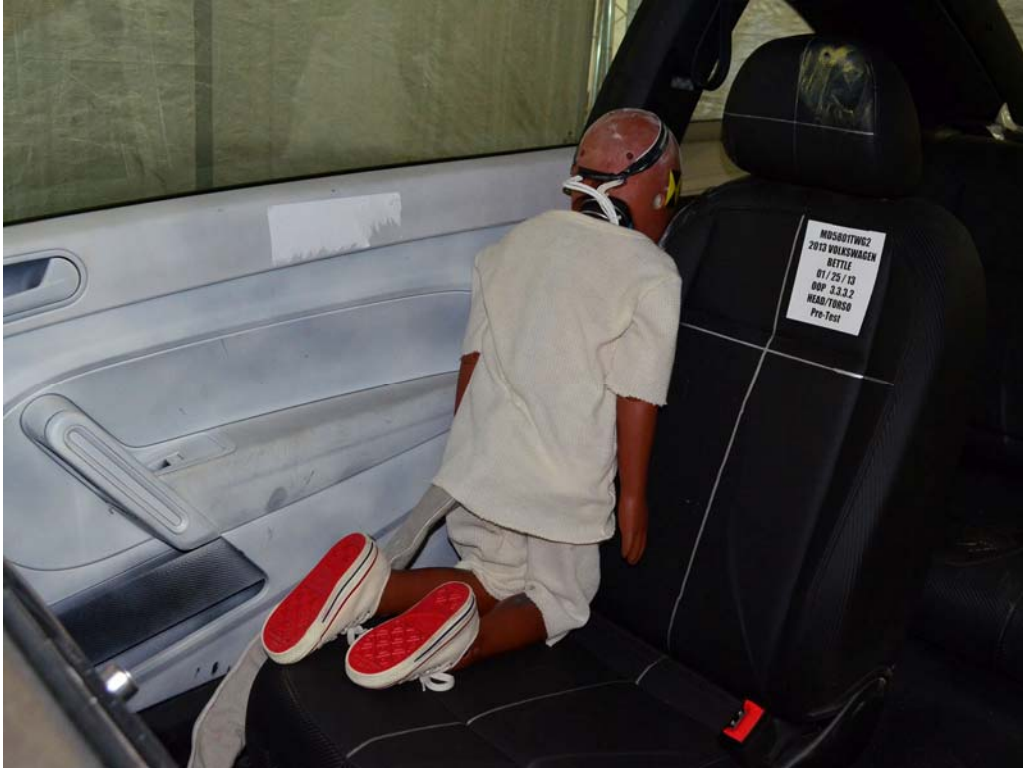
FIGURE 9. Pre-Test Dummy Position, 3/4 View

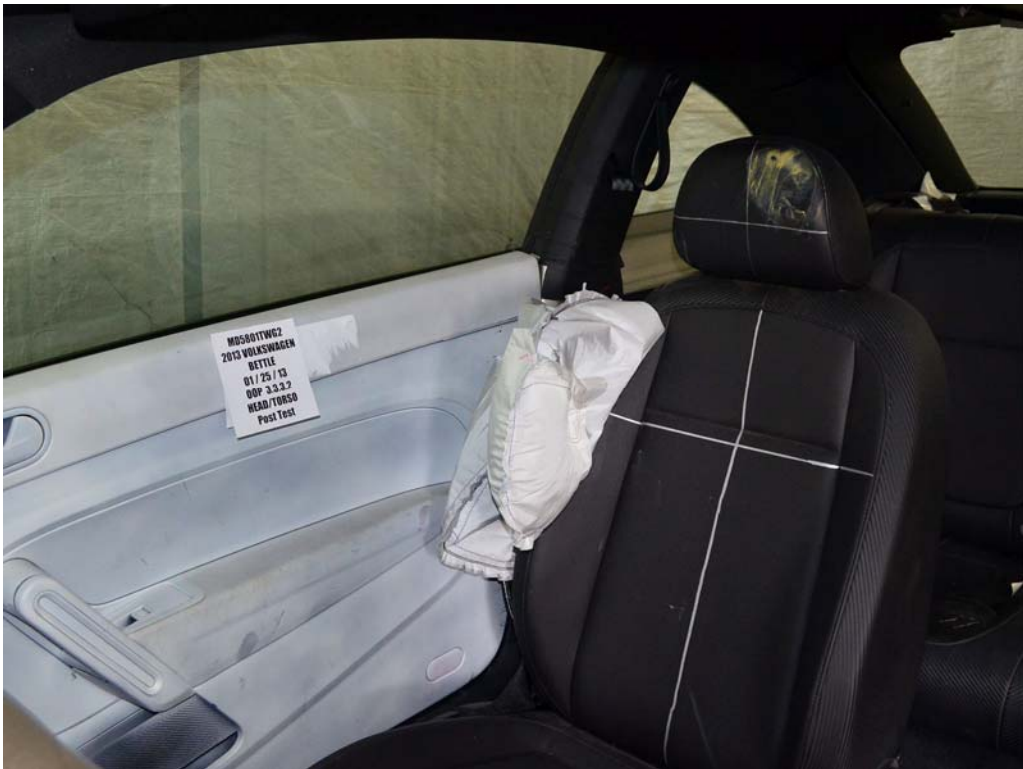
FIGURE 10. Post-Test Dummy Position, 3/4 View

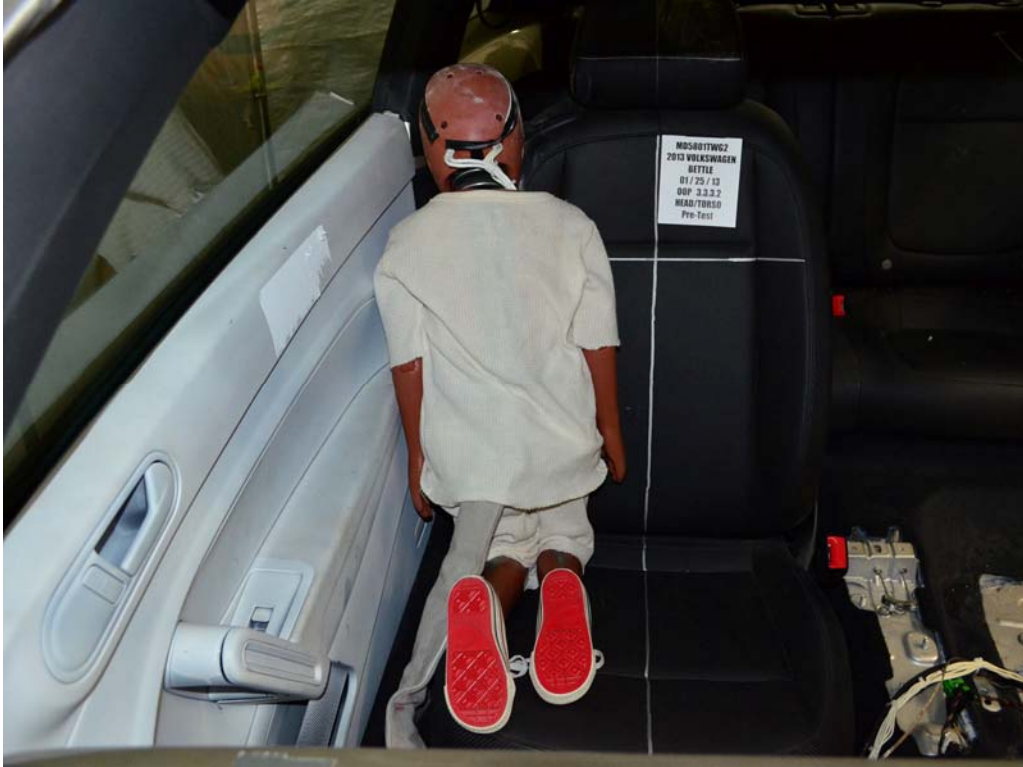
FIGURE 11. Pre-Test Dummy Position, Front View

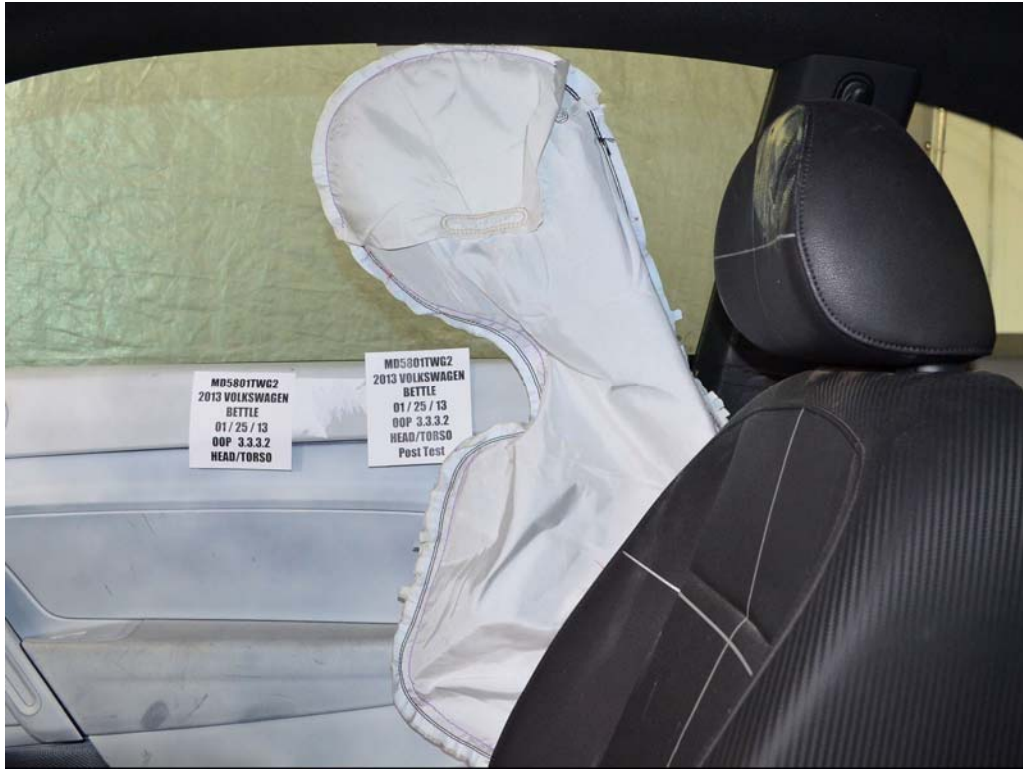
FIGURE 13. Post-Test Airbags, Left Side View

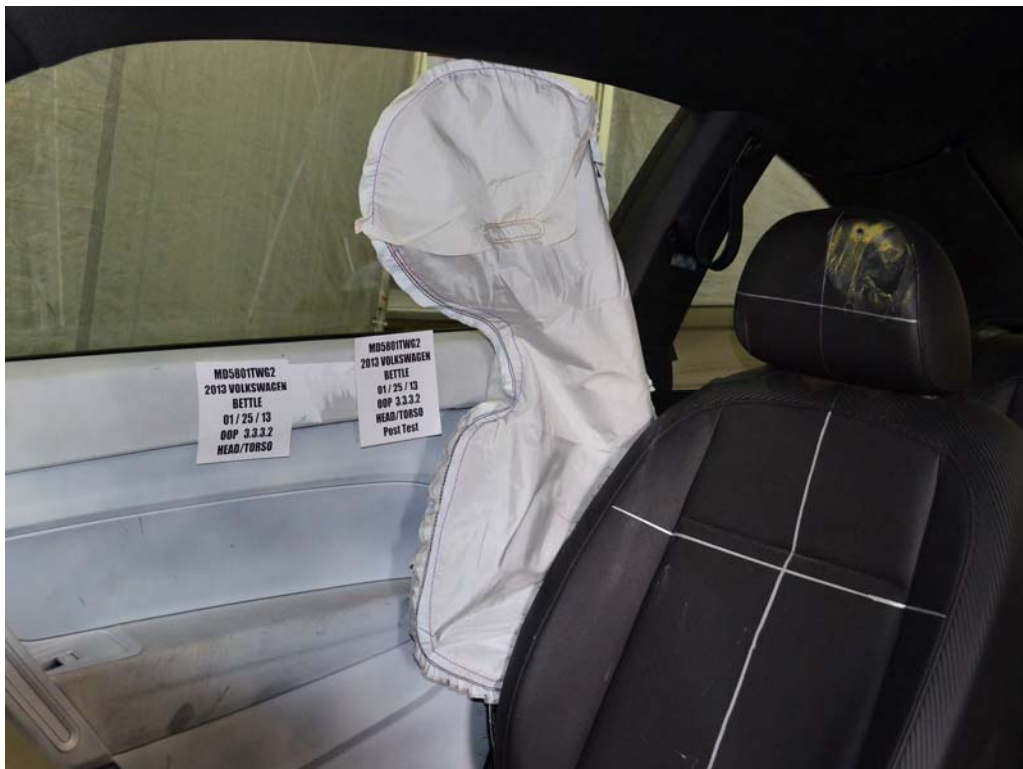
FIGURE 14. Post-Test Airbags, Left Front ¾ View
