REPORT NUMBER TR-P28003-10-NC

**NEW CAR ASSESSMENT PROGRAM
SIDE IMPACT TEST**

**FORD MOTOR CO.
2009 FORD FLEX SE
5-DOOR MPV**

NHTSA NUMBER: M90201

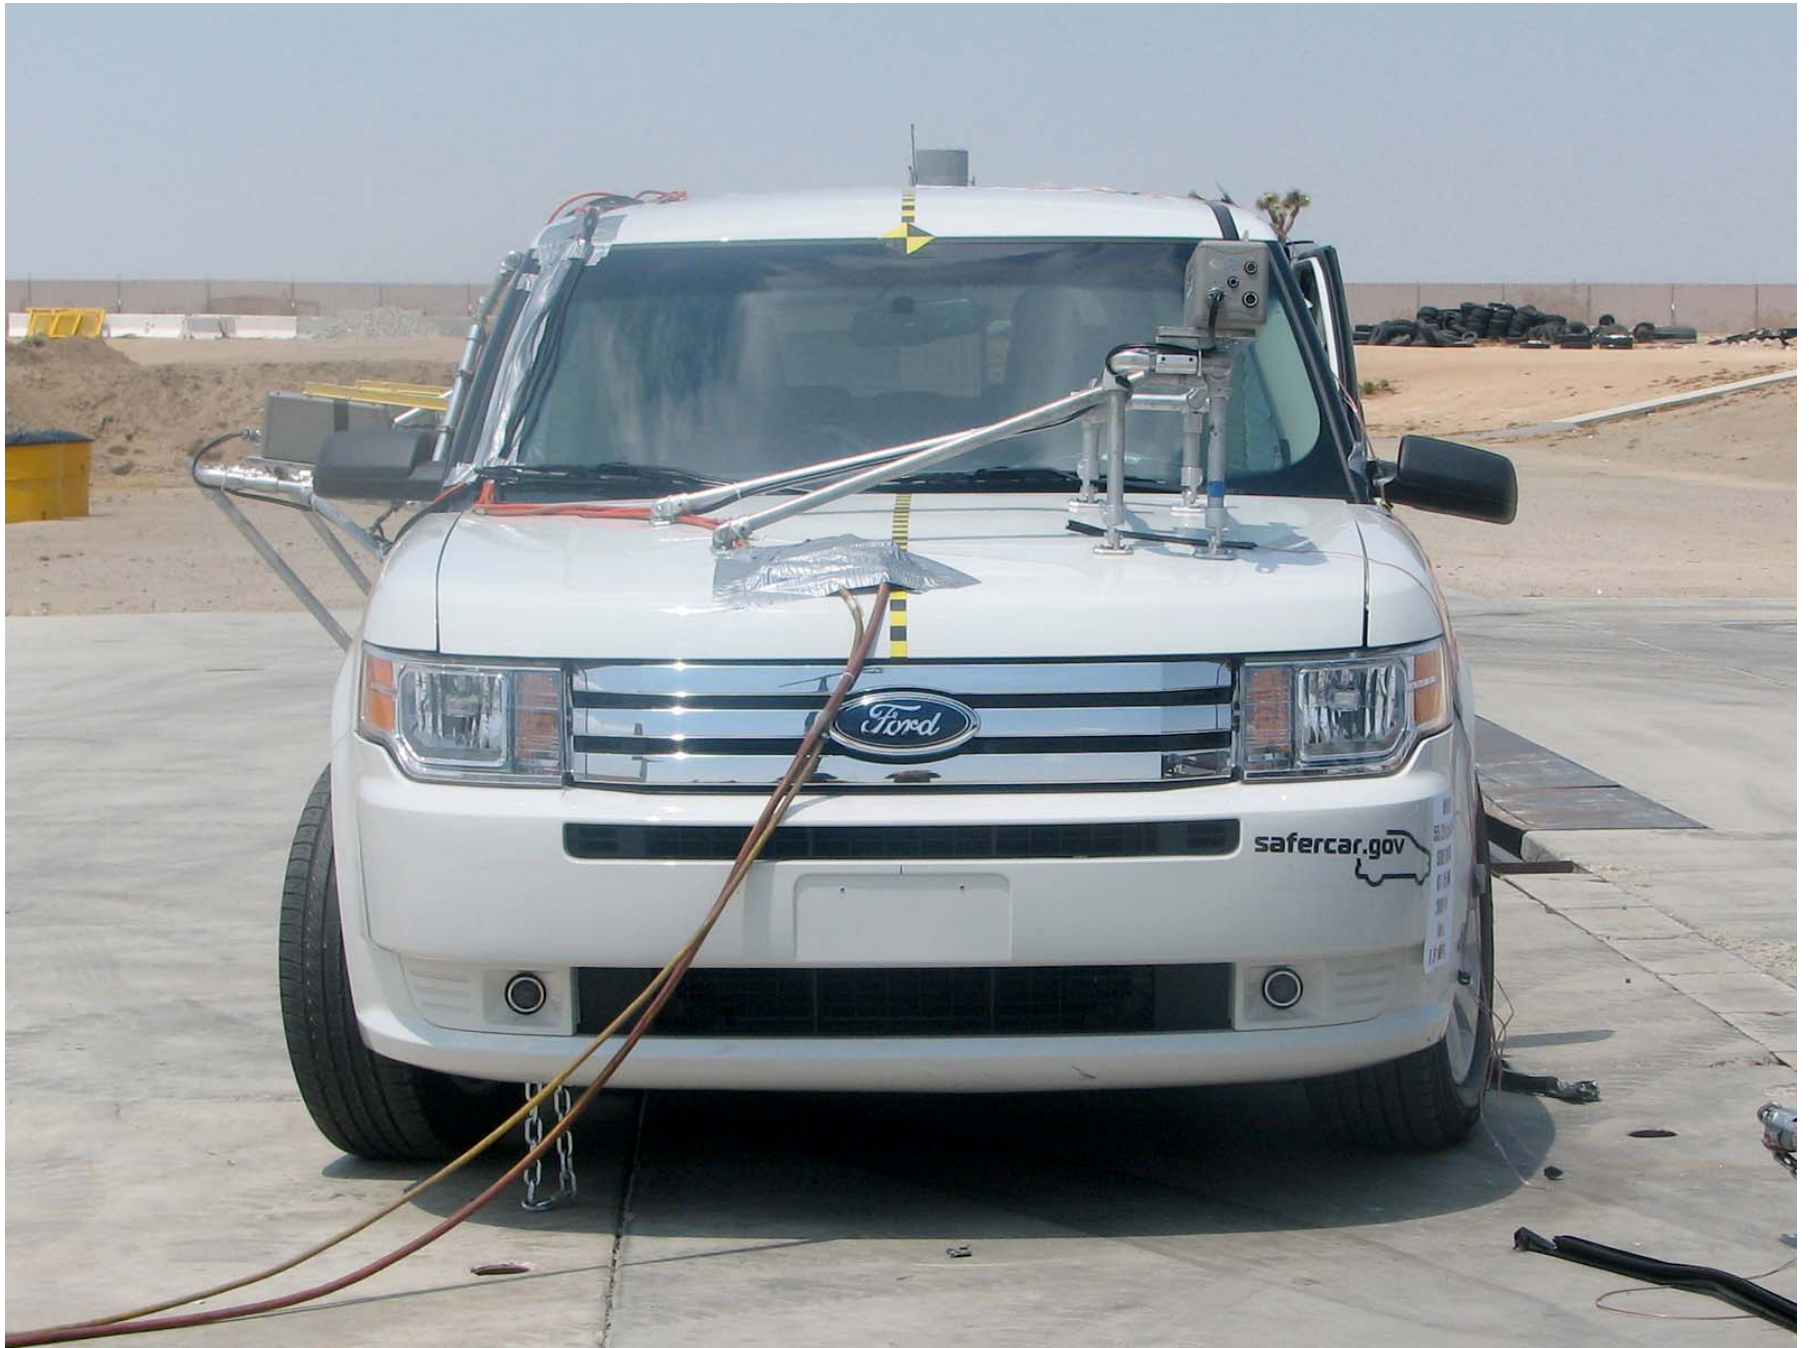
Figure A-6: Post-Test Front View

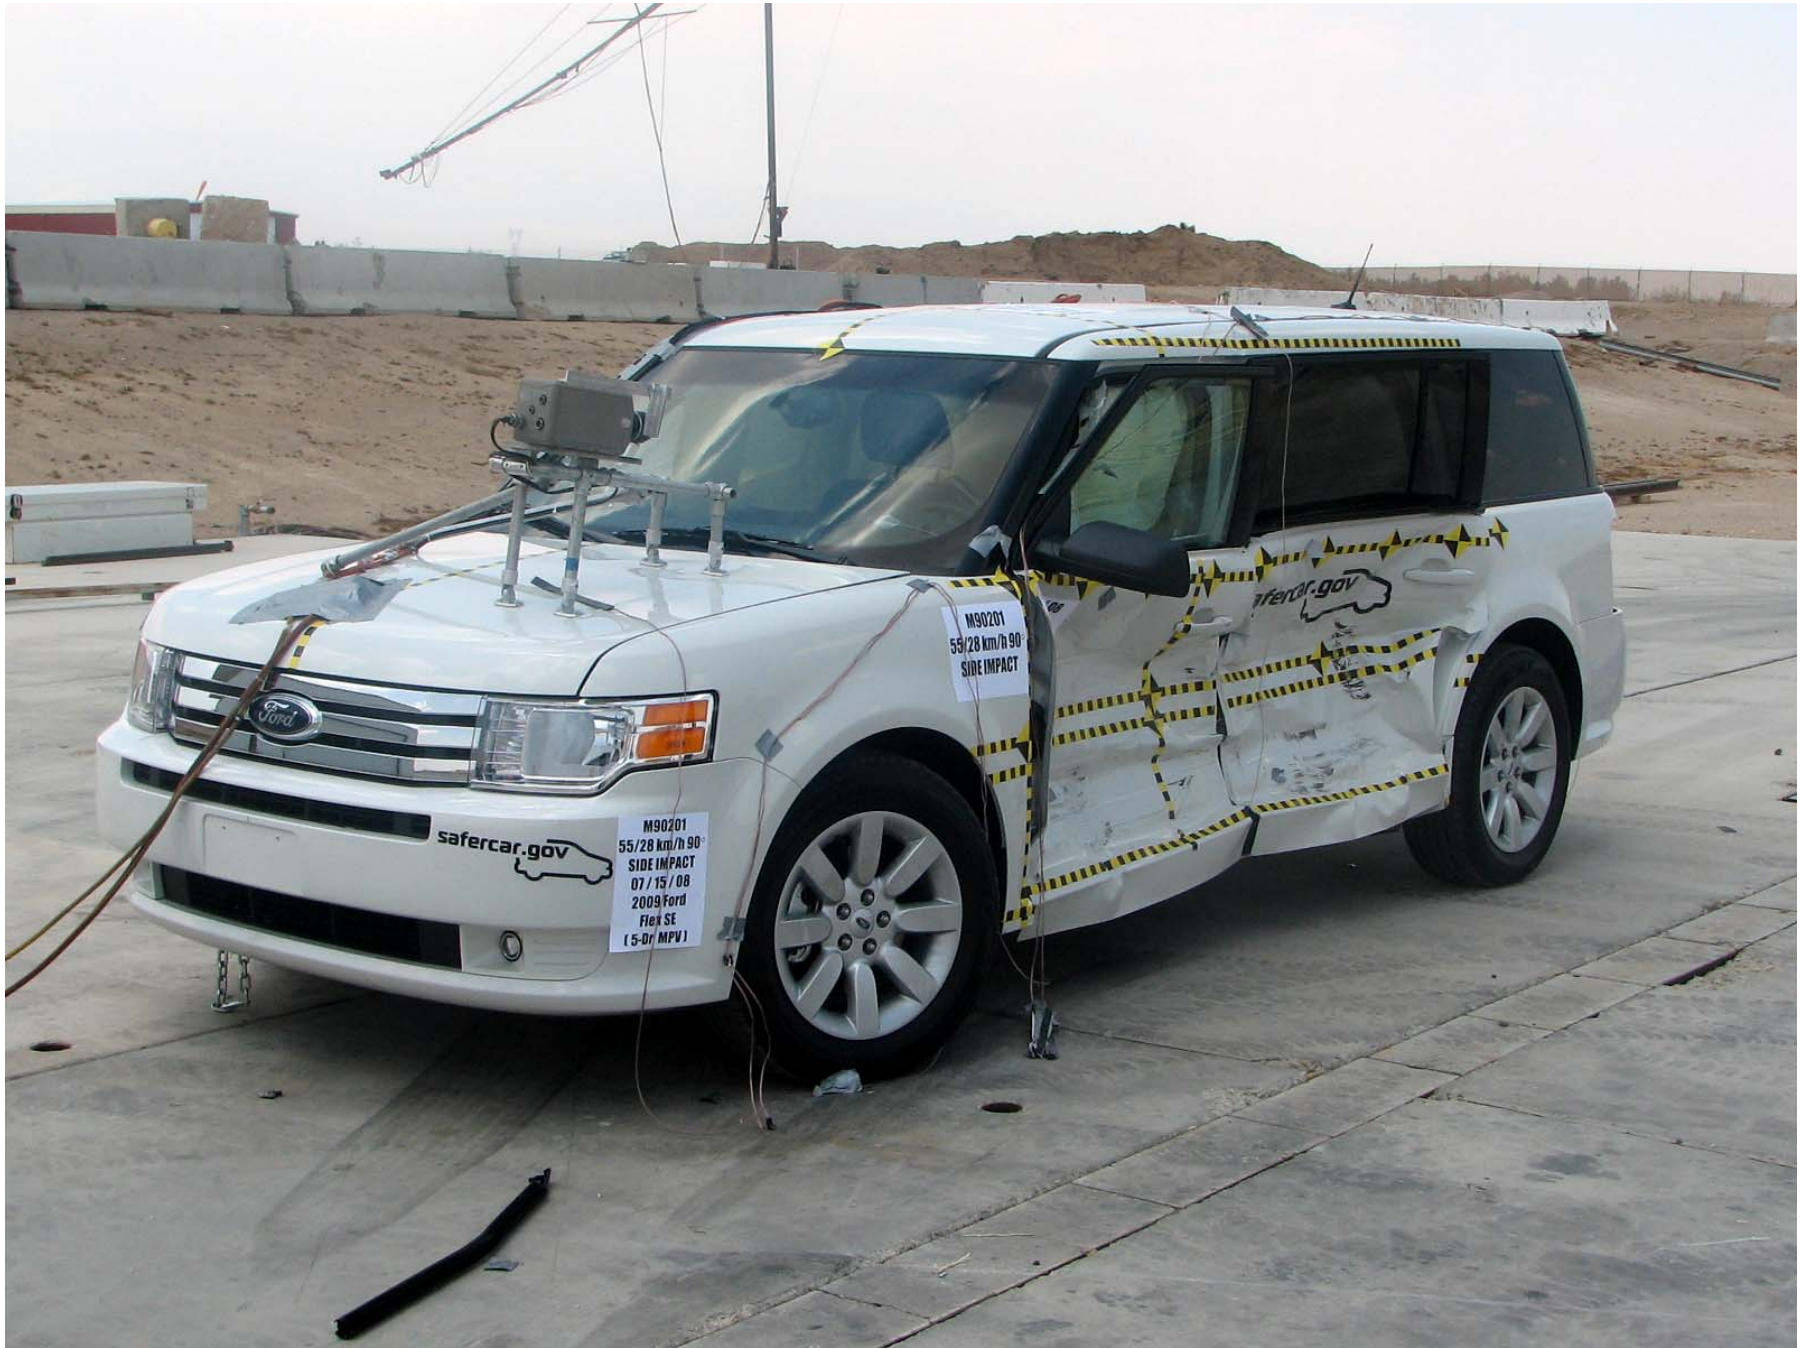
Figure A-8: Post-Test Left Front $\frac{3}{4}$ View

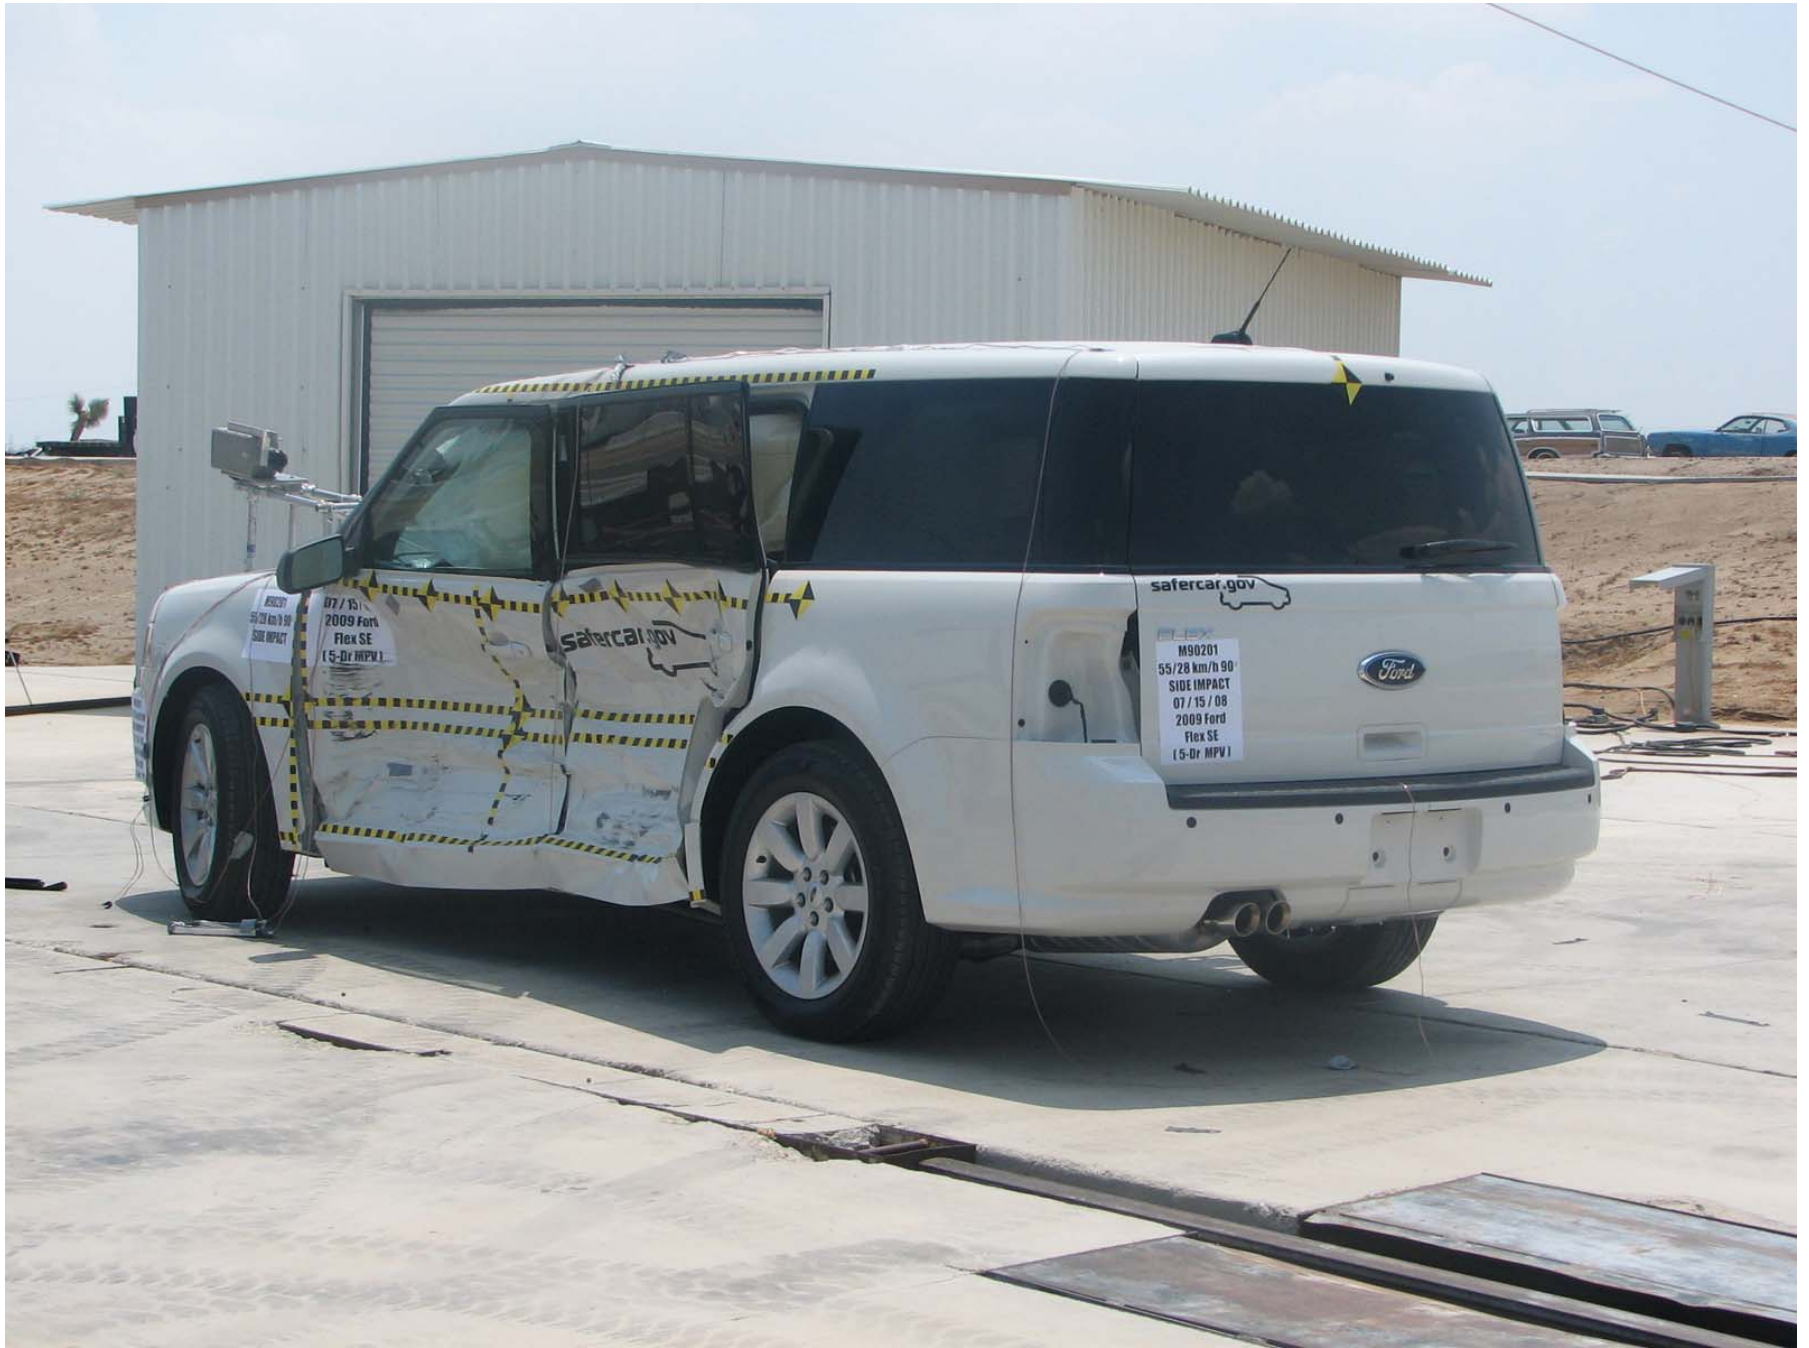
Figure A-12: Post-Test Left Rear ¾ View

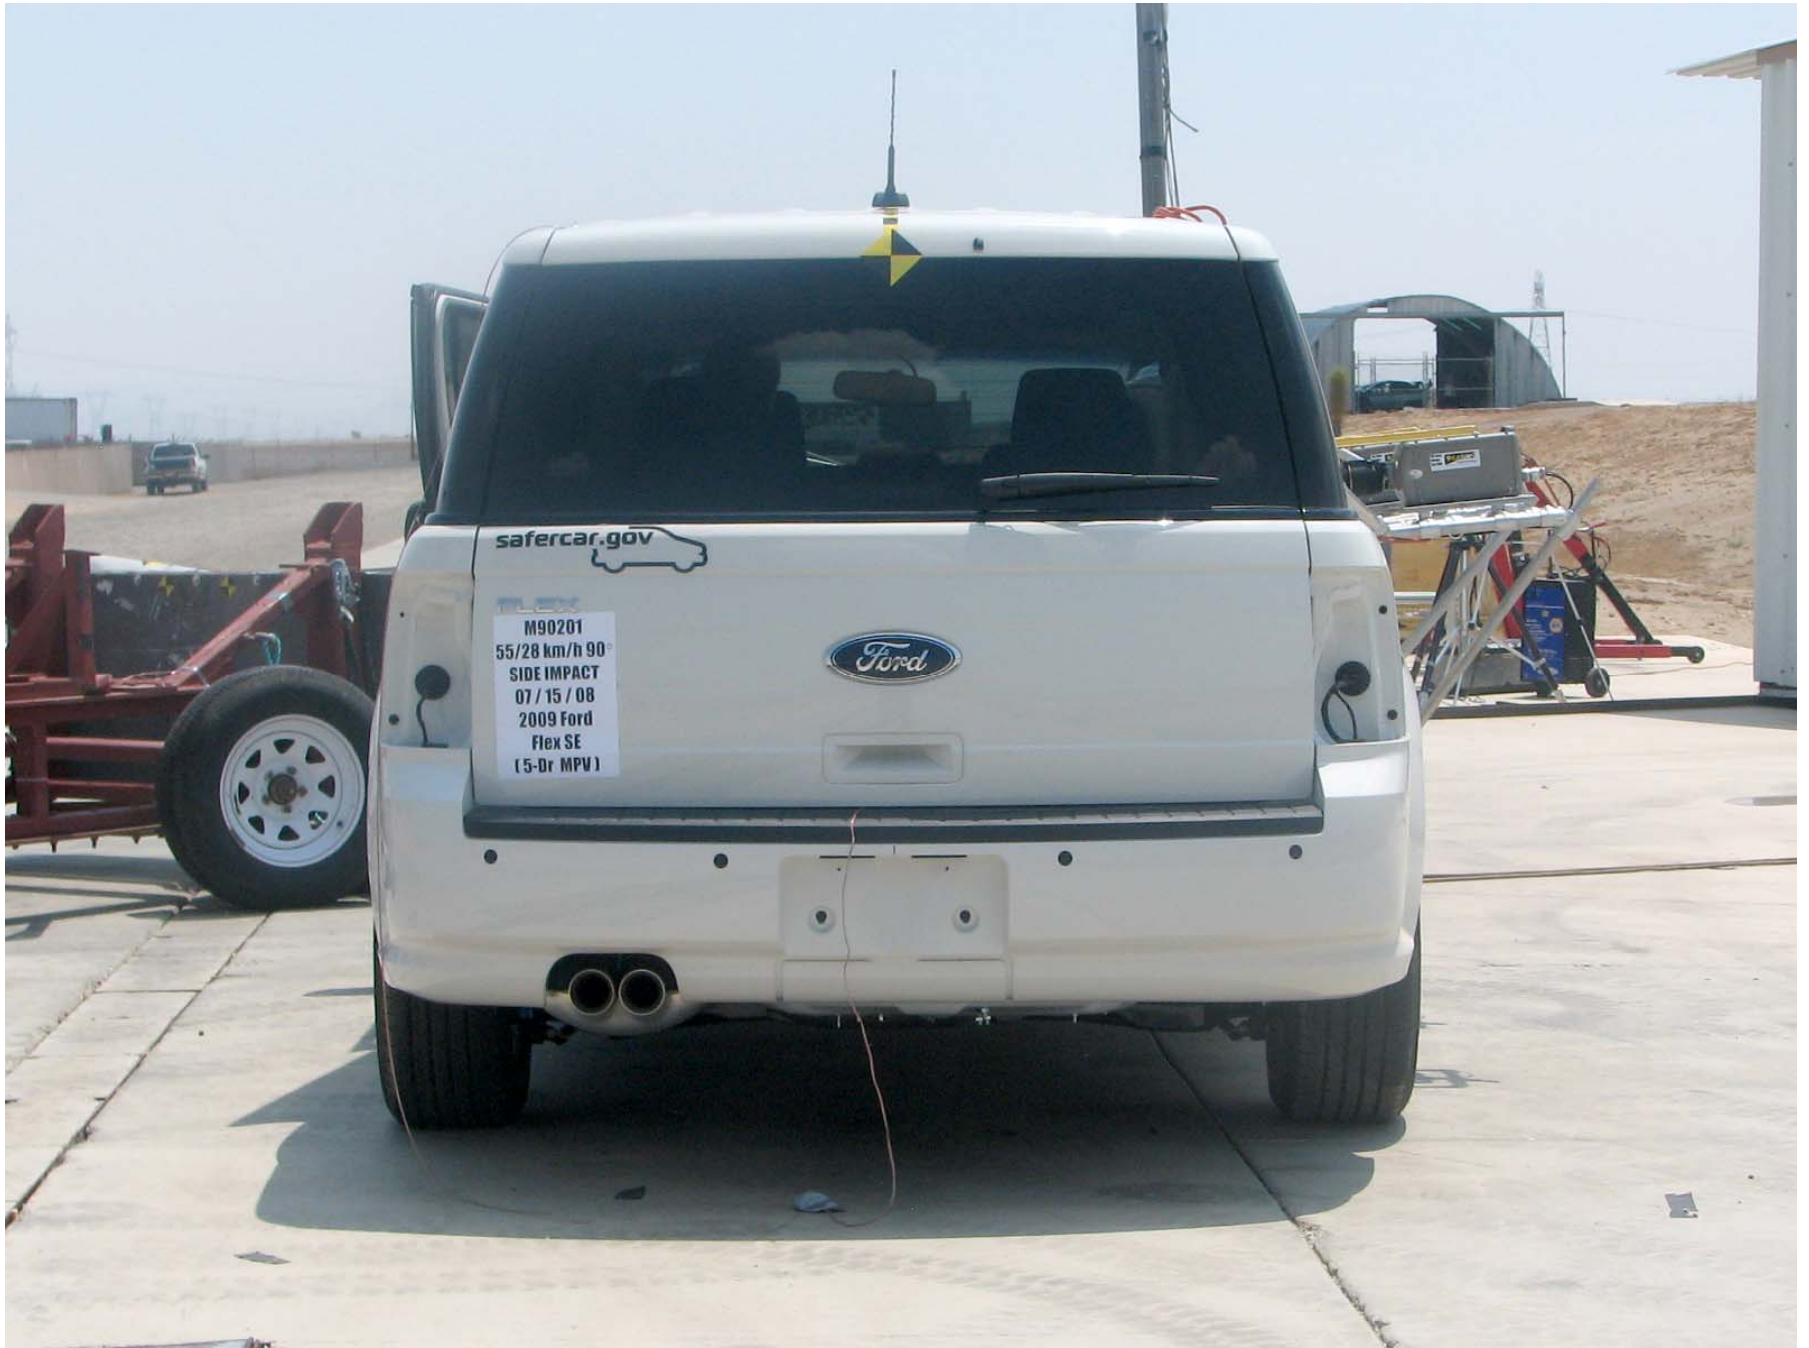
Figure A-14: Post-Test Rear View
